REPORT
DEPRECIATION SERVICES

Callisto

1281 West Cordova Street, Vancouver, BC

Date: May 17, 2024
Project Number: VR01431B

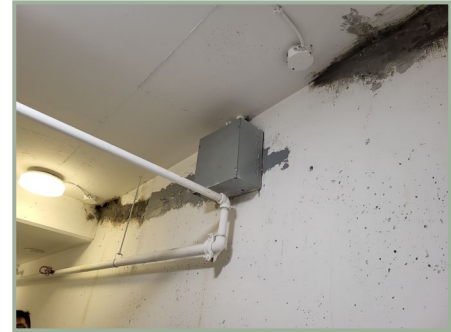
1 PARKADE	
BUILDING ENVELOPE AND STRUCTURE	Location: Below Grade
	Year Installed: 2005
	Typical Service Life (years): 50
	Effective Age (years): 18
	Remaining Service Life (years): 32
	Planned Renewal Date: 2055
<p>Description: This component includes the suspended concrete slab beneath landscaping, water fountain, concrete slab on grade, and the below grade concrete walls at the parkade.</p> <p>Condition: This asset appears to be in reasonable condition. Efflorescence was noted throughout the parkade. No active leaks were noted during the site visit; however, signs of possible past leaks and repairs were noted. JRS understands that local repairs and injections were completed under the fountain approximately 5 years ago. JRS completed three exploratory openings and did not find signs of water ingress or issues with the below grade membrane. JRS understands that a leak was reported earlier this year, and an inspection is ongoing.</p> <p>Comments: During the site visit, it was noted that there are a few locations with staining and efflorescence. JRS recommends cleaning the staining and efflorescence and monitoring if it appears again. An allowance for future repairs related to the recent leak under the fountain is included. The structural capacity of the foundation walls and slabs is expected to last the life of the building. The 50-year service life is an estimate as to when the owners can expect concrete repairs, typically related to delamination, water intrusion and wear.</p>

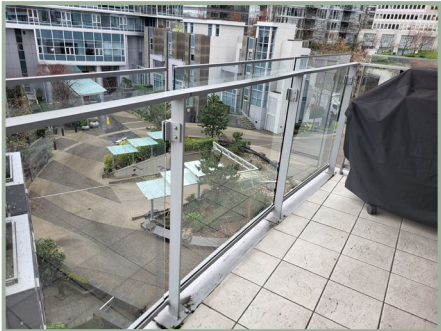
3 BALCONY GUARDRAILS			
BUILDING ENVELOPE AND STRUCTURE	Location:	Balconies and Roof Decks

Year Installed:	2005	
	Typical Service Life (years):	40	
	Effective Age (years):	14	
	Remaining Service Life (years):	26	
	Planned Renewal Date:	2049	
	<p>Description: The balcony and roof deck guardrail assemblies consist of aluminum railings with glass panels.</p> <p>Condition: The balcony guardrail assemblies are in satisfactory condition with no major deficiencies observed or reported.</p> <p>Comments: The reserve cost of this component includes the full renewal of the balcony guardrails. The balcony guardrail assemblies can be replaced in conjunction with the balcony waterproofing membranes. Although, this can be based on condition, aesthetics and other design considerations.</p>

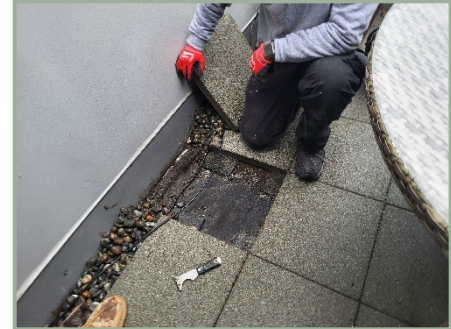
5 DECK MEMBRANE ASSEMBLIES	
BUILDING ENVELOPE AND STRUCTURE	Location: Roof Decks
	Year Installed: 2005
	Typical Service Life (years): 30
	Effective Age (years): 18
	Remaining Service Life (years): 12
	Planned Renewal Date: 2035
	<p>Description: The roof decks consist of an inverted roof system with a 2-ply SBS membrane covered in drainage board, insulation, filter fabric and concrete pavers.</p> <p>Condition: During the site visit, JRS conducted two openings to assess the condition of the waterproofing membrane. The roof deck membranes appear to be in reasonable condition with no signs of water ingress or issues observed or reported during the site visit.</p> <p>Comments: Reserve costs include full renewal of the roof deck membranes. An allowance for a review of the has been included prior to the planned renewal.</p>

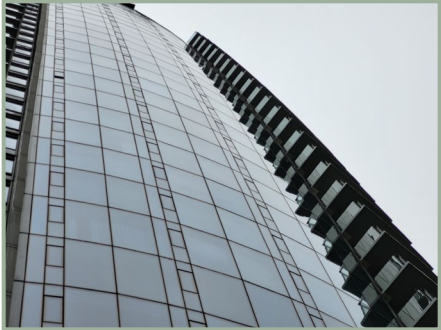
7 CURTAIN WALL			
BUILDING ENVELOPE AND STRUCTURE	Location:	Building Exterior

Year Installed:	2005	
	Typical Service Life (years):	40	
	Effective Age (years):	18	
	Remaining Service Life (years):	22	
	Planned Renewal Date:	2045	
	<p>Description: The curtain wall assemblies are installed on the exterior of targeted sections of the building. The curtain walls are aluminum framed with double-paned IGUs.</p> <p>Condition: The curtain wall assemblies are in satisfactory condition with no major deficiencies observed or reported. JRS understands that past targeted repairs were completed in the last decade.</p> <p>Comments: Allowances have been included every 2-3 years for targeted replacement of IGUs as required alongside the window wall allowance, and approximately every 10 years for targeted fishtanking repairs. The reserve cost of this component includes full renewal of the component at the end of its typical lifespan.</p>

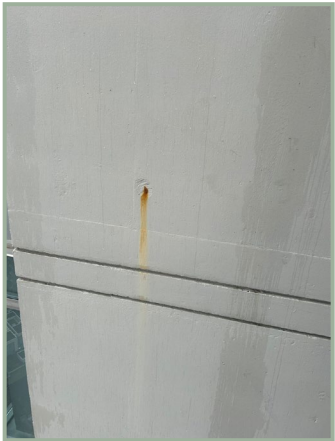
8 EXTERIOR WALLS - CONCRETE			
BUILDING ENVELOPE AND STRUCTURE	Location:	Building Exterior

Year Installed:	2005	
	Typical Service Life (years):	40	
	Effective Age (years):	18	
	Remaining Service Life (years):	22	
	Planned Renewal Date:	2045	
	<p>Description: This component includes concrete walls with elastomeric coating found on sections of the exterior walls.</p> <p>Condition: The concrete cladding is generally in fair condition with targeted sections of delamination and corrosion staining observed from the rope drops conducted. JRS understands that local repairs were completed in 2015-2017.</p> <p>Comments: Allowances have been included for targeted repair or replacement, including an estimated design package fee of the concrete delamination and corrosion, a periodic targeted repair allowance, and a building envelope condition assessment. Reserve costs are scheduled after 40 years of service life when targeted renewal and face sealing will generally be required.</p>

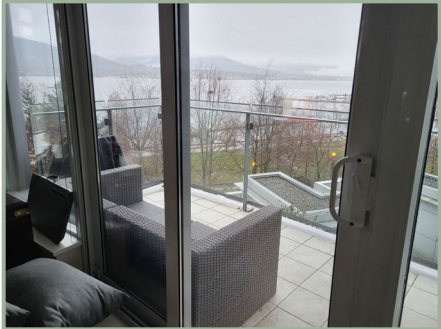
9 SLIDING DOORS														
BUILDING ENVELOPE AND STRUCTURE

Location:	Balconies and Roof Decks												
	Year Installed:	2005												
	Typical Service Life (years):	40												
	Effective Age (years):	18												
	Remaining Service Life (years):	22												
	Planned Renewal Date:	2045												
<p>Description: The aluminum framed sliding doors are installed at the balconies and roof decks.</p>														
<p>Condition: The sliding doors are in satisfactory condition with no major deficiencies observed or reported. JRS understands that resealing of targeted sliding doors was completed in 2015-2017.</p>														
<p>Comments: Reserve costs for this component include the replacement of the sliding doors.</p>

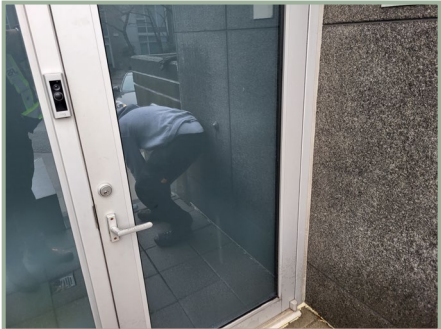
10 SWING DOORS														
BUILDING ENVELOPE AND STRUCTURE

Location:	Balconies and Roof Decks												
	Year Installed:	2005												
	Typical Service Life (years):	35												
	Effective Age (years):	18												
	Remaining Service Life (years):	17												
	Planned Renewal Date:	2040												
<p>Description: The exterior swing doors are aluminum framed with glass panels and are located at balconies and roof decks.</p>														
<p>Condition: The swing doors are in satisfactory condition with no major deficiencies observed or reported.</p>														
<p>Comments: The swing doors generally have long service lives if properly maintained and are often replaced for aesthetic reasons. Reserve costs for this component allow for the replacement of the swing doors after 35 years of service.</p>

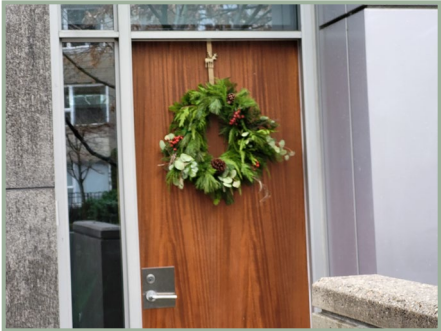
11 TOWNHOUSE ENTRY DOORS			
BUILDING ENVELOPE AND STRUCTURE	Location:	Townhouse Entry

Year Installed:	2005	
	Typical Service Life (years):	30	
	Effective Age (years):	18	
	Remaining Service Life (years):	12	
	Planned Renewal Date:	2035	
	<p>Description: The exterior townhouse entry doors are metal clad wooden swing doors.</p> <p>Condition: The swing doors are in satisfactory condition with no major deficiencies observed or reported. JRS understands targeted repairs to the mechanical components were completed in 2010.</p> <p>Comments: The swing doors generally have long service lives if properly maintained and are often replaced for aesthetic reasons. Reserve costs for this component allow for the replacement of the swing doors after 30 years of service.</p>

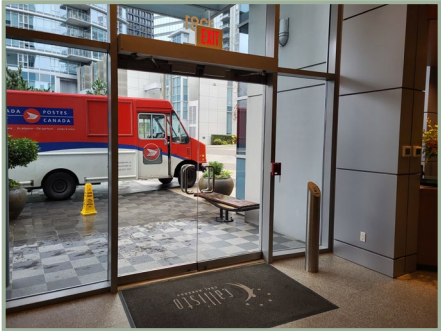
12 MAIN ENTRY DOORS			
BUILDING ENVELOPE AND STRUCTURE	Location:	Building Entry

Year Installed:	2005	
	Typical Service Life (years):	35	
	Effective Age (years):	18	
	Remaining Service Life (years):	17	
	Planned Renewal Date:	2040	
	<p>Description: The glass panel and double swing entrance doors are installed on the east and south entrances of the building.</p> <p>Condition: The front entrance doors are in satisfactory condition with no major deficiencies observed or reported.</p> <p>Comments: Reserve costs include full replacement of the front entrance doors.</p>

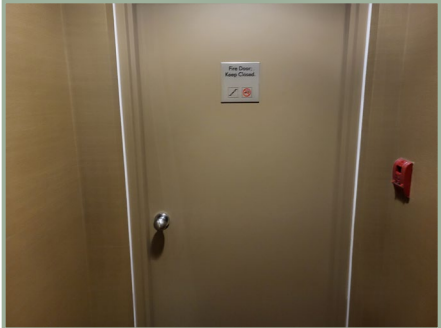
13 SERVICE DOORS			
BUILDING ENVELOPE AND STRUCTURE	Location:	Throughout Property

Year Installed:	2005	
	Typical Service Life (years):	40	
	Effective Age (years):	18	
	Remaining Service Life (years):	22	
	Planned Renewal Date:	2045	
	<p>Description: The exterior/interior service swing doors are metal doors and are located throughout the property including at building egress locations and parkade elevator lobby entrances.</p> <p>Condition: The swing doors are in satisfactory condition with no major deficiencies observed or reported.</p> <p>Comments: The swing doors generally have long service lives if properly maintained and are often replaced for aesthetic reasons. Reserve costs for this component allow for the replacement of the swing doors after 40 years of service.</p>

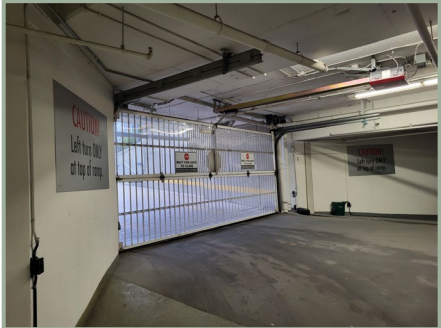
14 GARAGE DOORS			
BUILDING ENVELOPE AND STRUCTURE	Location:	Parkade

Year Installed:	2005	
	Typical Service Life (years):	35	
	Effective Age (years):	18	
	Remaining Service Life (years):	17	
	Planned Renewal Date:	2040	
	<p>Description: The metal picket garage doors are installed at the entrance of the parkade shared between Callisto and Carina, and between the residential and visitors' areas. They are powered by motorized units.</p> <p>Condition: The garage doors are in satisfactory condition with no major deficiencies observed. According to the information provided, the main garage door was replaced in 2007.</p> <p>Comments: Metal garage doors generally have a long service life if no vehicle collisions occur. However, the mechanical components and accessories (e.g., bearings, tracks) may require replacement more frequently. Allowances have been included for garage door motor replacements periodically. Reserve costs include the renewal of the main garage door (costs represent 56% share of strata) and the garage door dividing the residential and visitors' areas.</p>

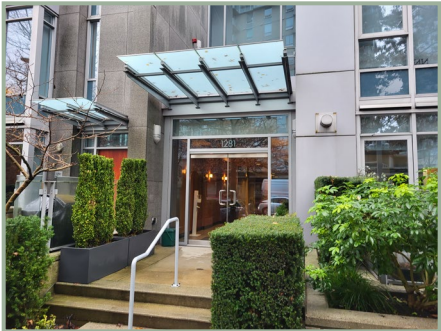
17 CANOPIES			
BUILDING ENVELOPE AND STRUCTURE	Location:	Building Exterior

Year Installed:	2005	
	Typical Service Life (years):	30	
	Effective Age (years):	18	
	Remaining Service Life (years):	12	
	Planned Renewal Date:	2035	
	<p>Description: This component includes the glass canopies at the building and townhouse unit entrances.</p> <p>Condition: The canopies are in satisfactory condition with no reported issues.</p> <p>Comments: Reserve costs include full renewal of the canopies at the end of its typical lifespan.</p>

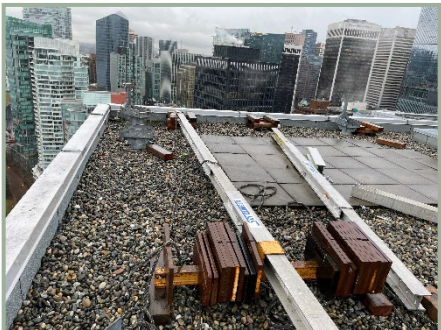
18 LOW SLOPE ROOF			
BUILDING ENVELOPE AND STRUCTURE	Location:	Roofs

Year Installed:	2005	
	Typical Service Life (years):	25	
	Effective Age (years):	18	
	Remaining Service Life (years):	7	
	Planned Renewal Date:	2030	
	<p>Description: The building's roofing system consists of inverted roof assemblies. The main roof consists of a 2-ply torch applied styrene-butadiene-styrene (SBS) membrane. The roof areas are protected by a membrane and covered with rigid insulation and either gravel ballast or concrete pavers.</p> <p>Condition: The roof membranes are in overall satisfactory condition.</p> <p>Comments: Organic matter and debris should be removed as build-up occurs. It is recommended to complete a Roof Condition Assessment 3 years prior to the end of the typical service life to better understand the condition of the roofing membrane. Reserve costs include allowances for a condition assessment and renewal of the assembly.</p>

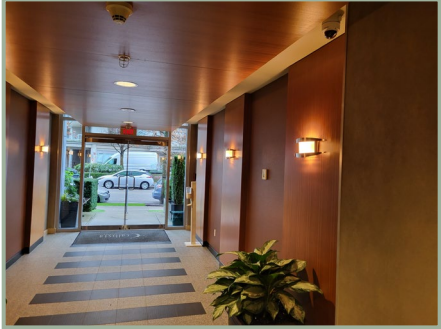
20 LOBBY			
INTERIOR	Location:	Lobby

Year Installed:	2005	
	Typical Service Life (years):	20	
	Effective Age (years):	18	
	Remaining Service Life (years):	2	
	Planned Renewal Date:	2025	
<p>Description: The lobby finishes include a combination of tile and wood panel walls, granite tile floors, water fountain tiling/membrane and painted drywall ceilings. Furnishings include couches, concierge desks, wood tables, and lights.</p> <p>Condition: The lobby finishes and furniture are in satisfactory condition with no major deficiencies observed.</p> <p>Comments: Due to the aesthetic nature of the interiors, the renewal year is subjective and at the discretion of the Owners. Information about the extent and cost of the renewal of this component has been provided by the Renovation Committee of the Callisto Strata Council. The cost estimate was based on a design provided by the architecture firm Dialogue Design and a budget provided by the project management firm Make Projects Ltd. Both firms were engaged by the Renovation Committee.</p>

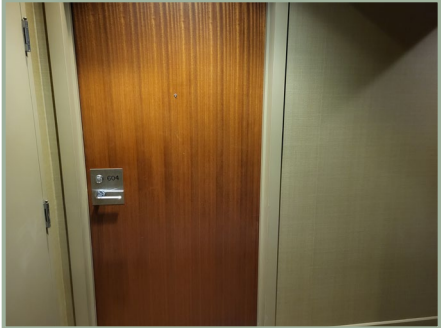
21 UNIT ENTRY DOORS			
INTERIOR	Location:	Unit Entries

Year Installed:	2005	
	Typical Service Life (years):	50	
	Effective Age (years):	18	
	Remaining Service Life (years):	32	
	Planned Renewal Date:	2055	
<p>Description: This component includes the wood unit entry doors.</p> <p>Condition: The unit entry doors are in satisfactory condition with no major deficiencies observed.</p> <p>Comments: The unit entry doors should be maintained to prolong the service life of this component.</p>

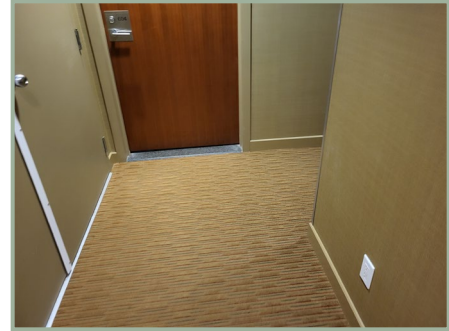
22 HALLWAYS, STAIRWELLS AND COMMON AREAS	
INTERIOR	Location: Interior
	Year Installed: 2005
	Typical Service Life (years): 15
	Effective Age (years): 13
	Remaining Service Life (years): 2
	Planned Renewal Date: 2025
<p>Description: This component includes the carpeting and painting in the hallways and stairwells.</p> <p>Condition: The carpeting and painting in the hallways appear to be in reasonable condition with no noted damage. JRS understands that targeted repairs have been completed in 2013.</p> <p>Comments: The reserve costs include replacement of all the interior flooring and painting of all interior hallways and stairwells. Information about the extent and cost of the renewal of this component has been provided by the Renovation Committee of the Callisto Strata Council. The cost estimate was based on a design provided by the architecture firm Dialogue Design and a budget provided by the project management firm Make Projects Ltd. Both firms were engaged by the Renovation Committee.</p>

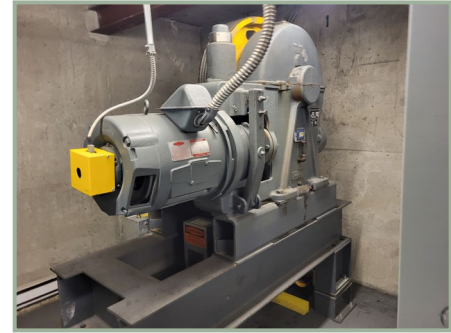
23 ELEVATOR - TRACTION	
CONVEYANCE	Location: Rooftop Elevator Room
	Year Installed: 2005
	Typical Service Life (years): 30
	Effective Age (years): 18
	Remaining Service Life (years): 12
	Planned Renewal Date: 2035
<p>Description: The tower has three overhead gear tractions manufactured by TKE North Elevators. The elevators have infrared door edges, voice call out systems, and are linked to the security system.</p> <p>Condition: The elevator mechanical systems appear to be in satisfactory condition and are maintained by Otis Elevators.</p> <p>Comments: Allowances for targeted repairs have been included based on the TK Elevators Capital Planning report. General renewal and cost information have been provided by Besant & Associates Engineers Ltd. The system should be inspected periodically for failure of gears, valves, door operators, relays, contactors, motor windings, and computer processors. JRS recommends the elevator systems be inspected and assessed by a qualified professional engineer to better gauge renewal year and costs associated with modernization. An allowance has been included for assessment and targeted repairs three years prior to modernization.</p>

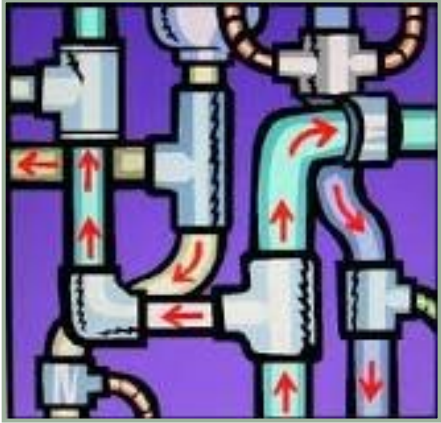
25	DOMESTIC WATER PIPES

MECHANICAL	Location:	Throughout Complex	
	Year Installed:	2005	
	Typical Service Life (years):	30	
	Effective Age (years):	13	
	Remaining Service Life (years):	17	
	Planned Renewal Date:	2040	
	Description: This component includes domestic water distribution (copper piping) for residential units and the building amenities.		
	Condition: The piping is generally in fair condition. For more information, please see the detailed piping assessment report completed by Besant & Associates Engineers Ltd.		
	Comments: Information regarding the condition, renewal and cost for this component has been provided by Besant & Associates Engineers Ltd. An allowance has been provided to replace the copper recirculation pipes as recommended in the detailed piping report. Copper water lines will deteriorate and their risk for failure will increase with time. Predicting when failure will occur is difficult as many variables must be considered including localized water pressure, water quality, temperature, copper material quality/condition, manufacturing/installation conditions, etc. Renewal costs do not include all interior work (e.g., drywall, paint, texturing, and finishes), which may vary substantially based on code updates, material compatibilities, and potential hazardous material in the drywall and insulation, etc. The lifespan of the domestic water pipes can be prolonged if a robust water treatment system is installed.

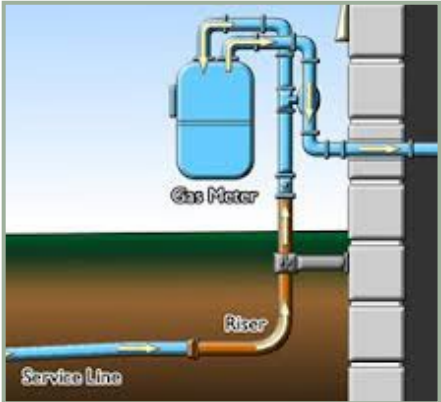
27 GAS PIPES			
MECHANICAL	Location:	Underground

Year Installed:	2005	
	Typical Service Life (years):	50	
	Effective Age (years):	18	
	Remaining Service Life (years):	32	
	Planned Renewal Date:	2055	
<p>Description: Gas is piped throughout the building for the fireplaces.</p> <p>Condition: The gas piping could not be visually reviewed; however, no issues were reported by the building representative.</p> <p>Comments: Gas piping generally lasts longer than municipal water piping because of the inert nature and lower density of natural gas. An allowance has been included for targeted repair to the gas piping.</p>

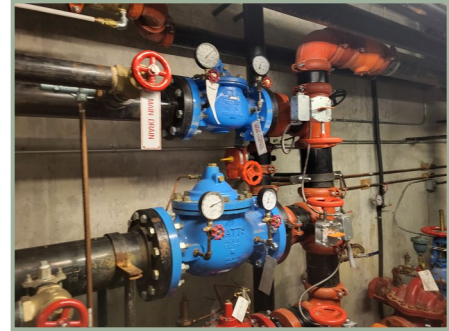
28 SPRINKLER PIPES	
MECHANICAL	Location: Throughout Complex
	Year Installed: 2005
	Typical Service Life (years): 50
	Effective Age (years): 18
	Remaining Service Life (years): 32
	Planned Renewal Date: 2055
<p>Description: This component includes the automated sprinkler system servicing the tower and the parkade in the complex and consists of sprinkler pipes and pumping/compressor equipment.</p> <p>Condition: The sprinkler pipes and fire pump components are in satisfactory condition with no major deficiencies observed or reported.</p> <p>Comments: The fire suppression lines will likely last for a significant period of time. Costs associated with this asset will likely consist of upgrading or repairing mechanical components such as: sprinkler heads, pumps, air compressors, etc. An allowance has been included to replace valves, pumps and controls as recommended by Besant & Associates Engineers Ltd.</p>

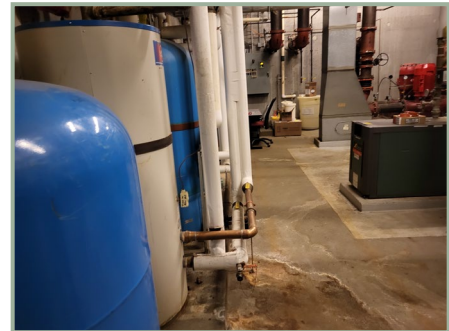
Description: There are four hot water storage tanks that store hot water from the boiler for distribution to individual suites and amenities. The hot water storage tanks are maintained by Honeywell.

Condition: The hot water storage tanks are in serviceable condition.

Comments: Information regarding the condition, renewal and cost for this component has been provided by Besant & Associates Engineers Ltd. Regular maintenance and inspection should be undertaken to ensure that the hot water storage tanks are operating at full efficiency. The tanks have a typical service life of around 20-25 years, varying based on frequency of use and maintenance.

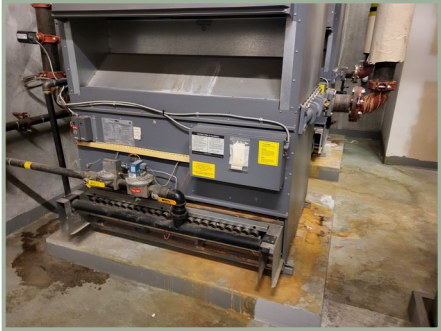
31	HEATING BOILER		
MECHANICAL	Location:	Mechanical Room

Year Installed:	2005	
	Typical Service Life (years):	25	
	Effective Age (years):	20	
	Remaining Service Life (years):	5	
	Planned Renewal Date:	2028	
	<p>Description: There are two Laars gas-fired atmospheric type boilers located in the mechanical rooms. The boilers are maintained by Honeywell. The boilers provide heated hot water for the primary water source heat pump loop, air handling units, and double walled heat exchangers that heat the pool and hot tub.</p> <p>Condition: The boilers are in serviceable condition. JRS understands that the boilers were overhauled in 2017.</p> <p>Comments: Information regarding the condition, renewal and cost for this component has been provided by Besant & Associates Engineers Ltd. Regular maintenance and inspection should be undertaken to ensure that the boilers are operating at full efficiency. The boilers have a typical service life of around 20-25 years, varying based on frequency of use and maintenance. While the purpose of the depreciation report is not to include any new components, Besant & Associates Engineers Ltd. recommended to install a new boiler for the pool, hot tub and make up air unit; the cost is estimated in the range of \$300,000.</p>

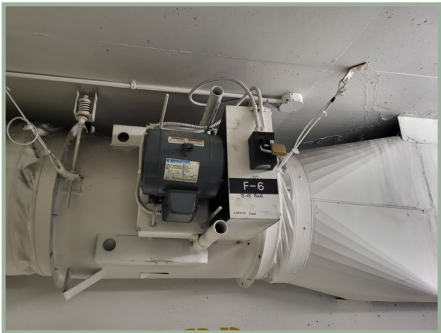
36 HVAC - PARKADE			
MECHANICAL	Location:	Parkade

Year Installed:	2005	
	Typical Service Life (years):	30	
	Effective Age (years):	13	
	Remaining Service Life (years):	17	
	Planned Renewal Date:	2040	
<p>Description: This component includes the CO sensors and exhaust fans used to ventilate the parkade areas.</p> <p>Condition: This component appears to be in functioning condition.</p> <p>Comments: As with the building HVAC system, the parkade HVAC equipment requires maintenance and regular inspection in order to operate at peak efficiency. The reserve costs include full replacement of the parkade ventilation components when they fail as well as an allowance for a professional review prior to its replacement.</p>

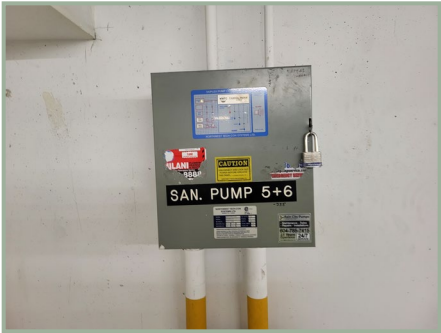
37 SUMP PUMPS	
MECHANICAL	Location: Parkade
	Year Installed: 2005
	Typical Service Life (years): 10
	Effective Age (years): 5
	Remaining Service Life (years): 5
	Planned Renewal Date: 2028

<p>Description: There are duplex sump pump systems for sanitary and storm water as well as for elevator sump pits.</p> <p>Condition: The sump pumps are in serviceable condition with no reported issues.</p> <p>Comments: Reserve costs include full renewal of the pumps at the end of its typical lifespan.</p>

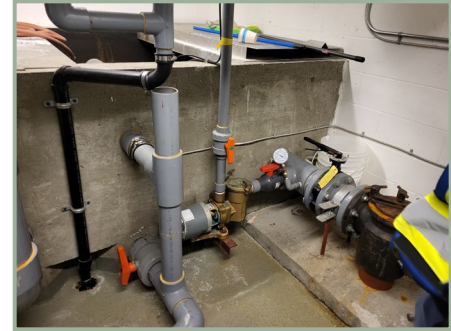
39 POOL AND HOT TUB MECHANICAL COMPONENTS

Description: This component includes the pool, and hot tub feature mechanical system including the pump, filter, and piping.

Condition: The pool and hot tub system are in serviceable condition.

Comments: Information regarding the condition, renewal and cost for this component has been provided by Besant & Associates Engineers Ltd. Reserve costs include full renewal of the pool and hot tub mechanical system. An allowance has been provided to install a new pool and hot tub boiler as recommended by Besant Associates Engineers Ltd.

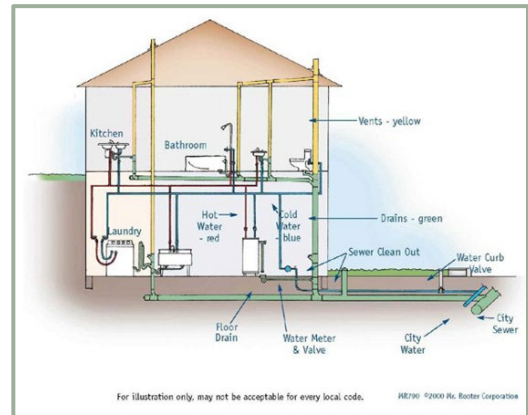
40 SANITARY AND DRAINAGE LINES

Description: This component includes the sanitary and storm piping running from the units' kitchens.

Condition: The sanitary and storm piping is generally in serviceable condition.

Comments: Information regarding the condition, renewal and cost for this component has been provided by Besant & Associates Engineers Ltd. Reserve costs include full renewal of this component.

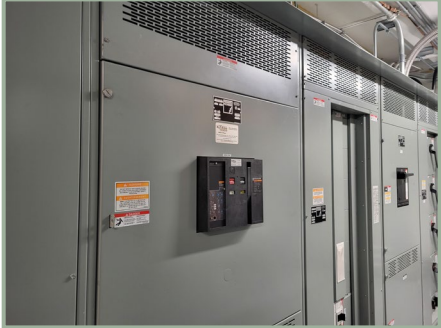
41 SERVICE DISTRIBUTION			
ELECTRICAL	Location:	Electrical Room

Year Installed:	2005	
	Typical Service Life (years):	50	
	Effective Age (years):	18	
	Remaining Service Life (years):	32	
	Planned Renewal Date:	2055	
	<p>Description: This component includes incoming underground service and electrical equipment (i.e., circuit breaker panels, electrical panels, and disconnect switches) inside electrical rooms. Transformers of various sizes are included.</p> <p>Condition: The service distribution components appear to be in satisfactory condition.</p> <p>Comments: Allowances have been included every 5 years for infrared scanning and vault maintenance of the electrical rooms.</p>

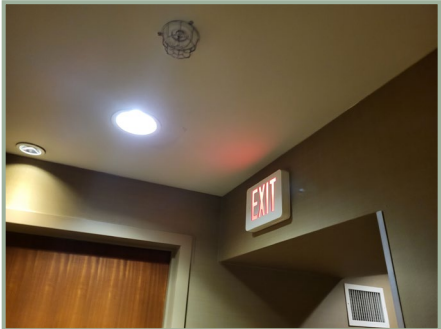
42 POWER DISTRIBUTION			
ELECTRICAL	Location:	Throughout Building

Year Installed:	2005	
	Typical Service Life (years):	40	
	Effective Age (years):	18	
	Remaining Service Life (years):	22	
	Planned Renewal Date:	2045	
	<p>Description: This component includes a small percentage of wiring in walls and lighting (interiors, exit signs, parkade).</p> <p>Condition: The wiring could not be visually inspected; however, it is generally in functioning condition with no reported issues. JRS understands that targeted lights have been renewed to LED in 2015.</p> <p>Comments: Information regarding the condition, renewal and cost for this component has been provided by Besant & Associates Engineers Ltd. An allowance has been added to replace the common area lighting in 2034. Routine inspection and maintenance should be performed as required. Reserve costs are to replace a small percentage of the building wiring, as it is expected to last the lifetime of the building, and partial renewals for lighting, baseboard heaters and exit signs.</p>

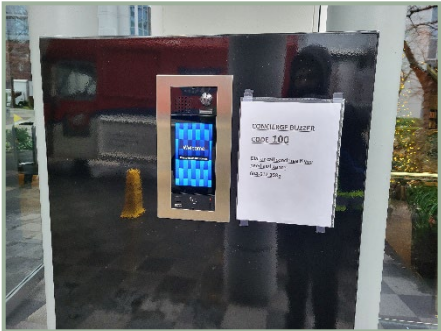
43 ENTERPHONE SYSTEM			
ELECTRICAL	Location:	Front Entrance

Year Installed:	2023	
	Typical Service Life (years):	20	
	Effective Age (years):	1	
	Remaining Service Life (years):	19	
	Planned Renewal Date:	2042	
<p>Description: This component includes the enterphone systems at the entrances to the buildings.</p> <p>Condition: The enterphone systems are in reasonable condition and were replaced in 2023.</p> <p>Comments: Reserve costs include full renewal of the enterphone system.</p>

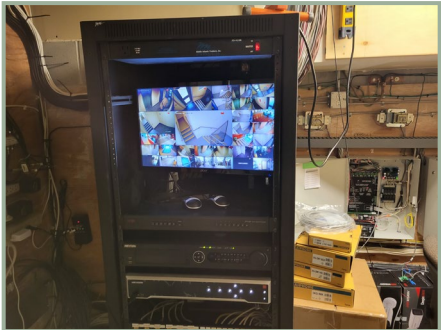
44 SECURITY SYSTEM AND CAMERAS			
ELECTRICAL	Location:	Throughout Building

Year Installed:	2023	
	Typical Service Life (years):	20	
	Effective Age (years):	1	
	Remaining Service Life (years):	19	
	Planned Renewal Date:	2042	
<p>Description: This component includes the cameras, recording and monitoring devices, a computer, and fob access scanners.</p> <p>Condition: The security access system is in reasonable condition. JRS understands that a new DVR system was installed in 2017.</p> <p>Comments: Information regarding the condition, renewal and cost for this component has been provided by Besant & Associates Engineers Ltd. Electronic equipment is sensitive to dust and debris. As such, they should be inspected and cleaned regularly. Any upgrades or expansions of the system will affect the cost. As issues arise, they should be repaired immediately to maintain building security. Reserve costs include an allowance, the cost provided by the Strata Corporation, to replace the security system.</p>

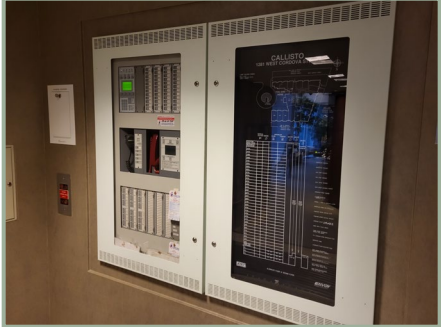
45 FIRE ALARM PANEL			
ELECTRICAL	Location:	Throughout Complex

Year Installed:	2005	
	Typical Service Life (years):	30	
	Effective Age (years):	26	
	Remaining Service Life (years):	4	
	Planned Renewal Date:	2027	
<p>Description: This component includes the fire alarm panels and annunciator at the common building entrances, as well as emergency lighting throughout the building. The panel is used by firefighters in case of an emergency to locate the fire.</p> <p>Condition: The fire alarm panel is in fair condition with no reported issues.</p> <p>Comments: The fire alarm system should be inspected regularly, ensuring that it functions as intended. An allowance has been included for a professional review prior to the planned replacement.</p>

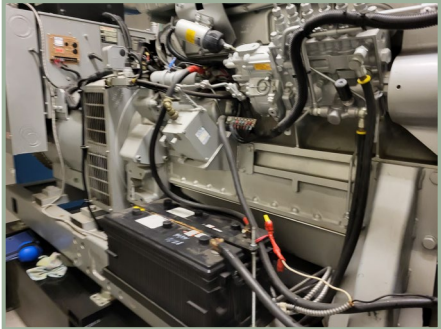
46 EMERGENCY GENERATOR			
ELECTRICAL	Location:	P1 Level

Year Installed:	2005	
	Typical Service Life (years):	40	
	Effective Age (years):	18	
	Remaining Service Life (years):	22	
	Planned Renewal Date:	2045	
<p>Description: This component includes a 400 kW Volvo diesel emergency generator located in the P1 level of parking garage.</p> <p>Condition: The emergency generator appears to be in functioning condition with no issues reported.</p> <p>Comments: Information regarding the condition, renewal and cost for this component has been provided by Besant & Associates Engineers Ltd. The emergency generator should be inspected regularly, ensuring that it functions as intended. An allowance to refurbish the generator has been added in 2025.</p>

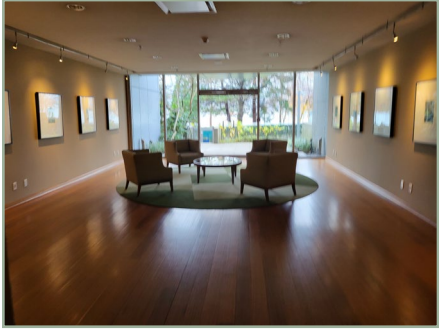
47	LOUNGE		
SPECIALTY	Location:	First Floor

Year Installed:	2005	
	Typical Service Life (years):	20	
	Effective Age (years):	18	
	Remaining Service Life (years):	2	
	Planned Renewal Date:	2025	
	<p>Description: This component includes the lounge interior finishes including flooring, wall paint, furniture, and doors.</p>		
<p>Condition: The lounge is generally in reasonable condition.</p>			
<p>Comments: Due to the aesthetic nature of the interiors, the renewal year is subjective and at the discretion of the Owners. Information about the extent and cost of the renewal of this component has been provided by the Renovation Committee of the Callisto Strata Council. The cost estimate was based on a design provided by the architecture firm Dialogue Design and a budget provided by the project management firm Make Projects Ltd. Both firms were engaged by the Renovation Committee.</p>

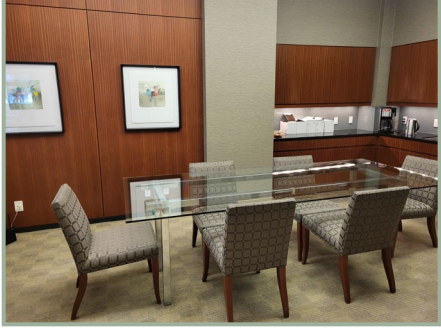
48	MEETING ROOM		
SPECIALTY	Location:	First Floor

Year Installed:	2005	
	Typical Service Life (years):	15	
	Effective Age (years):	13	
	Remaining Service Life (years):	2	
	Planned Renewal Date:	2025	
	<p>Description: This component includes the meeting room's interior finishes including flooring, wall paint, furniture, and glass walls.</p>		
	<p>Condition: The meeting room is generally in reasonable condition.</p>		
	<p>Comments: Due to the aesthetic nature of the interiors, the renewal year is subjective and at the discretion of the Owners. Information about the extent and cost of the renewal of this component has been provided by the Renovation Committee of the Callisto Strata Council. The cost estimate was based on a design provided by the architecture firm Dialogue Design and a budget provided by the project management firm Make Projects Ltd. Both firms were engaged by the Renovation Committee.</p>

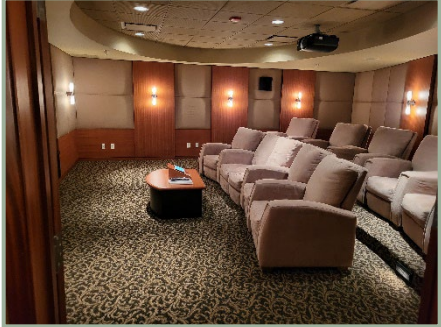
49 MULTIMEDIA ROOM			
SPECIALTY	Location:	First Floor

Year Installed:	2005	
	Typical Service Life (years):	15	
	Effective Age (years):	11	
	Remaining Service Life (years):	4	
	Planned Renewal Date:	2027	
<p>Description: This component includes the multimedia room’s interior finishes including flooring, wall paint, furniture, and multimedia equipment.</p> <p>Condition: The multimedia room is generally in reasonable condition. JRS understands that the finishes, furniture, and equipment were renewed in 2014.</p> <p>Comments: Due to the aesthetic nature of the interiors, the renewal year is subjective and at the discretion of the Owners. Reserve costs include periodic allowance for upgrades as needed.</p>

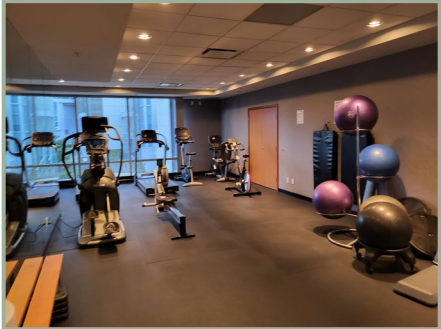
50 FITNESS ROOM			
SPECIALTY	Location:	Second Floor

Year Installed:	2005	
	Typical Service Life (years):	15	
	Effective Age (years):	11	
	Remaining Service Life (years):	4	
	Planned Renewal Date:	2027	
<p>Description: This component includes the fitness room’s interior finishes including flooring, wall paint, and fitness equipment.</p> <p>Condition: The fitness room is generally in reasonable condition. JRS understands that the fitness room equipment was replaced in 2016.</p> <p>Comments: Due to the aesthetic nature of the interiors, the renewal year is subjective and at the discretion of the Owners. Reserve costs include periodic allowance for upgrades as needed.</p>

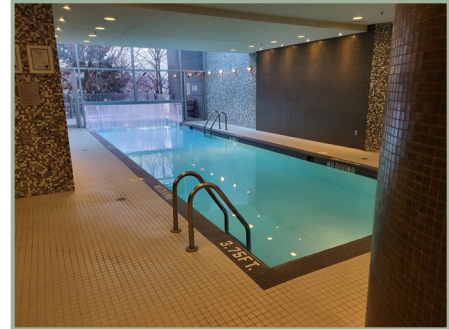
51 SWIMMING POOL, HOT TUB AND STEAM ROOM	
SPECIALTY	Location: Pool Area
	Year Installed: 2005
	Typical Service Life (years): 15
	Effective Age (years): 11
	Remaining Service Life (years): 4
	Planned Renewal Date: 2027
<p>Description: This component includes the finishing and equipment for the main swimming pool, hot tub, and steam room.</p> <p>Condition: The swimming pool, hot tub and steam room are room is generally in reasonable condition. JRS understands that targeted tiles have been renewed at the hot tub and steam room in 2015 and 2009.</p> <p>Comments: Allowances have been included for the targeted renewal of the swimming pool and hot tub.</p>

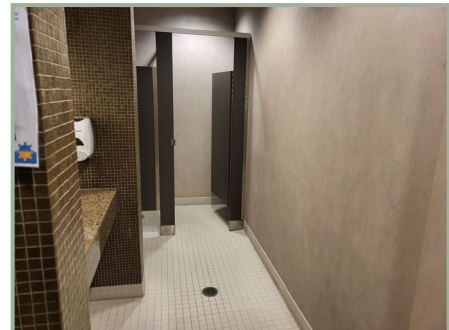
52 WASHROOMS AND CHANGEROOMS	
SPECIALTY	Location: Pool Area
	Year Installed: 2005
	Typical Service Life (years): 15
	Effective Age (years): 11
	Remaining Service Life (years): 4
	Planned Renewal Date: 2027
<p>Description: This component includes the finishing, and washroom fixtures in the two changing rooms.</p> <p>Condition: The change rooms are in reasonable condition with no reported issues.</p> <p>Comments: Reserve costs include allowances for the targeted renewals of finishing, and fixtures.</p>

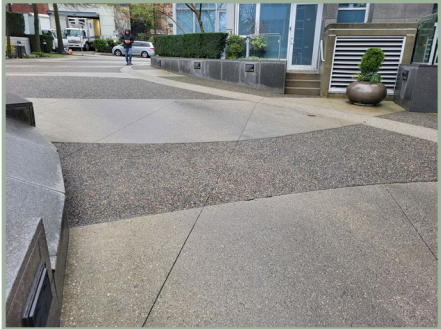
54 HARDCAPING			
SITE SERVICES	Location:	Around Property

Year Installed:	2005	
	Typical Service Life (years):	50	
	Effective Age (years):	18	
	Remaining Service Life (years):	32	
	Planned Renewal Date:	2055	
	<p>Description: This component includes the concrete parkade ramps, curbs, walkways, staircases, pavers, and asphalt driveway around the property.</p> <p>Condition: The hardscaping is in overall satisfactory condition with no reported issues.</p> <p>Comments: Targeted repair is scheduled to occur simultaneously with the replacement of the below grade waterproofing membrane, as this type of work will require the removal of the majority of the hardscaping elements. Allowances have also been allocated for targeted hardscaping repairs at the 30- and 50-year mark to address major renewals. Due to the aesthetic nature of this asset, its renewal year is subjective and therefore renewal requirements are at the discretion of the Owners. An allowance has been included for future expenses to the parkade leak by the fountain.</p>

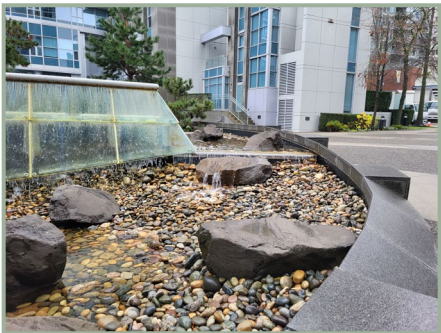
55 OUTDOOR FOUNTAIN			
SITE SERVICES	Location:	Around Property

Year Installed:	2005	
	Typical Service Life (years):	40	
	Effective Age (years):	18	
	Remaining Service Life (years):	22	
	Planned Renewal Date:	2045	
<p>Description: This component includes the hardscaping and glass finishing associated with the fountain located east of the property above the parkade entrance.</p> <p>Condition: The water feature is in fair condition with no reported issues.</p> <p>Comments: Reserve costs include allowances for targeted repairs for a large-scale renewal after 40 years of service.</p>

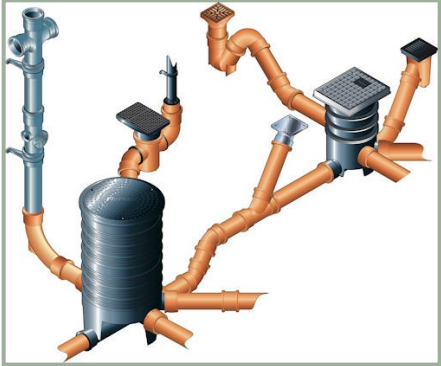
56 UNDERGROUND WATER SUPPLY AND DRAINAGE			
SITE SERVICES	Location:	Underground

Year Installed:	2005	
	Typical Service Life (years):	40	
	Effective Age (years):	18	
	Remaining Service Life (years):	22	
	Planned Renewal Date:	2045	
<p>Description: This component consists of the incoming water supply from the water mains, sewer, and stormwater drainage, and perimeter drain tile.</p> <p>Condition: These components could not be visually reviewed; however, they are generally in satisfactory condition with no reported issues.</p> <p>Comments: Reserve costs consist of an allowance to replace a percentage of the underground piping systems. Additional allowance has been included to flush the drainage system every 5 years.</p>

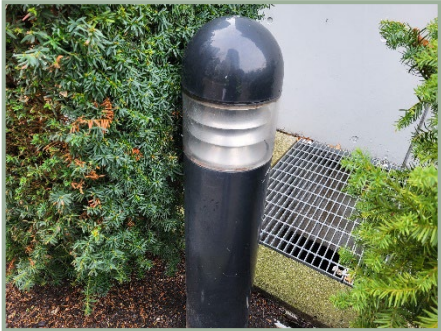
57 OUTDOOR LIGHTING AND ELECTRICAL			
SITE SERVICES	Location:	Around Property

Year Installed:	2005	
	Typical Service Life (years):	40	
	Effective Age (years):	18	
	Remaining Service Life (years):	22	
	Planned Renewal Date:	2045	
<p>Description: This component includes the pole and other exterior lighting around the complex.</p> <p>Condition: The lights are in reasonable condition with no reported issues.</p> <p>Comments: Reserve costs include full renewal of all exterior lights.</p>

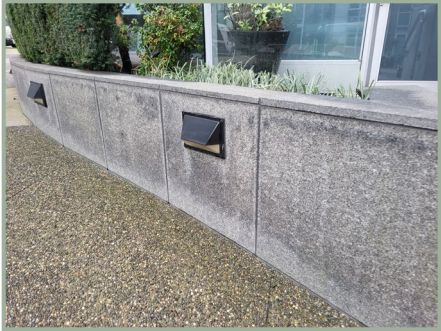
58 RETAINING WALLS			
SITE SERVICES	Location:	Around Property

Year Installed:	2005	
	Typical Service Life (years):	40	
	Effective Age (years):	18	
	Remaining Service Life (years):	22	
	Planned Renewal Date:	2045	
<p>Description: This component includes the concrete retaining walls around the complex.</p> <p>Condition: The retaining walls are generally in reasonable condition.</p> <p>Comments: Periodic cleaning and maintenance are recommended. Reserve costs include allowance for repairs.</p>

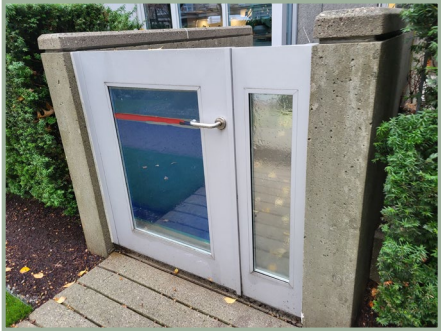
59 GLASS FENCING AND METAL GATES			
SITE SERVICES	Location:	Around Property

Year Installed:	2005	
	Typical Service Life (years):	30	
	Effective Age (years):	18	
	Remaining Service Life (years):	12	
	Planned Renewal Date:	2035	
<p>Description: This component includes the metal supported glass fencing with metal gates around the property and primarily at the townhouse entrances.</p> <p>Condition: The glass fencing, and metal gates are in satisfactory condition with no major deficiencies observed or reported.</p> <p>Comments: Reserve costs include the full replacement after 30 years of service.</p>
