# Depreciation Report

NWS 222 – Wiltshire House

**RE: Depreciation Report for Strata Plan NWS 222  
File No. NW222DR25**

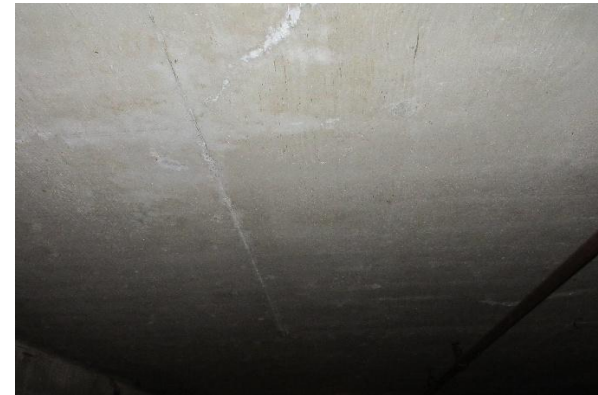
Parkade roof deck

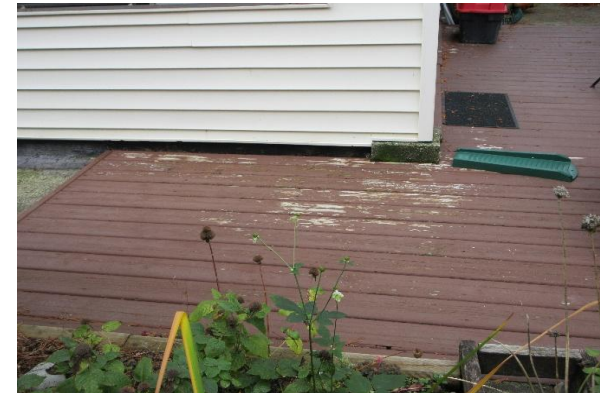
Peeling paint on wooden patio decking

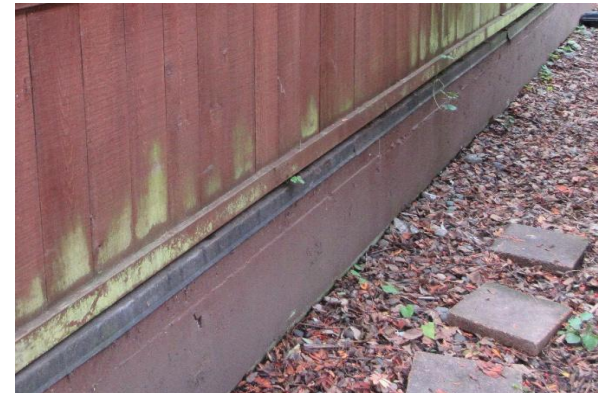
Paint on concrete wall below wooden fencing

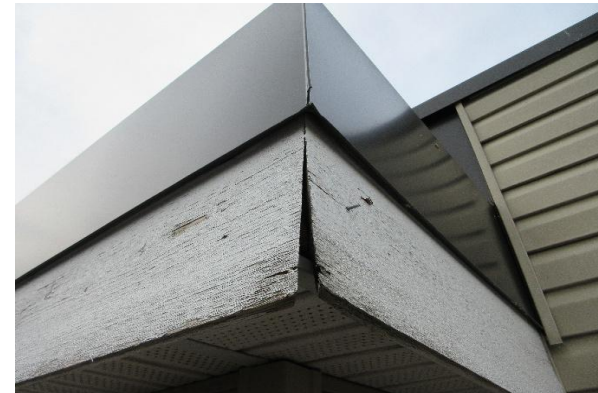
Warped and separated wooden fascia boards

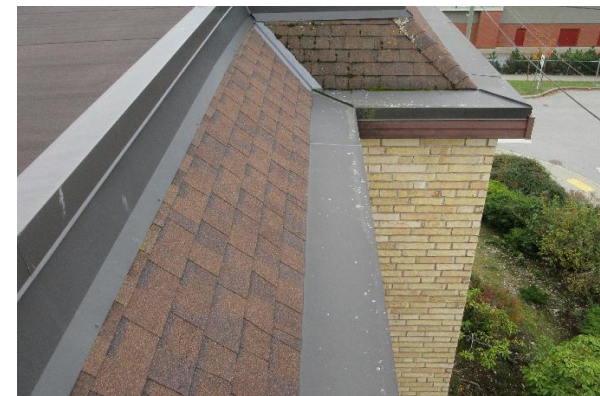
Asphalt shingle roofing

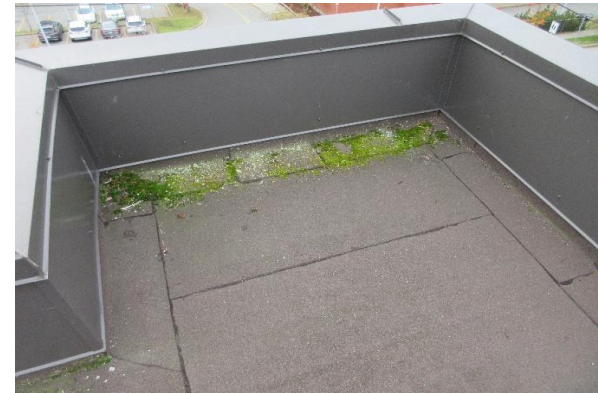
Moss growth on SBS membrane roofing

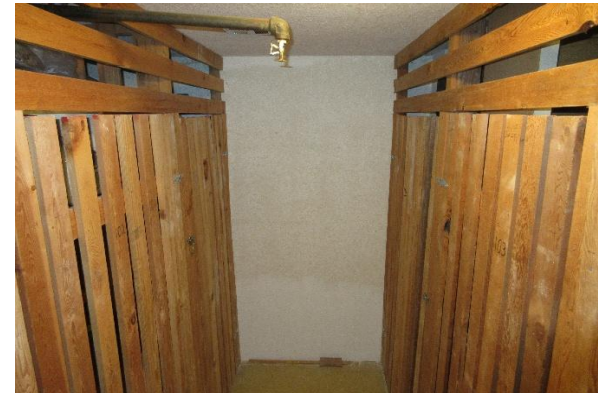
| Condition Analysis | Deterioration | Cracks in vinyl storage room flooring was observed in one location at floor 3. | | | |

Storage room finishes

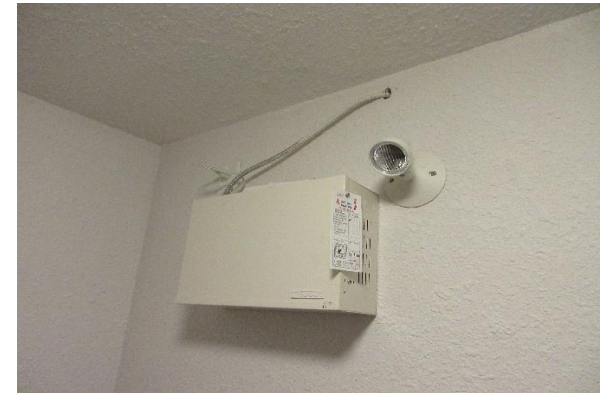
Emergency light with battery pack

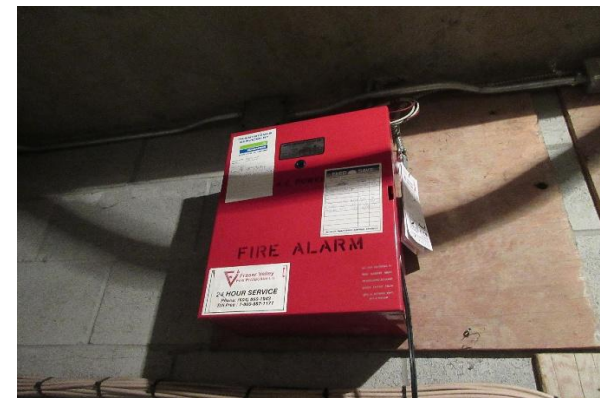
Fire alarm system

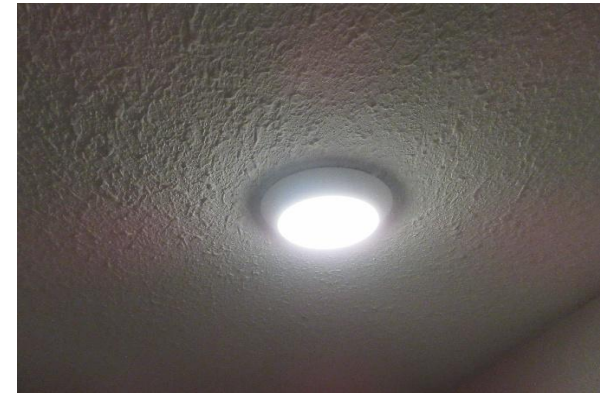
Interior ceiling-mounted light fixture

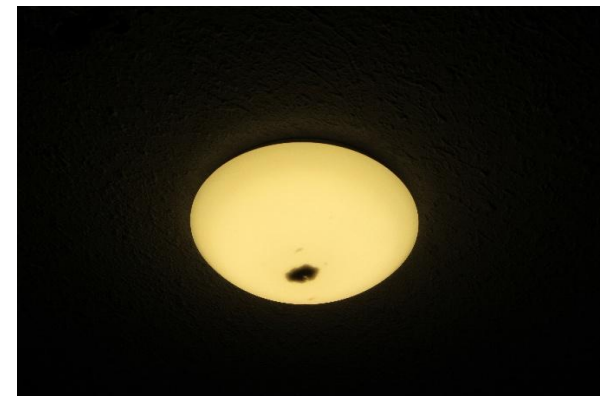
Interior ceiling-mounted light fixture

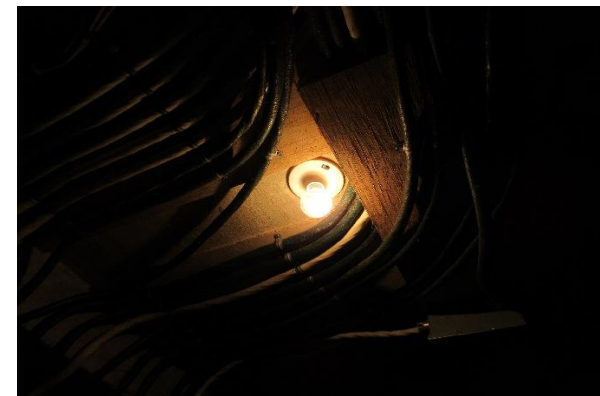
Service room light fixture

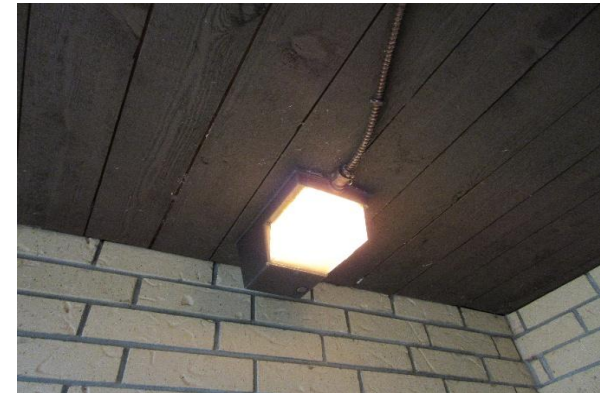
Exterior soffit-mounted light fixture

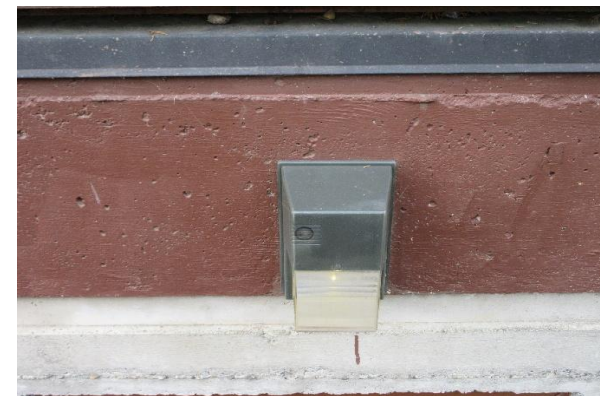
Exterior facade-mounted light fixture

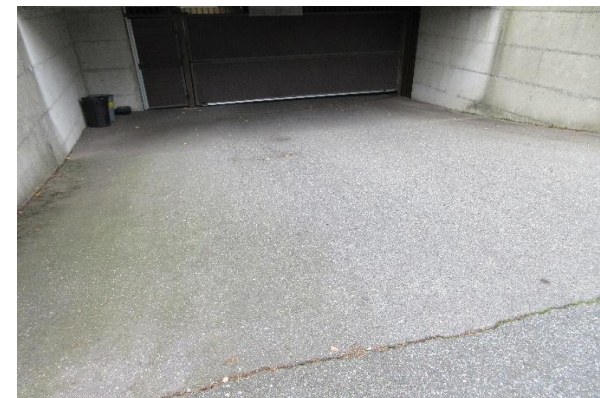
| Condition Analysis | Deterioration | Cracks in concrete paving was observed in isolated locations. | | | |
| | Overall Condition | Fair. | | | |

Exterior concrete paving

| Preventative<br>Maintenance | Stresses producing minor defects are constantly at work. Early detection and repair (patching, crack sealing, etc.) of minor defects is essential before they deteriorate into pavement failures requiring major repair expenditures. | | | | |
