BUILDING ENVELOPE CONDITION ASSESSMENT

The Ivys

**STRATA CORPORATION LMS 2379
652- 689 WEST 7TH AVENUE
VANCOUVER, BC**

August 16, 2004

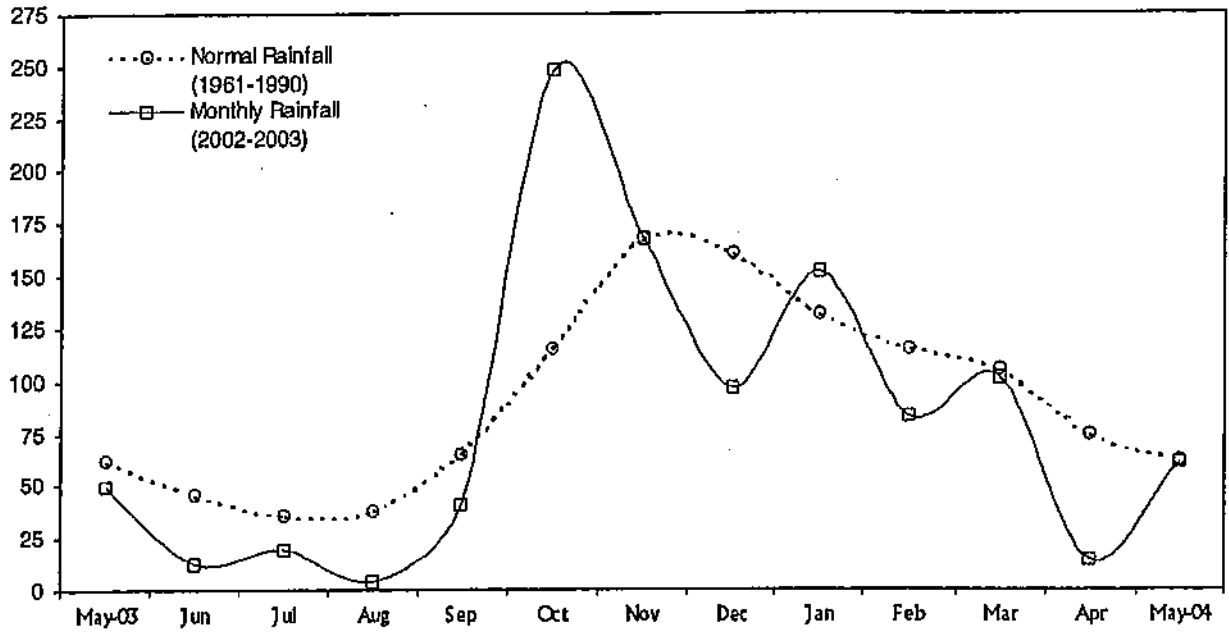
RAINFALL (mm) Fig.A

- .5 The climate data suggest that we are currently on a drying trend and little rainfall has occurred during the month of April. The moisture content readings obtained at this time of the year may be lower than those taken during an average year or at a wetter period.
