Appendix A - Contingency Reserve Fund Study For

Heatherstone
3218 - 3278 Heather Street
Vancouver, BC

October 21, 2008

Project Number: 208vA019A

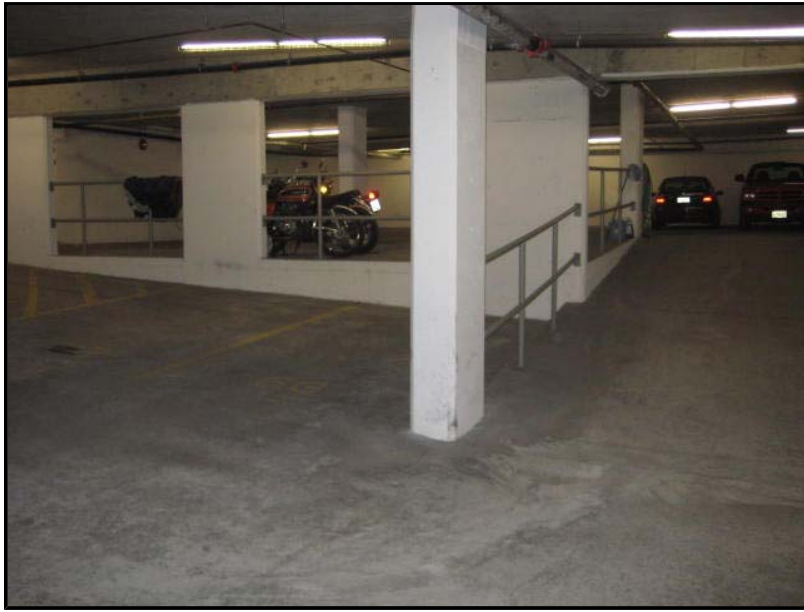
Photo No. 4: Parking Garage

- diagonal crack with evidence of past leakage at exterior wall adjacent parking space # 68
- diagonal crack with evidence of past leakage at exterior walls (corner) opposite the garage entrance ramp
- cracks with evidence of past leakage at underside of the P1 level suspended slab above drive aisle opposite parking spaces # 47 and # 50
- diagonal crack with evidence of past leakage in the wall opposite the south side of the entrance ramp (crack follows the line of the ramp)
- ponding water outside water room adjacent parking space #11 (water is leaking into the water room)

Peter Winstanley was not aware of any of the cracks listed above as actively leaking. The cracks in the P1 level suspended slab should be checked for leakage after washing/cleaning of the garage, and local repairs or re-waterproofing carried out as required on an as-needed basis.
