June 2, 2010

MH Ref: 5105311.00

**Re: 15 Month Common and 2 Year Warranty Review – “ Lotus”
5900 Alderbridge Way & 7371-7373 Westminster Hwy, Richmond, BC**

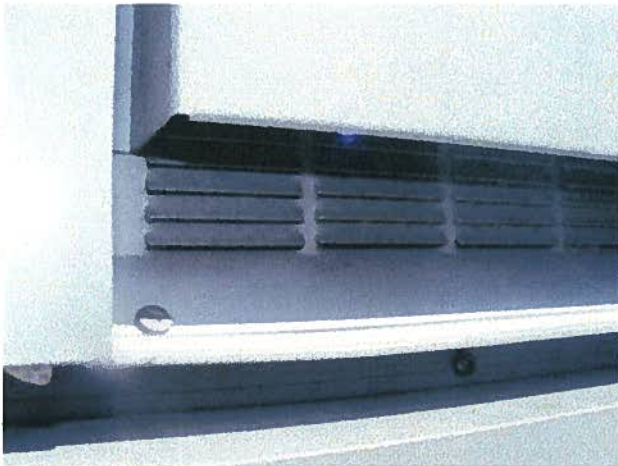
| Photo/Item | Sample Location | Deficiency Description | Category | Corrective Action |
|---|--|--|---|--|
| B3 | Tower A – Bosun Chair Drop 1 – South | Lint build-up was observed within the exhaust vents. Observed at Levels 8, 10 and 15. | M | Annual cleaning of dryer vents is recommended. |

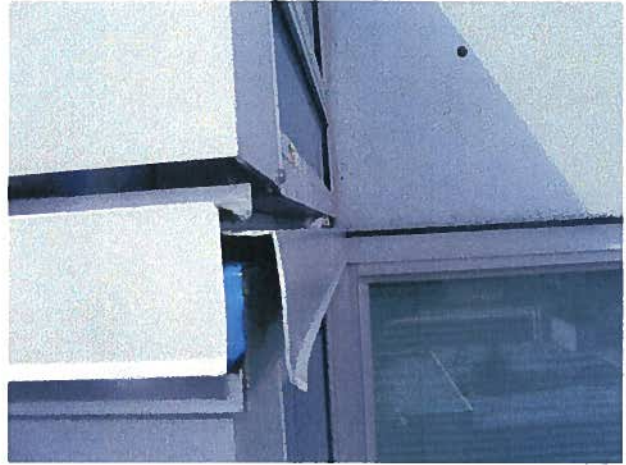
| Photo/Item | Sample Location | Deficiency Description | Category | Corrective Action |
|---|--|--|---|--|
| B6 | Tower B – Bosun Chair Drop 3 – East – Top Floor Unit | Metal closure flashing missing at outside corner. Also, observed flashing negatively sloped and loose. Also, sealant is missing along transition from concrete to window head in background of photo. | D | A closure flashing should be provided at inside and outside corners and the metal flashings should be positively sloped away from building and properly secured. Provide sealant between dissimilar materials. |

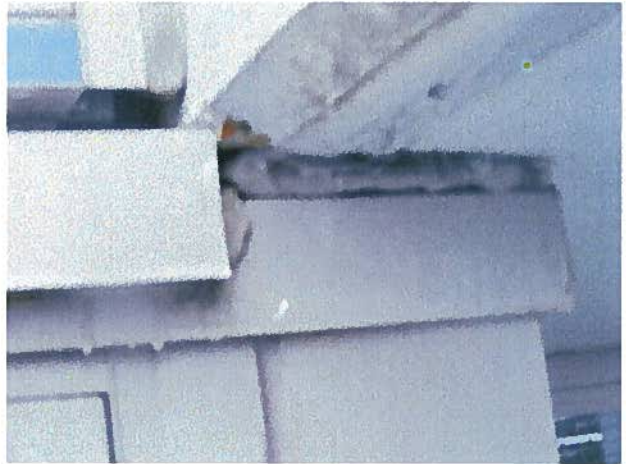
| Photo/Item | Sample Location | Deficiency Description | Category | Corrective Action |
|---|--|--|---|--|
| B8 | Tower C – Bosun Chair Drop 5 – South | Traffic coating splattered on window frame. Observed at various locations | D/M | Remove splatter from window system. |
