# **Building Envelope Maintenance Report**

**May 2010**

**The Compton  
1316 West 11<sup>th</sup> Avenue  
Vancouver, BC**

**LMS 4382**

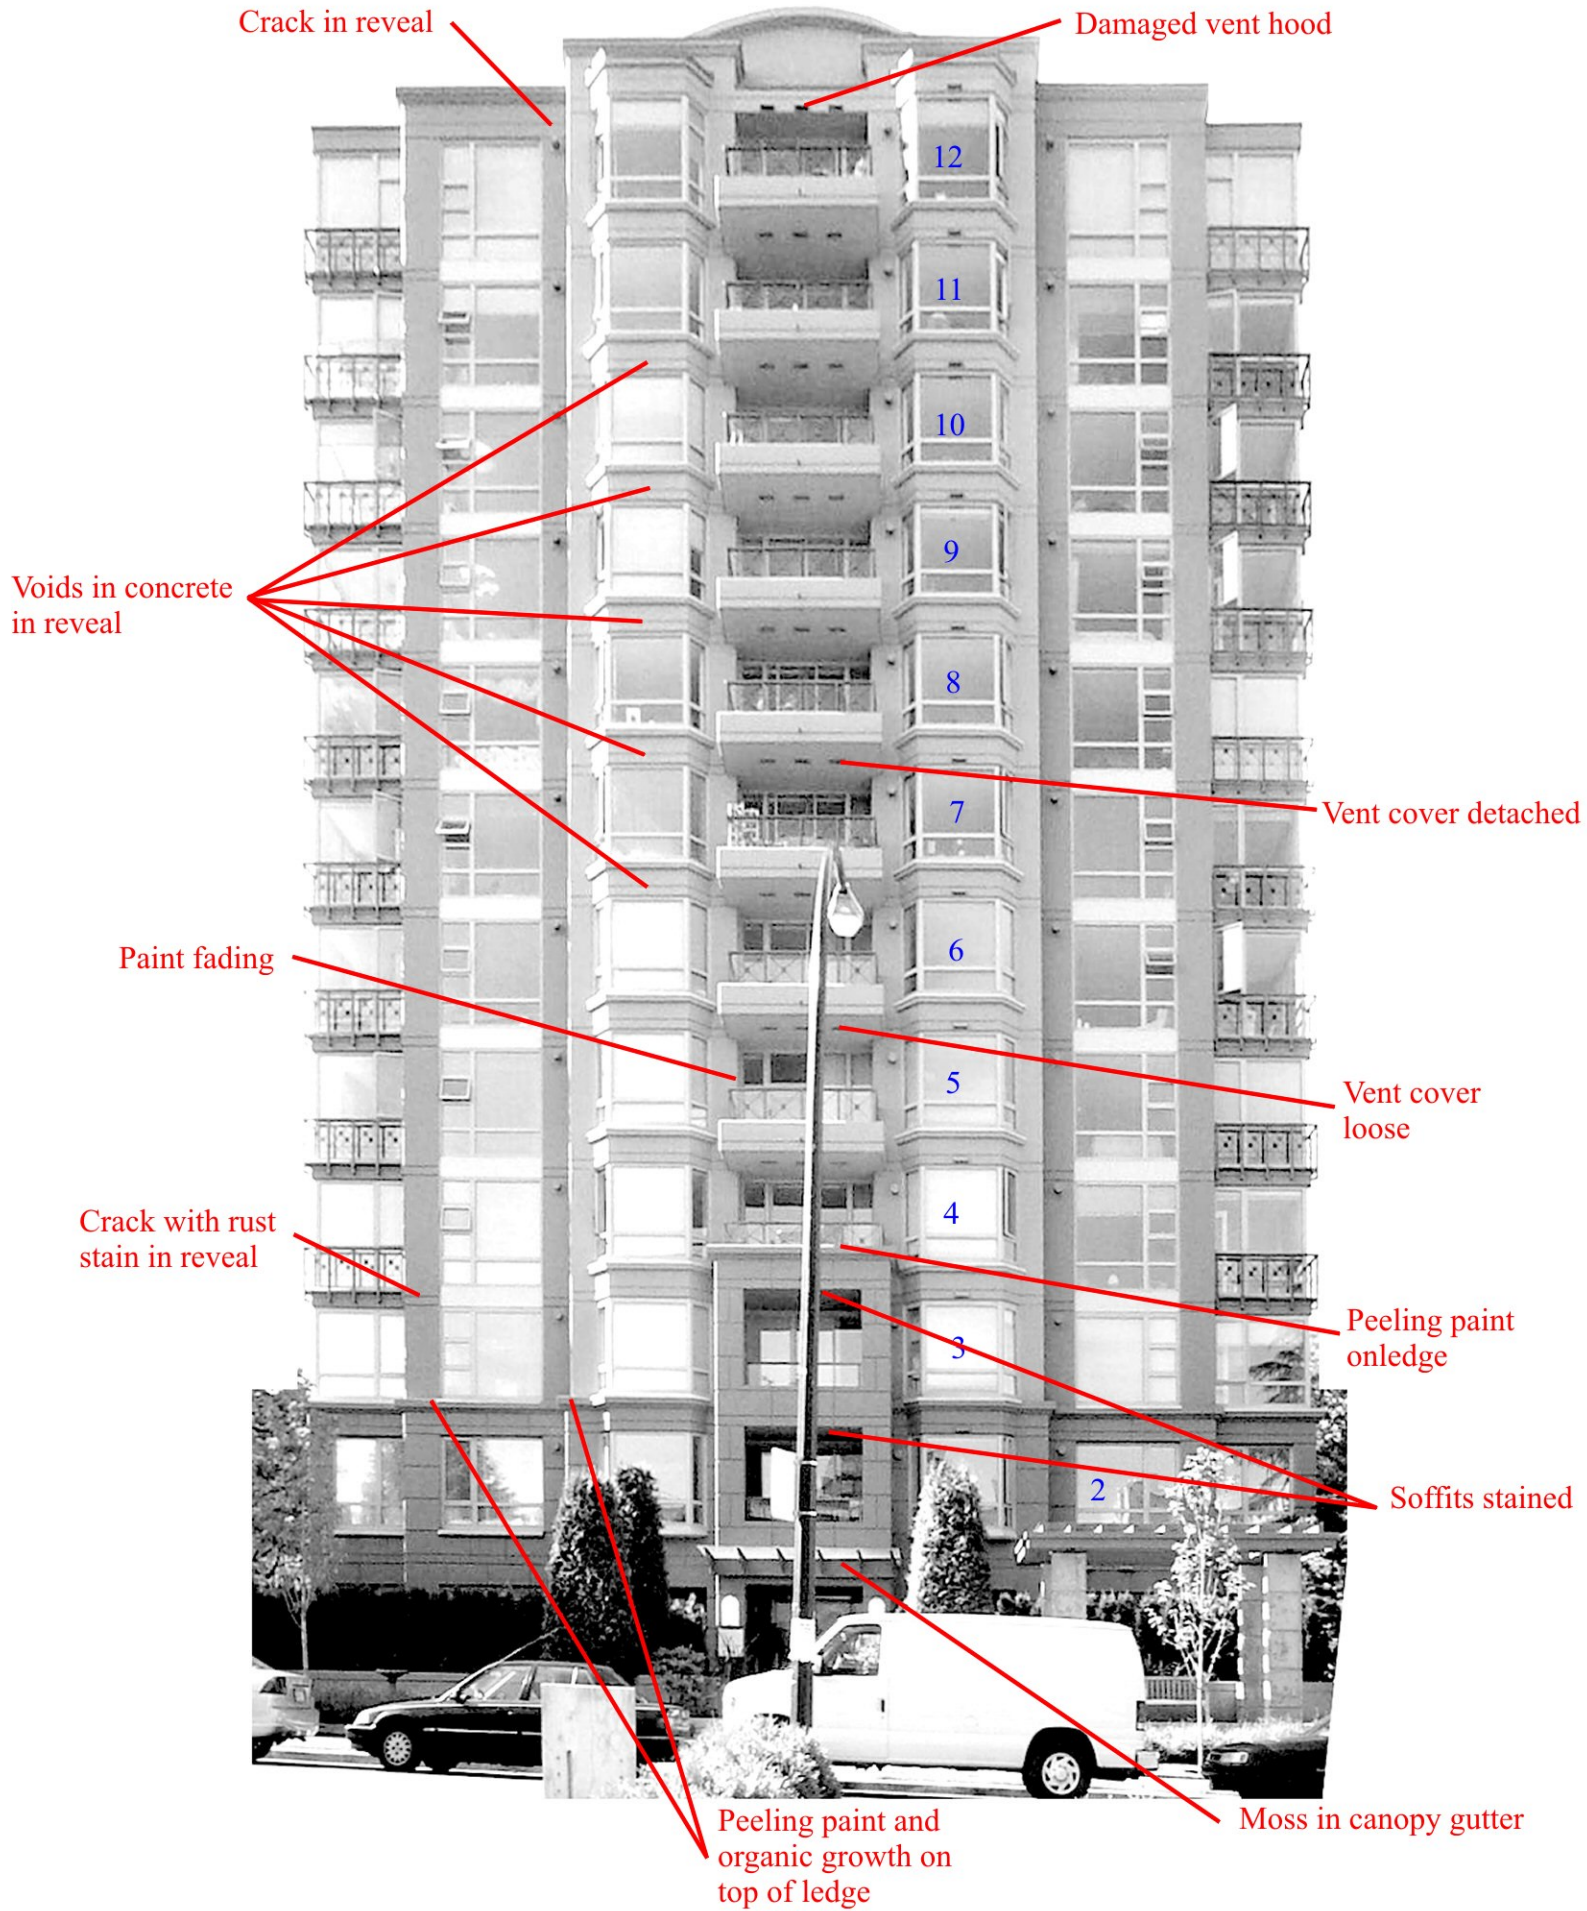
# North Elevation

Damaged vent  
hood

Fireplace vents  
corroding. Common

Exposed rebar and  
missing paint in  
reveal

Rust stains and  
peeling paint on  
ledge

Moisture behind  
light fixture

Crack and small  
hole in ledge

Crack with  
efflorescence

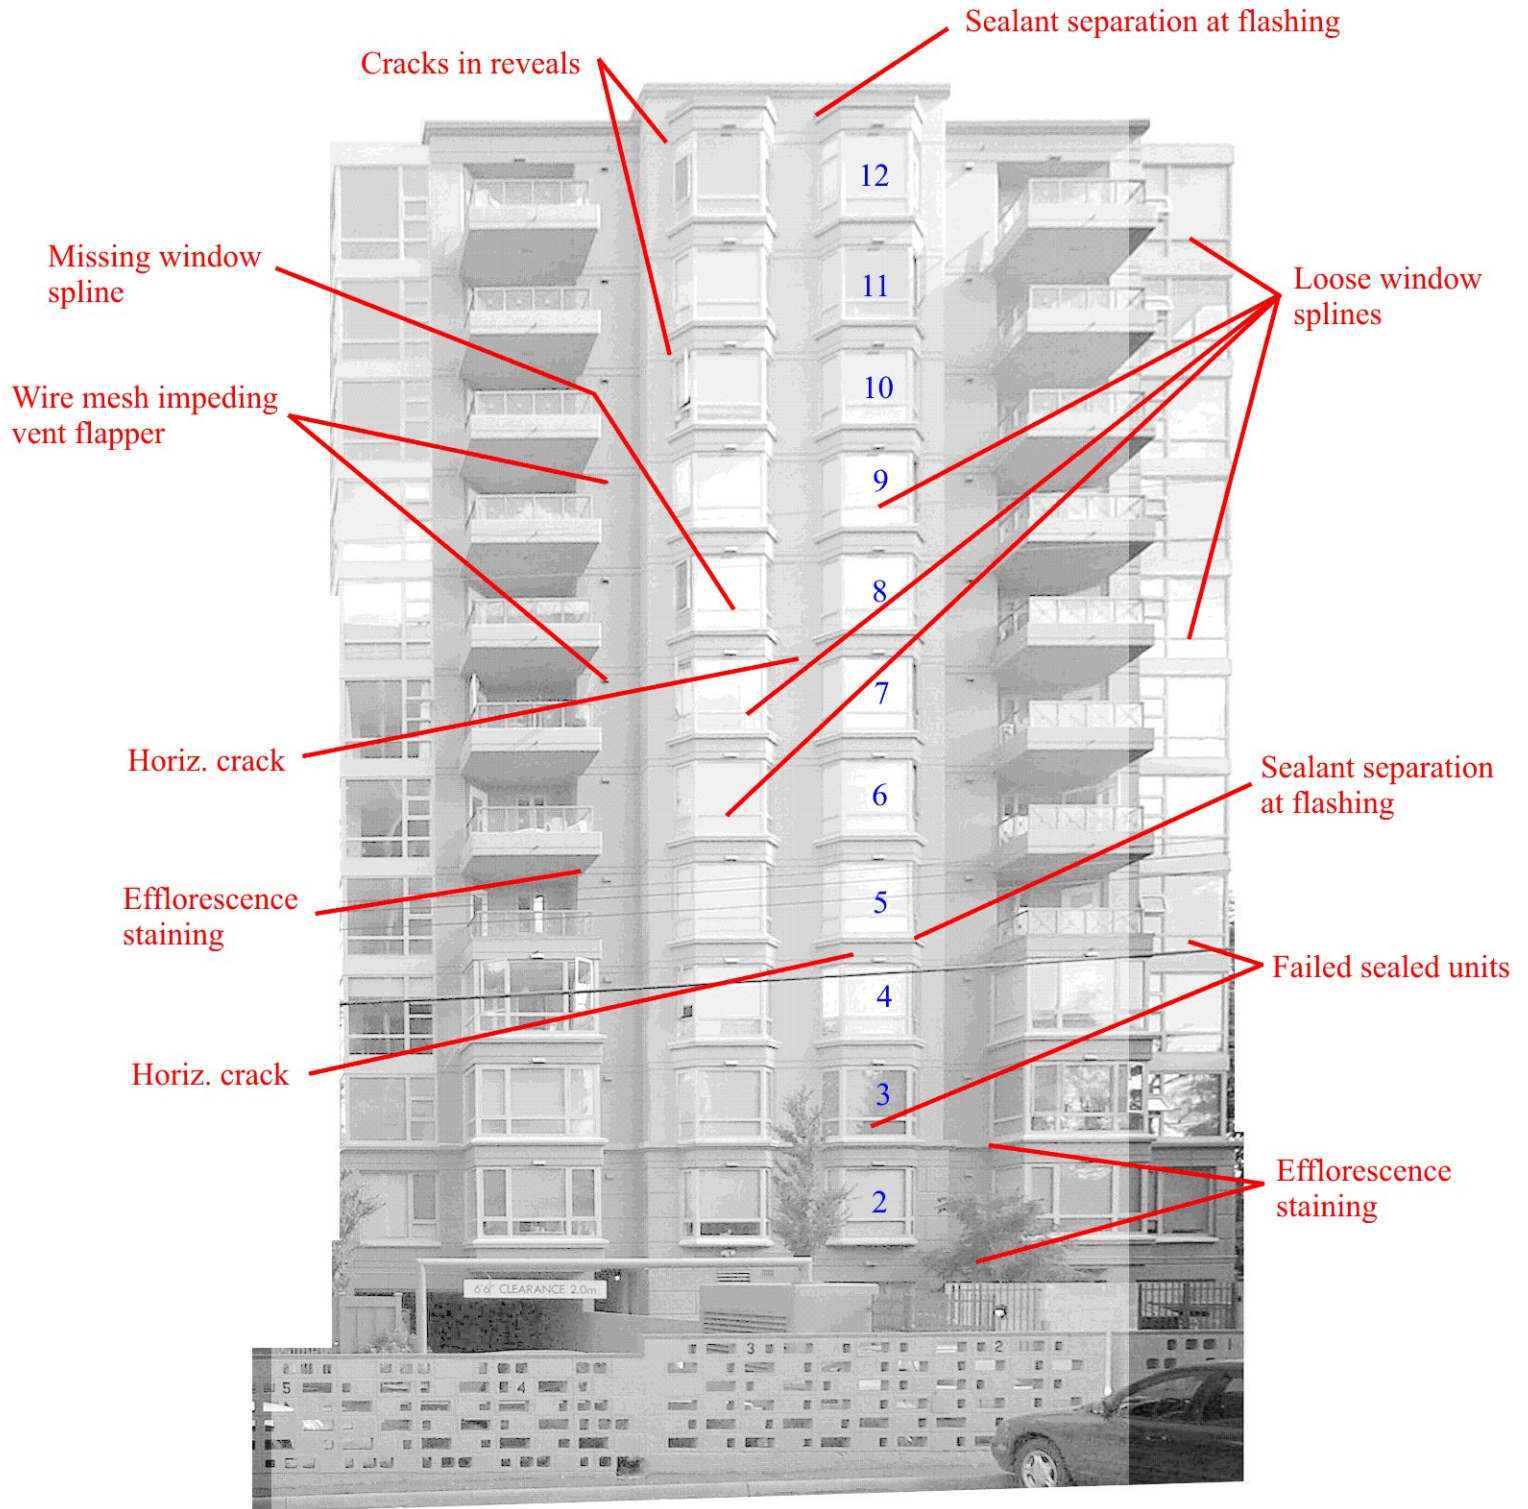
## South Elevation

Failed sealed unit

Sealant separation at cap flashing

Vert. crack in  
concrete

Vert. crack in  
reveal

Crack in reveal

Cracks in reveal

Loose window  
spline
