## **APPENDIX A - PHOTOGRAPHS**

**Appendix A - 1188 Richards Street Photos**

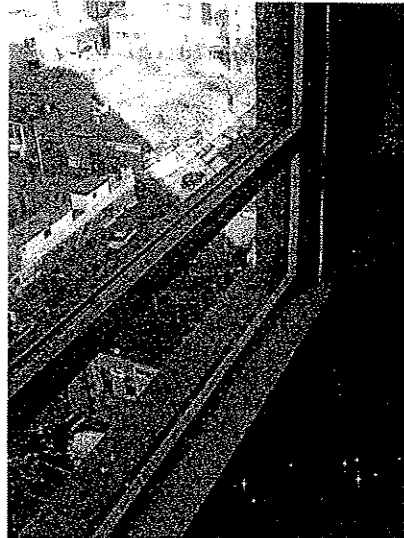
108 1608 Window at south bedroom interior

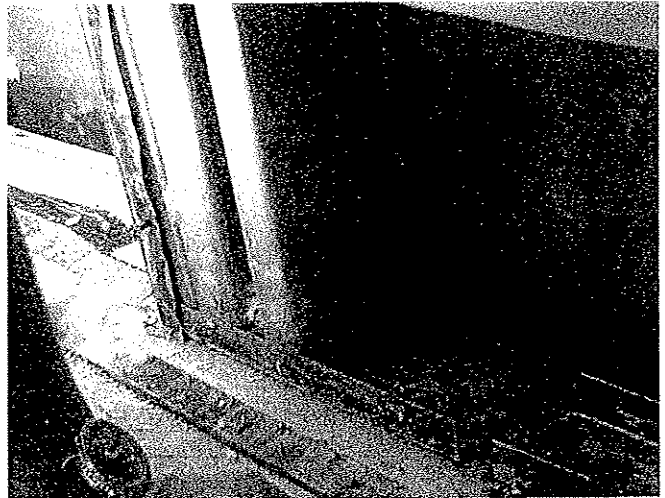
114 1608 showing concrete structure behind brick

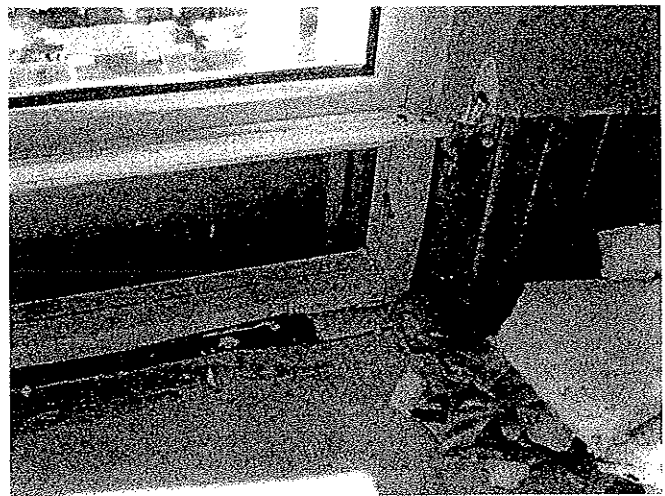
116 1608 With interior finishes removed at window to

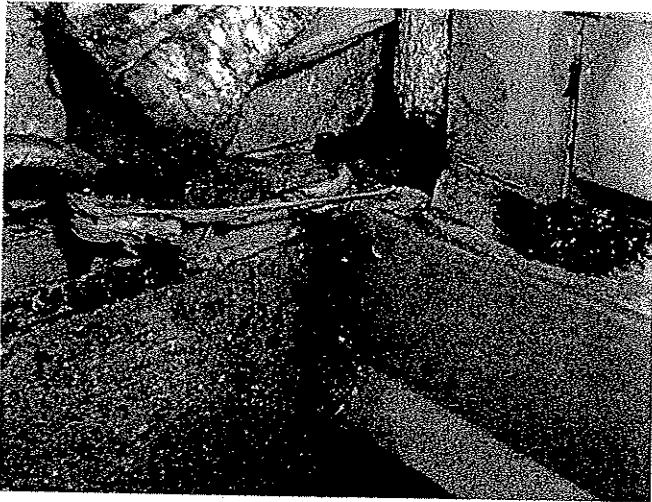
205 1608 sealants removed from shelf angle and

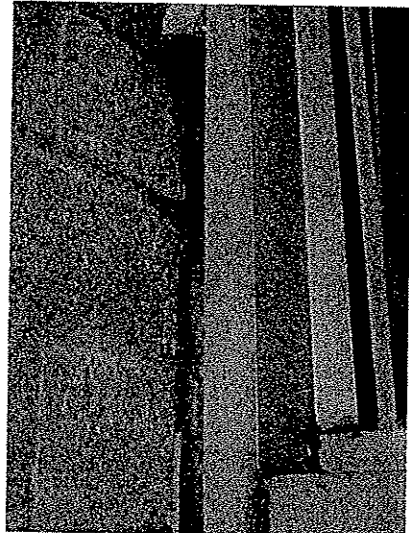
206 Discolouration behind sealant

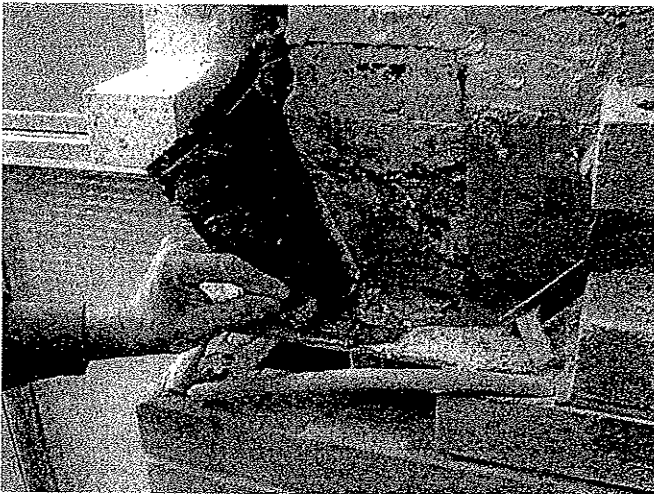
705 Blueskin membrane partially removed at shelf

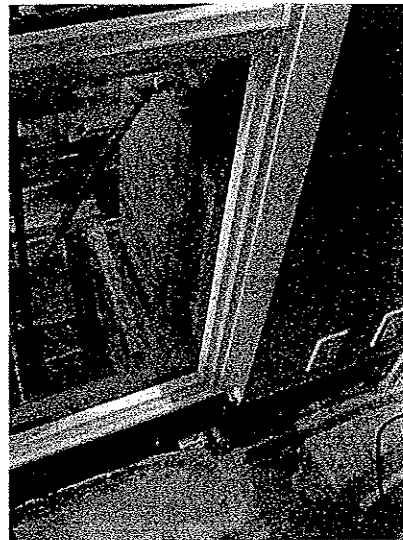
710 No water ingress during test

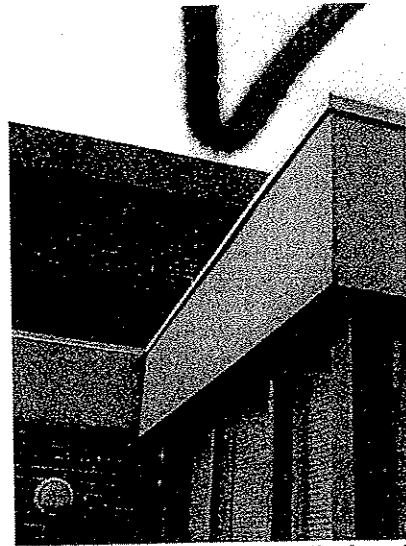
901 EIFS band at window wall of roof deck

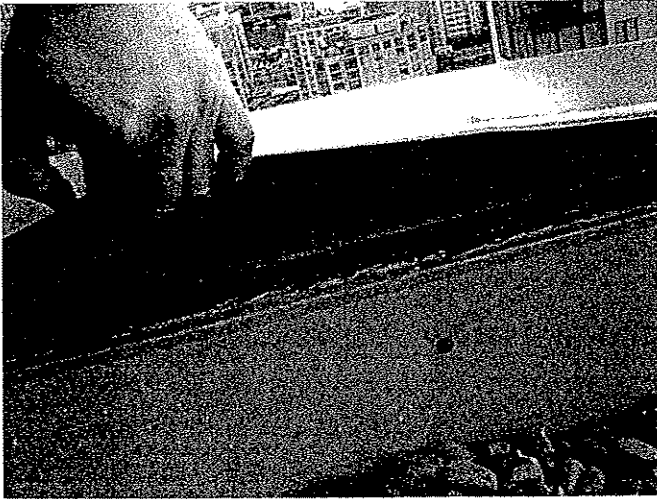
915 Roof membrane termination at flashing gum

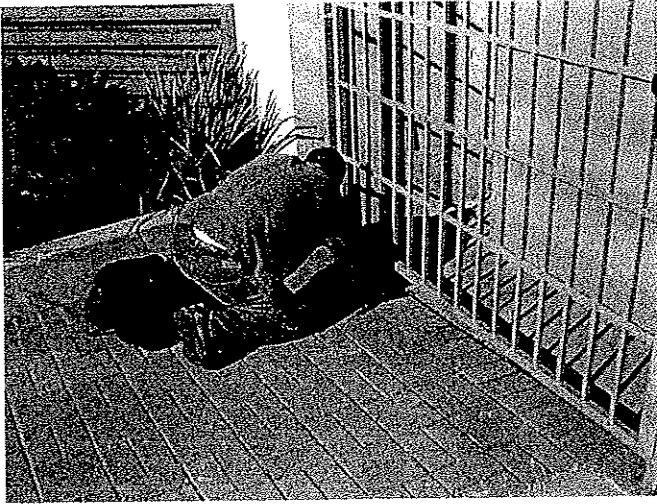
923 Paver removal for membrane examination, north
