BUILDING ENVELOPE ASSESSMENT

**AT
LEXINGTON NORTH
3709 PENDER STREET
BURNABY, BC**

File No. 071-03272

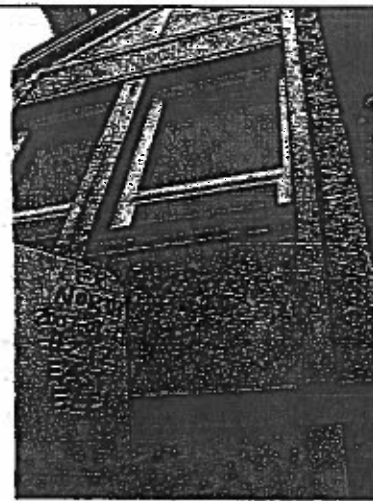
Photo 44: Unit #212 Level 3 East elevation: has been renovated in the past to be a "rain screen" look-alike.

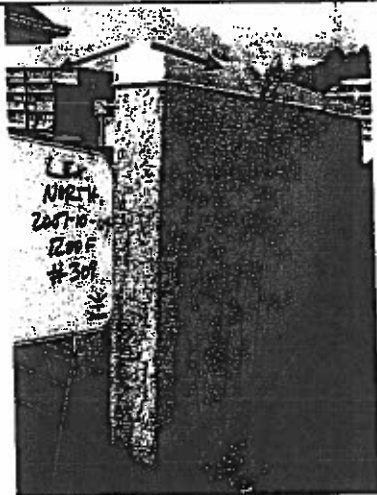
Photo 57: Unit #309 roof deck privacy wall is not adequately secured. It moves when little pressure is applied to top (see arrows).
