Depreciation Study Report for Sandborne Woods

Prepared for:
Strata Plan LMS 259
c/o Baywest Management Corporation
13468 – 77th Avenue
Surrey, BC
V5W 6Y3

Project Number:
VAN-00203248-01

Date Submitted:
2013.05.31

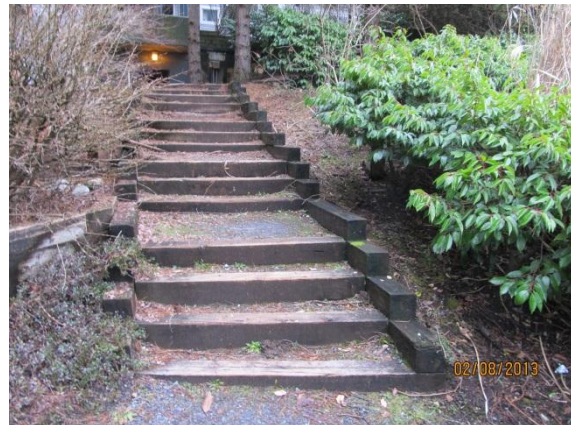
Existing wood deterioration was observed in several landscape timbers located in the northwest and southwest areas of the site. Immediate replacement of several components should be undertaken.

Timber steps at southwest yard.

We have provided a cost, as outlined in Table 1 - Cost Summary, for the periodic replacement of deteriorated landscape timber elements.

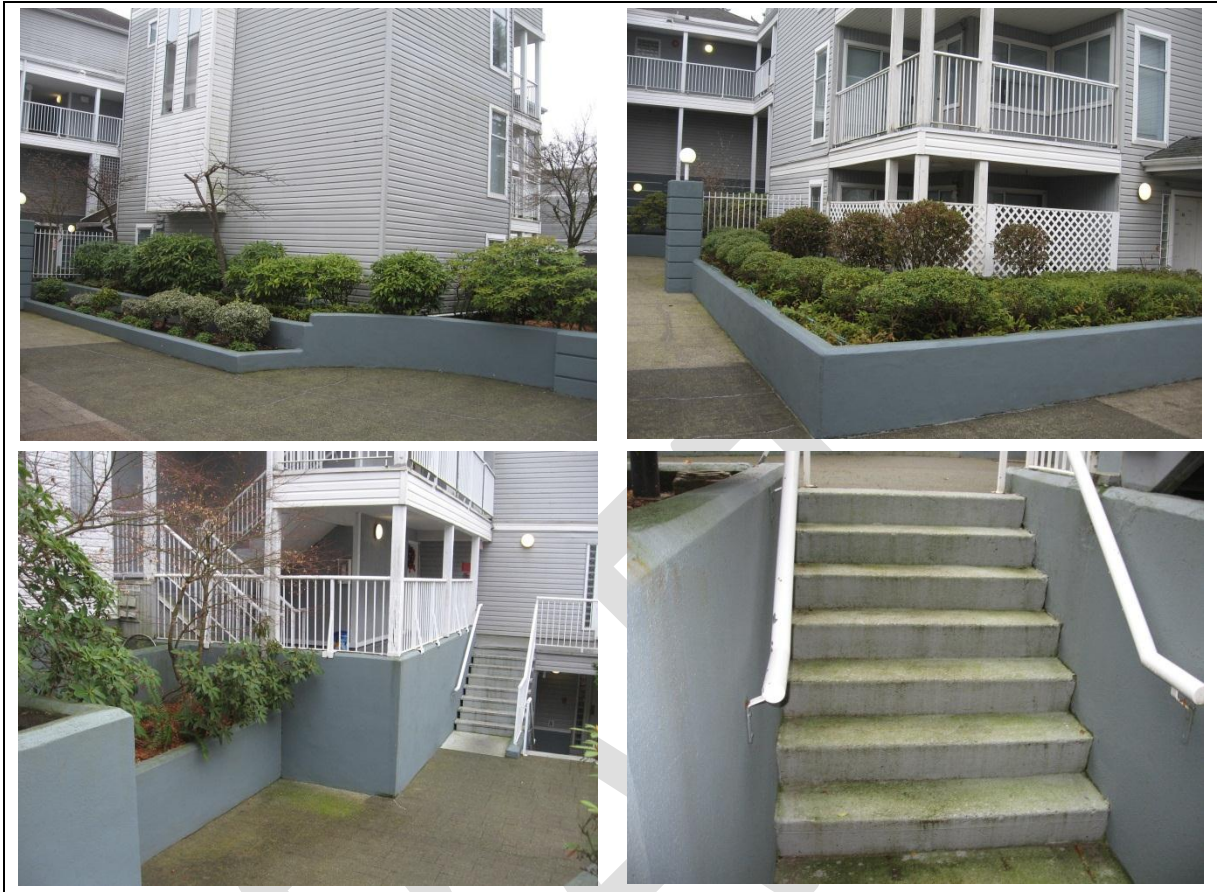
The hardscape site elements were generally observed to be in serviceable condition at this time. The hardscape site elements should not require replacement over the duration of this Study and possibly for the expected service life of this development. However, occasionally we expect localized repair of damaged concrete from such occurrences as physical impacts, shrinkage cracks, settlement, spalling etc.

We have provided a cost, as outlined in Table 1 - Cost Summary, for the periodic localized repair of hardscape elements.

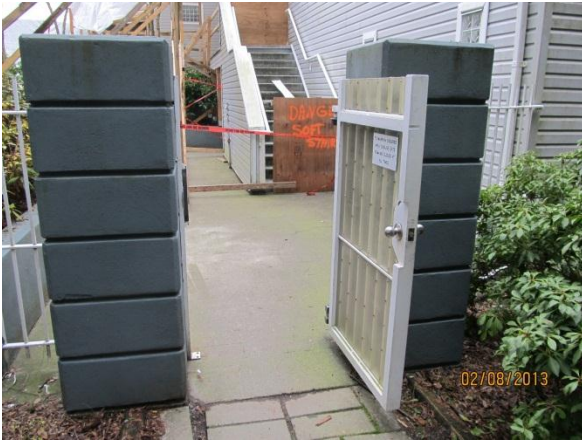
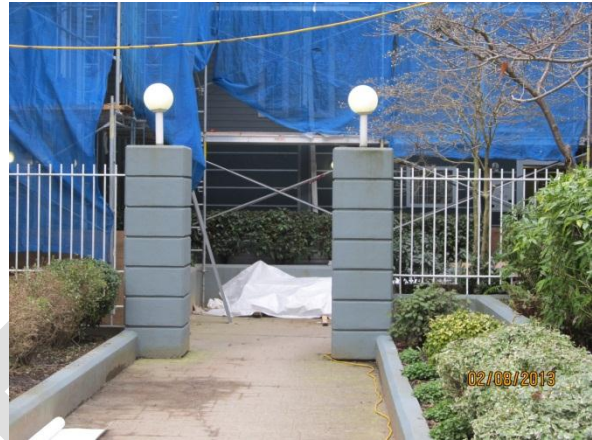
Pre-finished metal picket fencing is located sporadically throughout the site, mostly between buildings. All observed picket-style fencing and swing gates were generally observed to be in good condition.

We have provided a cost for the eventual replacement of pre-finished metal picket fencing and related hardware, as outlined in Table 1 - Replacement Cost Summary.

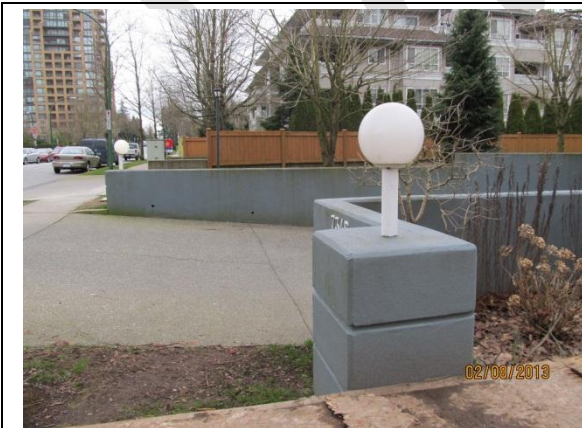
Illumination at vehicle entrance.

All observed site lighting was generally observed to be in serviceable condition.

We have provided a cost for eventual removal and replacement of exterior lighting systems, as outlined in Table 1 - Cost Summary. We note the maintenance costs of light fixtures such as touch-up painting and replacement of bulbs is to be conducted from the Operating Budget.

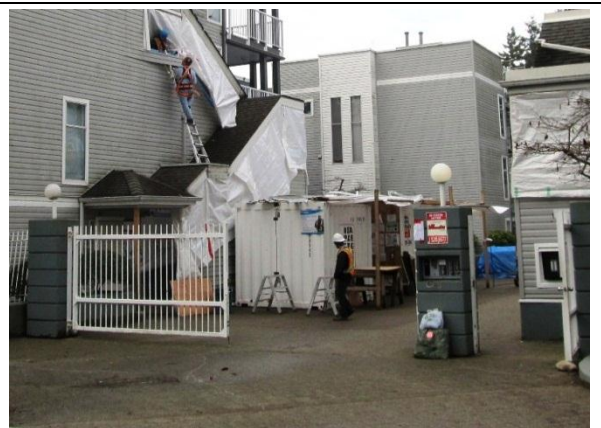
Illumination at pedestrian entrance.

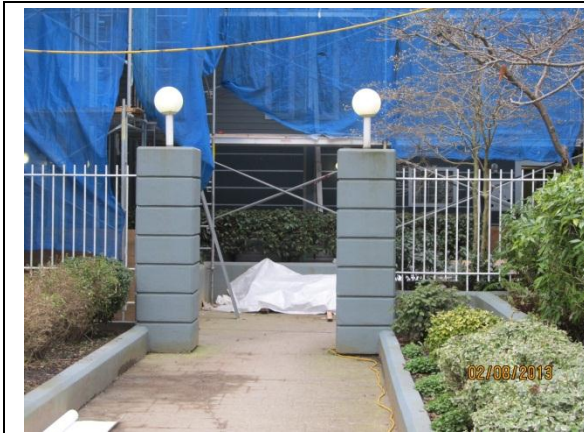
Illumination at interior courtyard.

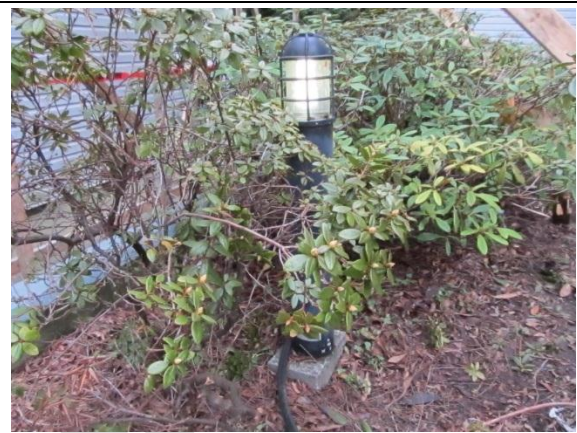
Illumination at interior courtyard.

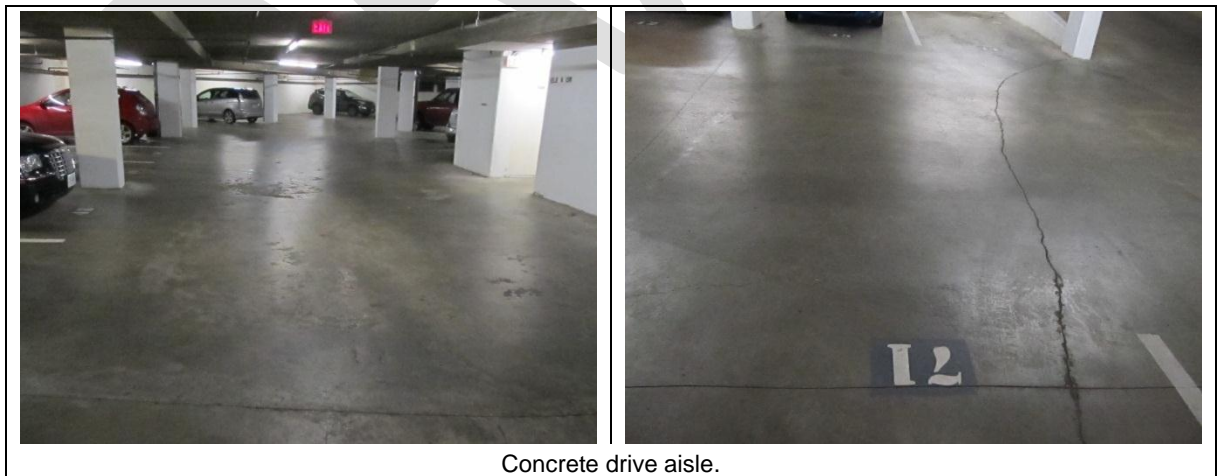
The lowest level of the below-grade parking garage is slab-on-grade concrete. The condition of the slab-on-grade floor was observed to be in serviceable condition. Some concrete shrinkage cracks were observed.

The slab on-grade assembly on the P2 level is expected to last the lifetime of the building and, therefore, complete replacement is not anticipated to be required. We have not included any allowance for localized crack repair as it may occur, as this repair work is to be funded from the Operating Budget, i.e. frequency of less than a year.

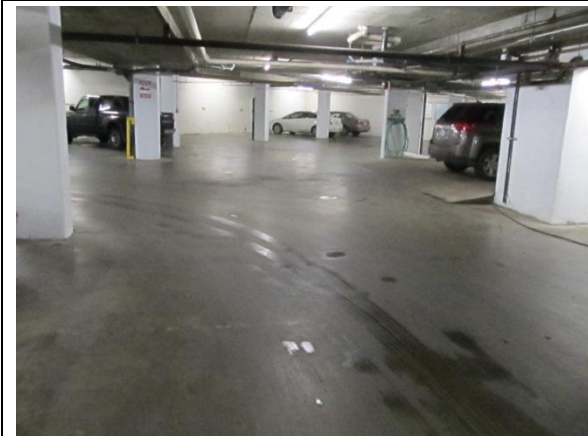
Overall, the painted finishes on below-grade concrete assemblies and components such as concrete walls, columns, ceilings, stairwells and partition walls, including line paintings and stenciled signage, were found to be in good condition.

Typical painted concrete walls and columns at P1.

We have provided a cost for re-painting concrete elements of the garage, including concrete walls, columns, ceilings, stairwells and partition walls, including line paintings and stenciled signage. We have also included for minor concrete repairs as required prior to re-painting as outlined in Table 1 – Cost Summary.

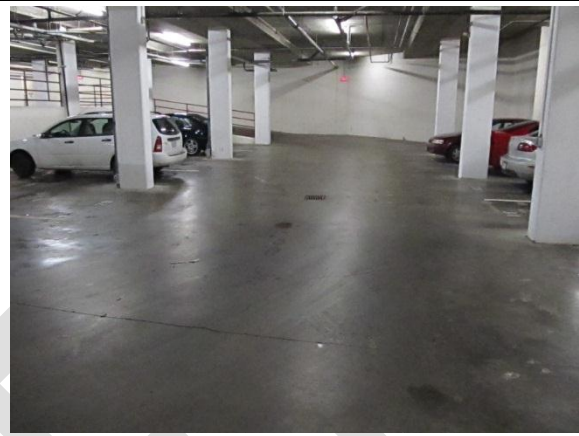
Typical painted concrete walls and columns at intermediate parking level.

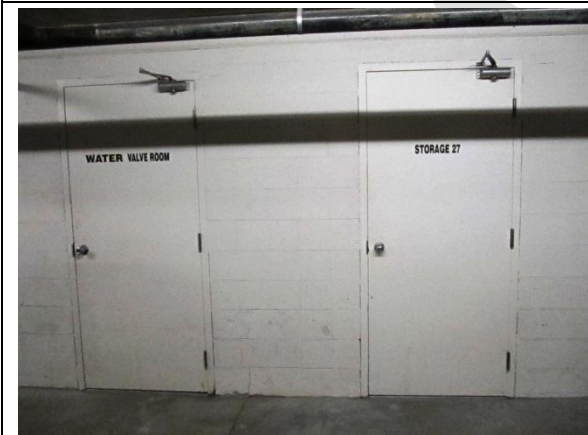
Painted concrete wall at storage lockers.

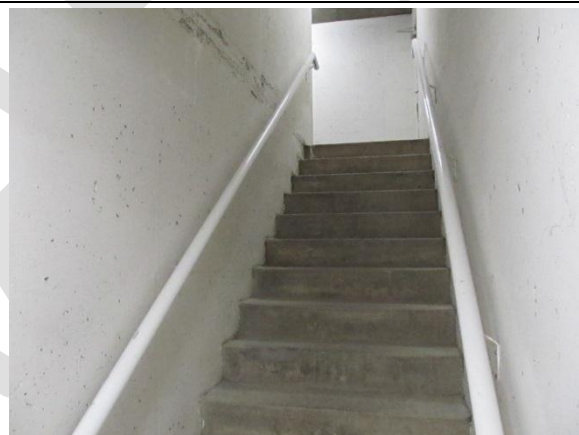
Typical painted concrete stairwell.

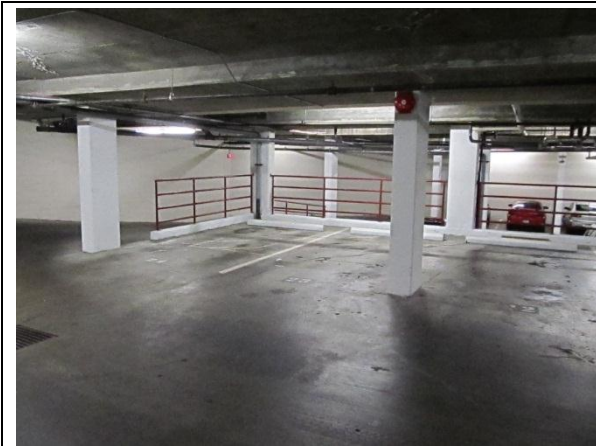
P1 drive aisle.

Existing concrete sealer was typically not observed on parking garage floors P1 and P2.

We recommend installation of a concrete sealer on drive aisles and parking stalls throughout the parking garage.

We have provided a cost for application of concrete sealer on drive aisles and parking stalls throughout the parking garage, as outlined in Table 1 - Cost Summary. We note that maintenance costs to repair concrete cracks as they may occur, is to be funded from the Operating Budget.

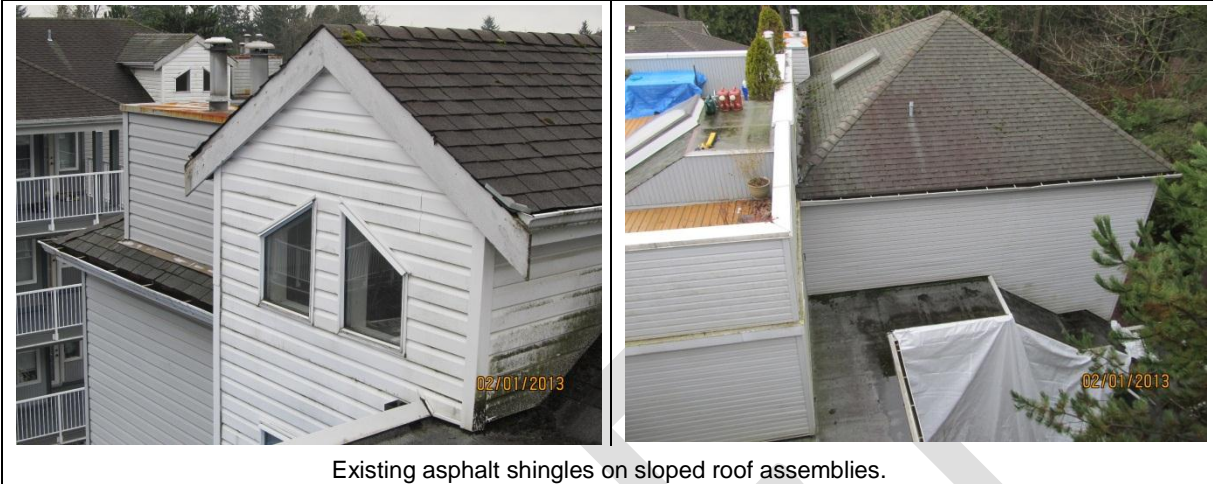
Existing asphalt shingles on sloped roof assemblies.

We have provided a cost for the eventual replacement of asphalt shingles, including associated metal flashings and tie-ins to existing low-slope membrane roof areas, as outlined in Table 1 – Cost Summary.

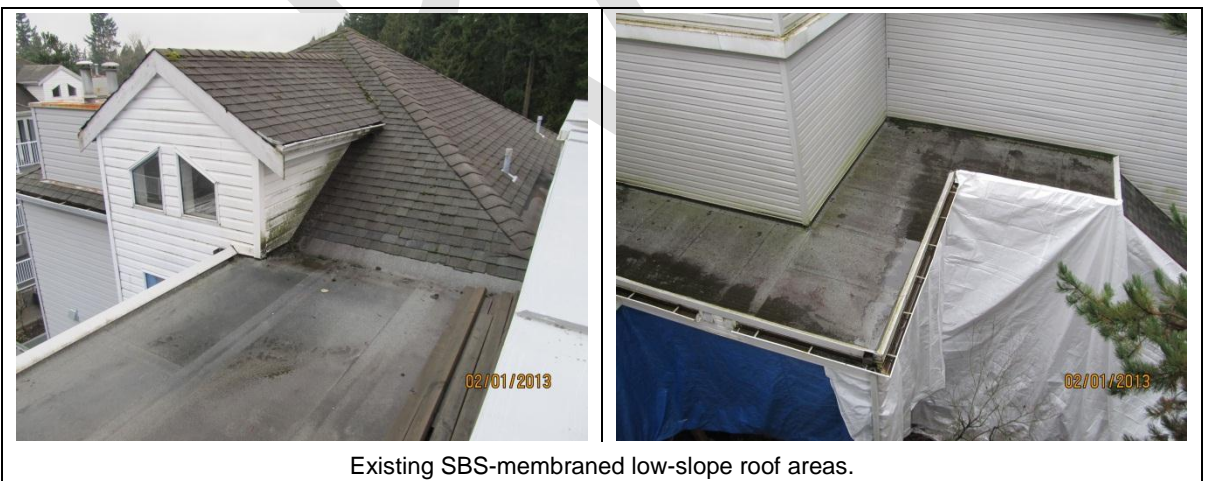
Existing SBS-membraned low-slope roof areas.

We have provided a cost for the eventual replacement of 2-ply SBS-membraned roof areas, as outlined in Table 1 - Cost Summary.

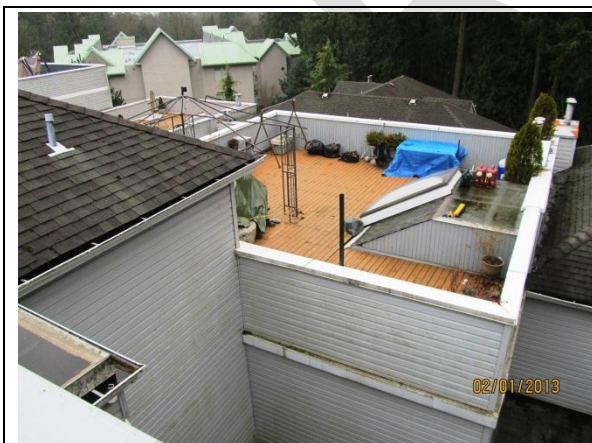
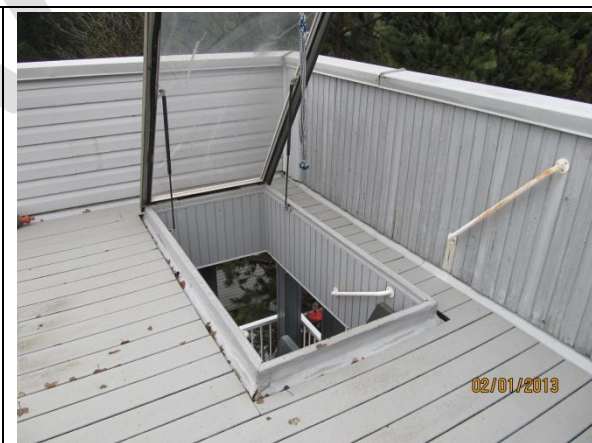
Wood frame guardwalls capped with sheet metal drip-edge cap flashings, are featured at residential roof decks. Interior sides of the guardwalls are clad with painted vertical orientation wood boards. Some interior surfaces have been re-clad with vinyl siding panels. The exterior sides of guardwalls are clad with horizontal vinyl siding.

Typical roof deck.

The service life of wood framing of roof deck guardwalls may exceed the duration of this Study. Sheet metal cap flashing replacement intervals are covered elsewhere.

We have provided a cost for the replacement of interior and exterior finishes of the wood frame guardwalls, including cap flashing replacement, as outlined in Table 1 – Cost Summary.

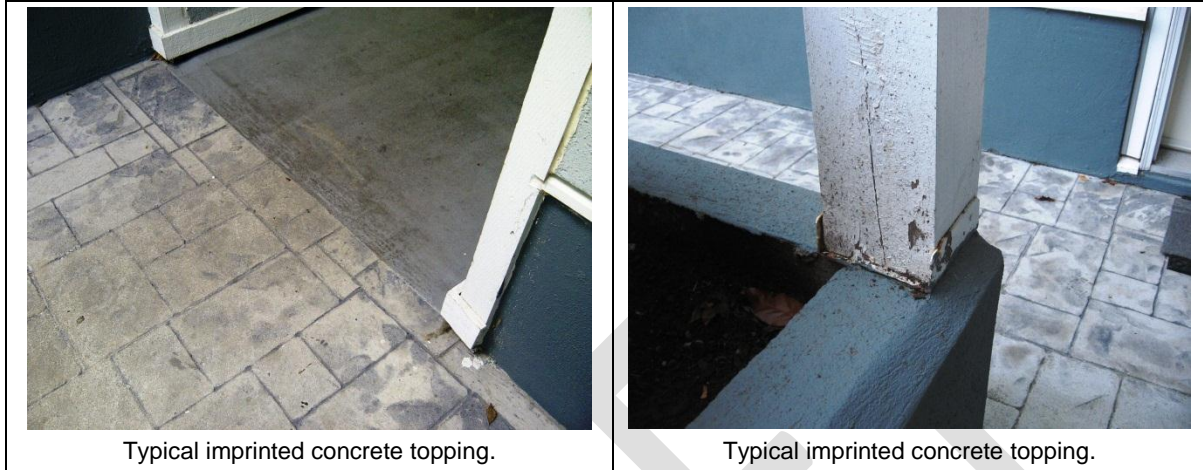
Textured concrete topping is featured on exterior corridors located on the concrete suspended slab of the below-grade parking structure. The patterned concrete transitions to liquid-applied membrane in wood framed corridor areas.

Existing textured concrete is not anticipated to require replacement during the timeframe of this Study. We have provided a cost for re-application of protective coating, as outlined in Table 1 – Cost Summary.

The removal and replacement of this textured concrete topping will be required as part of the replacement of the parking garage waterproofing membrane, which is expected to require replacement within the duration covered by this Study. Such costs are included in the 2nd level suspended slab waterproofing membrane replacement costs.

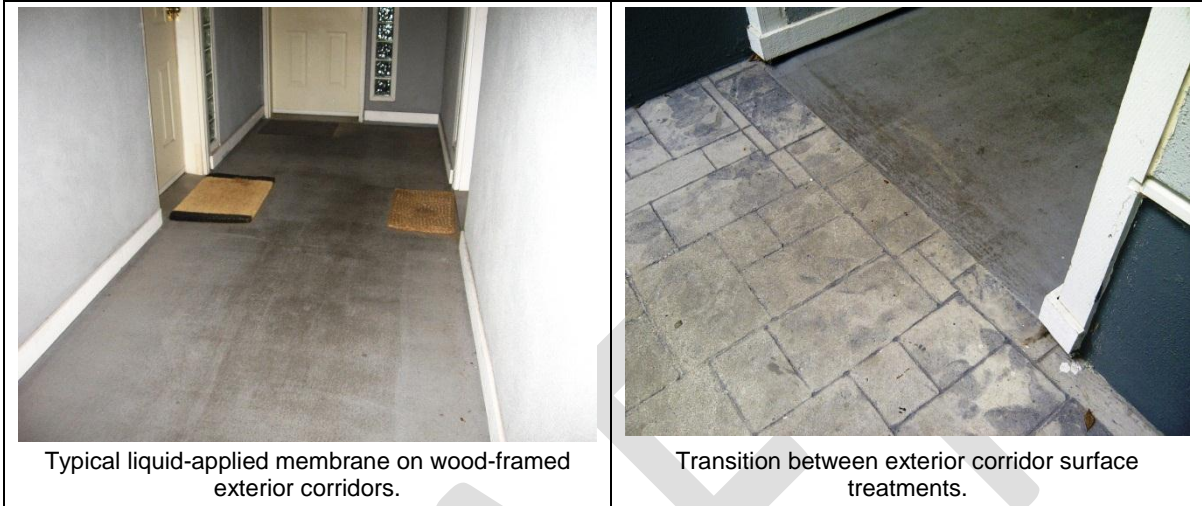
Liquid-applied deck coating is featured on exterior corridors located in wood framed areas of the complex. Wood framed corridors transition to textured concrete in areas atop the concrete parking garage structure.

Existing wood-framed structure of the exterior corridors is not anticipated to require replacement during the timeframe of this Study.

We have provided a cost for re-application of liquid-applied membrane to exterior corridors, as outlined in Table 1 – Cost Summary.

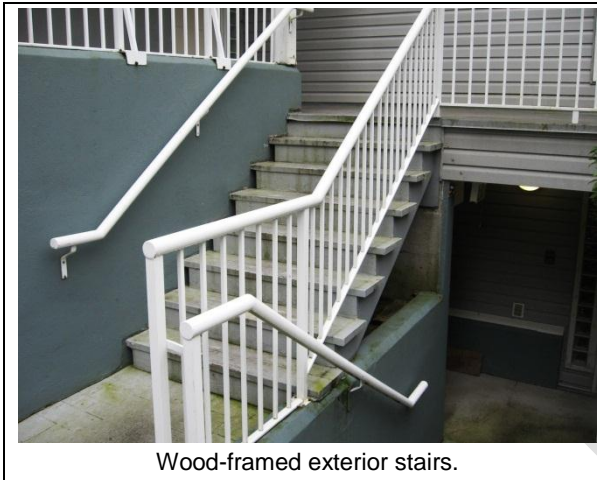
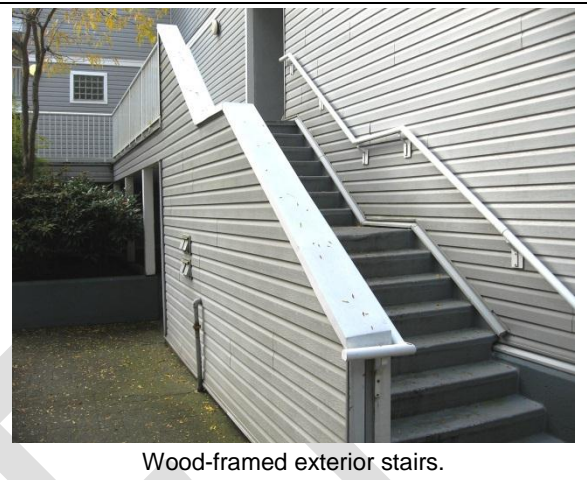
Wood-framed exterior stairs.

We have provided a cost for the replacement of exterior wood-frame stair structures, considering their high pedestrian traffic volume and full exposure to wet weather.

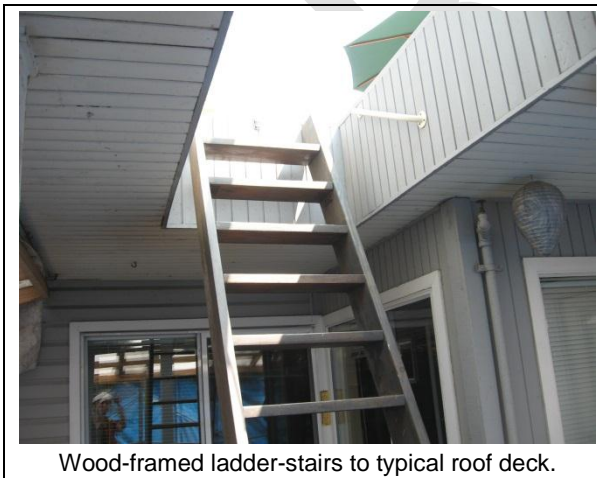
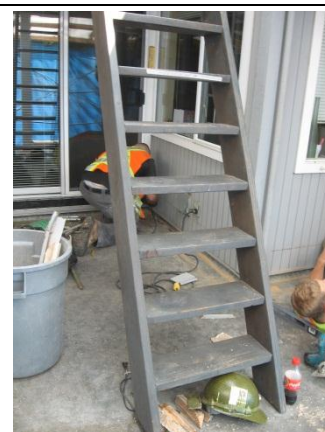
Wood-framed ladder-stairs to typical roof deck.

Existing wood-framed ladder-stair structures are not anticipated to require replacement during the timeframe of this Study due to their present location under full cover of the roof. However, repainting of these ladder units is included as an allowance in the Operating Budget.

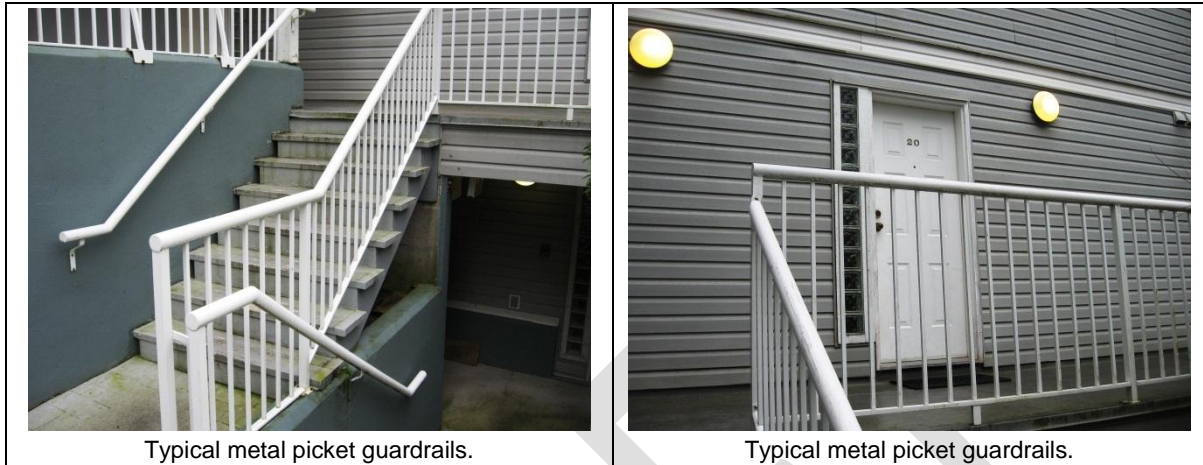
Pre-finished, metal picket, top-mounted guardrails are features at exterior corridors and stair assemblies.

We have provided a cost for the eventual replacement of metal picket railings (recommended side-mounted) at exterior corridors and stairs, as outlined in Table 1 - Cost Summary.

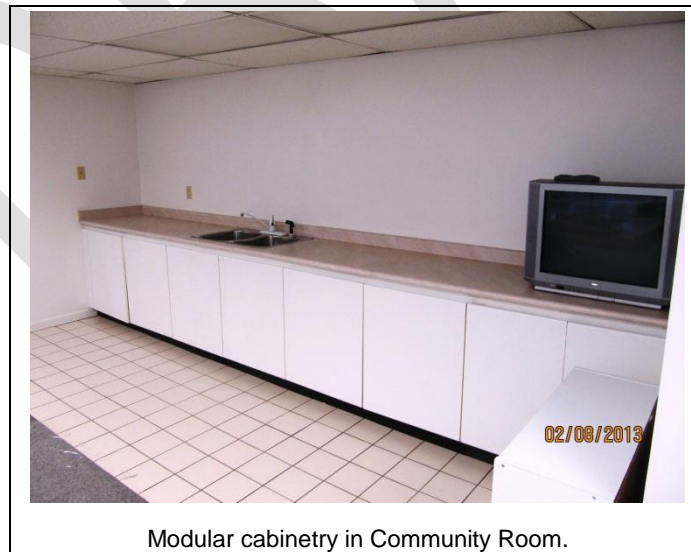
Modular cabinetry with laminate countertops are featured in the Community Room.

We have provided a cost for the eventual removal and replacement of existing modular cabinetry and laminate c/tops, as outlined in Table 1 - Cost Summary.

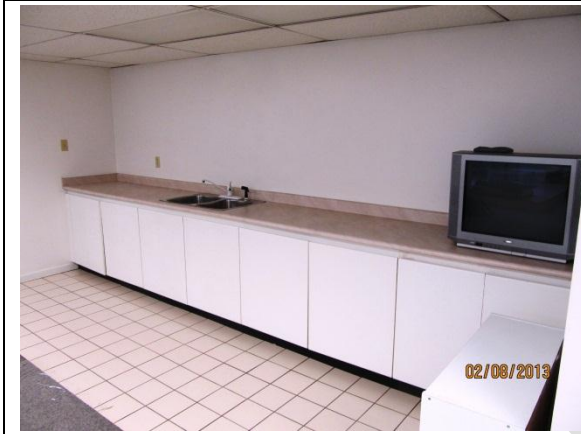
Ceramic tile floor in Community Room.

Ceramic tile is not anticipated to require replacement during the timeframe of this Study. We have provided a cost for grout replacement. However, cost for occasional replacement of broken tiles is to be funded from the Operating Budget.

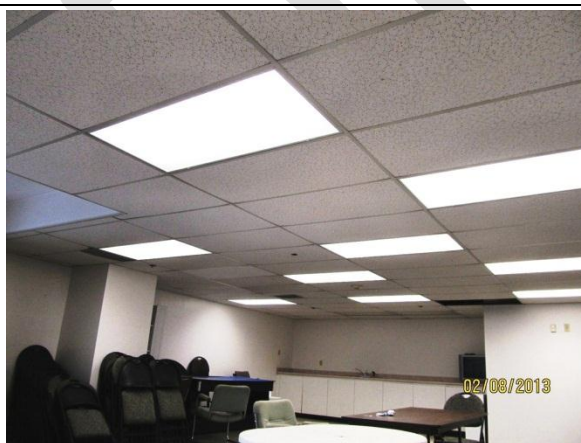
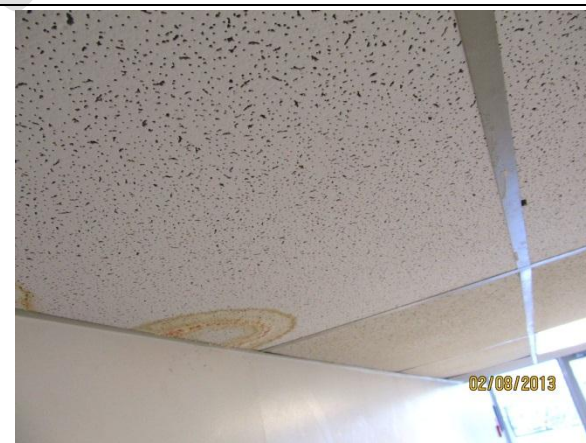
Suspended ceiling with acoustic panels.

We have provided a cost for the eventual replacement of suspended acoustic panel ceiling, as outlined in Table 1 - Cost Summary.

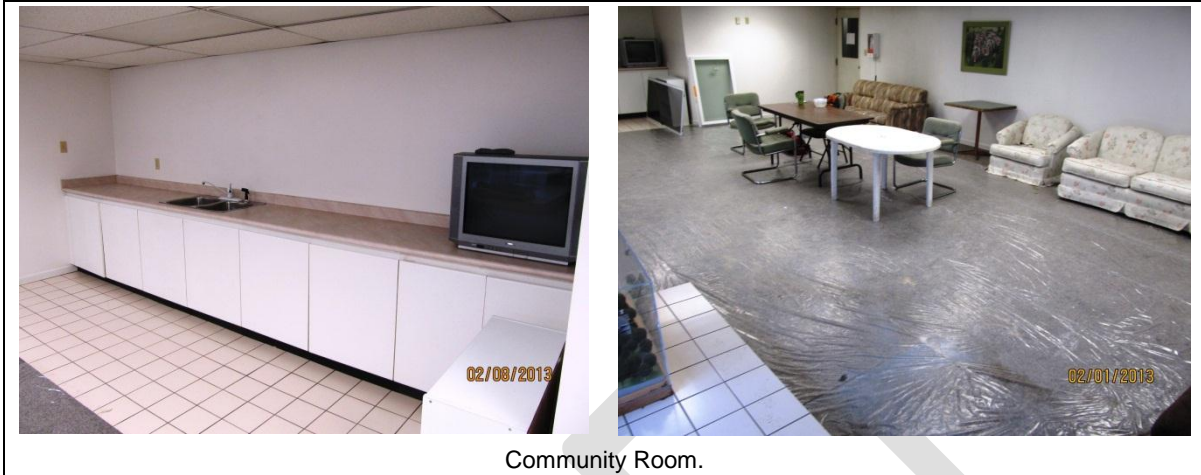
The common area Community Room features painted gypsum board walls.

Gypsum board is not generally anticipated to require replacement over the intended lifespan the building. We have provided a cost for repainting existing gypsum board panels, as outlined in Table 1 - Cost Summary.

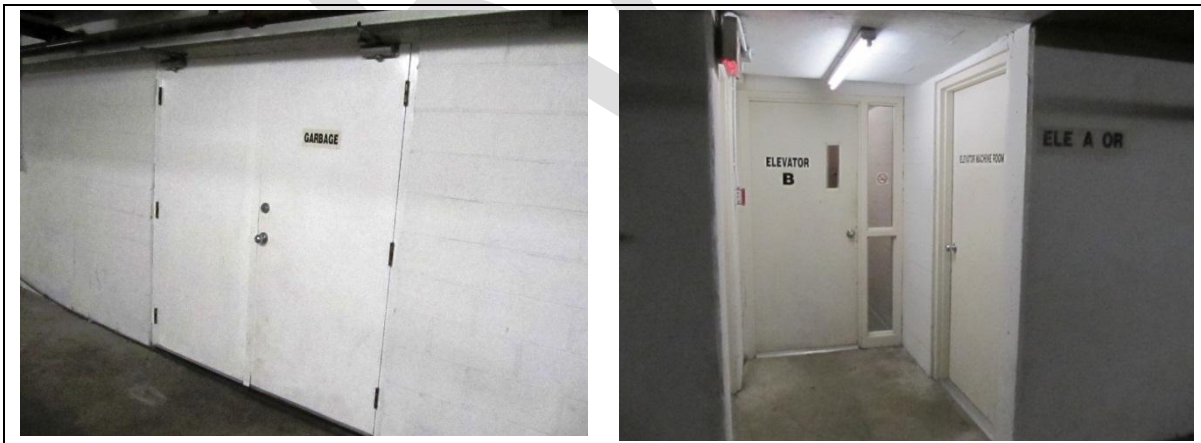
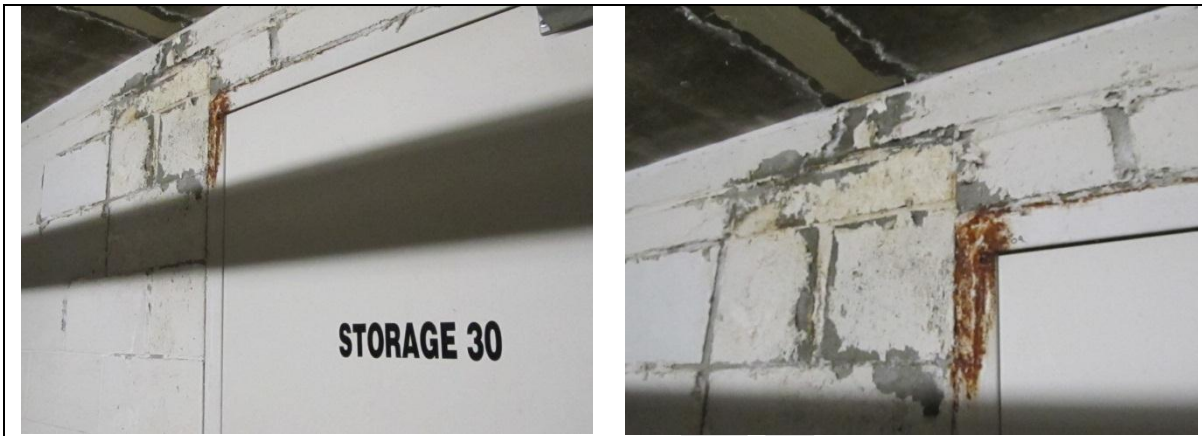
Metal frame, metal-clad flat-panel swing doors are featured at interior core elevator/ stairwell lobbies, throughout the parking garage and at utility/ storage rooms. Existing corrosion was observed on metal frames of some doors at parking garage storage lockers.

The normal life expectancy of typical metal swing doors is typically about 20 years. We have provided an allowance for the replacement of these utility room metal swing doors, as outlined in Table 1 – Cost Summary.

Maintenance cost for removal of existing corrosion on metal frames/ doors is to be funded from the Operating Budget.

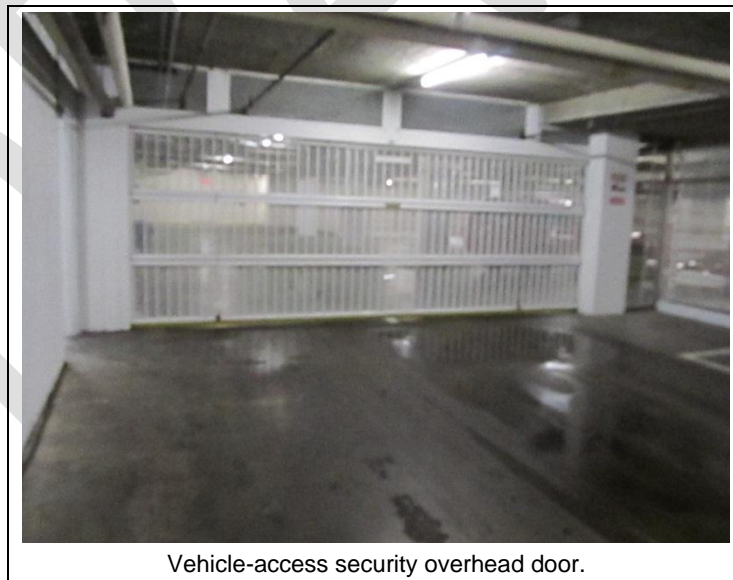
Vehicle-access security overhead door.

We have provided a cost for the eventual replacement of this vehicle-access overhead door, as outlined in Table 1 - Cost Summary. Refer to the Electrical portion of this report for the predicted life expectancy of typical electric-assist motors.

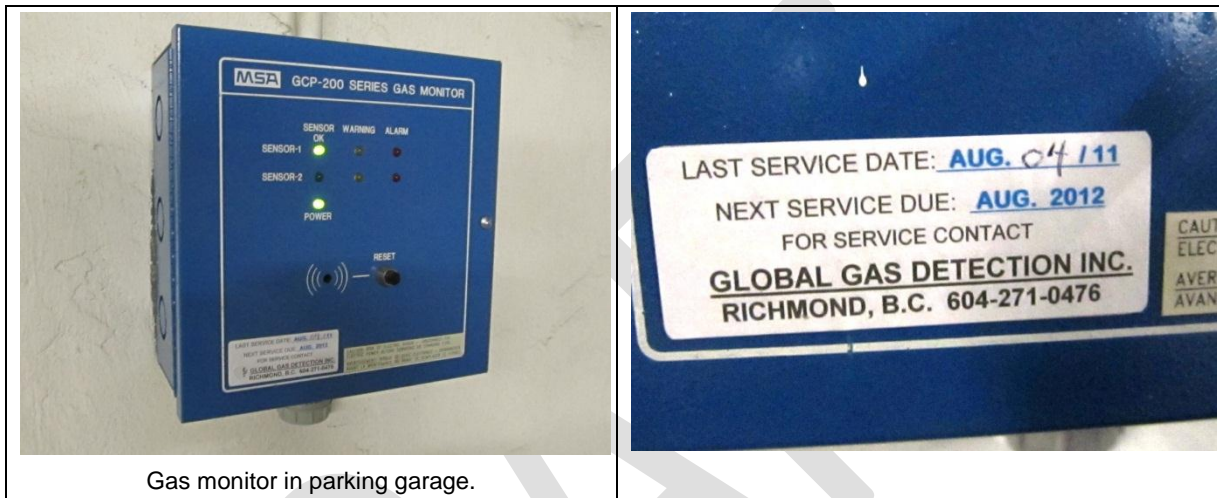
The normal life expectancy is approximately 15 to 20 years and based on our observations, we expect this unit may remain serviceable for several years, if properly serviced and maintained.

Gas monitor in parking garage.

We have provided a cost for removal and replacement, as outlined in Table 1 - Cost Summary.

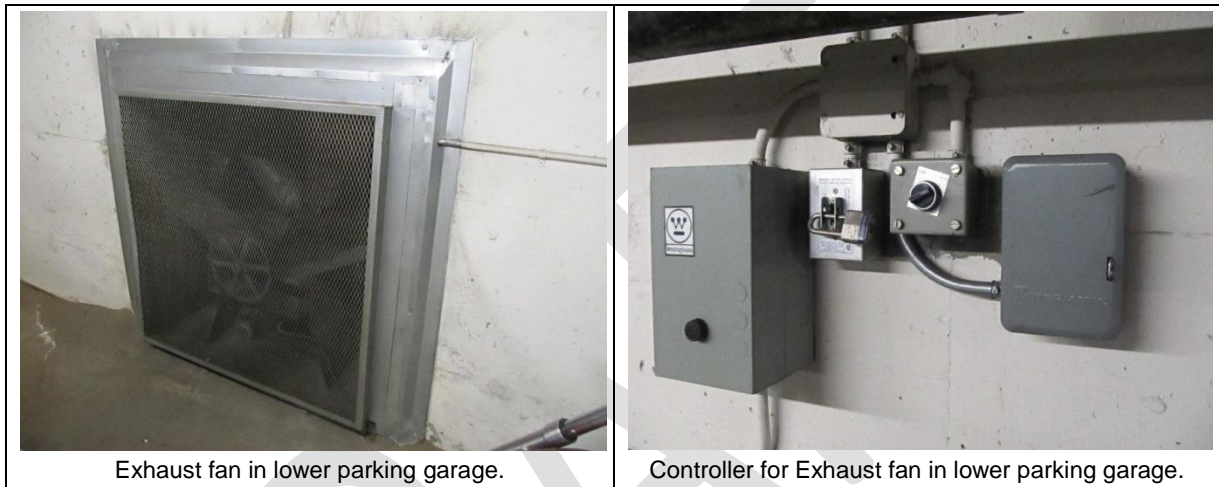
Fans of this type have an average life expectancy of 25 to 30 years. Based on our observations, we expect that this fan should be able to remain in service for several more years, if properly maintained and serviced.

Exhaust fan in lower parking garage.

Controller for Exhaust fan in lower parking garage.

We have provided a cost for removal and replacement, as outlined in Table 1 - Cost Summary.
