BC Roof Inspections

July 31, 2019

Re: Residence at The Crystal
6028 & 2088 Willingdon Avenue,
Burnaby

As per your request we have completed a roof survey of the address noted above and offer the following recommendations.

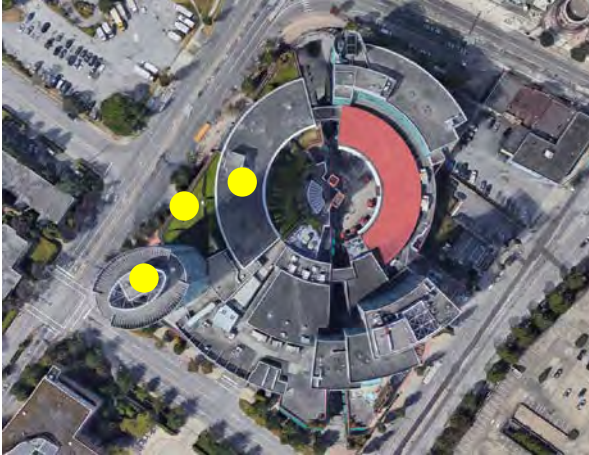
<p>1.</p>

<p>View of the building being inspected. Roof sections inspected are marked with a yellow dot (the townhouse decks, flat and slope roof were reviewed).</p>
<p>2.</p>
