# Depreciation Report

BCS3495 – Grand Central

**RE: Depreciation Report for Strata Plan BCS3495  
File No. B3495DR17**

The subject of this depreciation report consists of “Grand Central” – Strata Corporation Section, a 642-unit apartment and commercial complex constructed in 2009/2012/2014 and located at 2968 – 2978 Glen Drive and 2975 Atlantic Avenue in Coquitlam, BC. We are pleased to present you with the enclosed depreciation report, which we believe will serve as the basis of your reserve planning to help better equip your members for future expenditures.

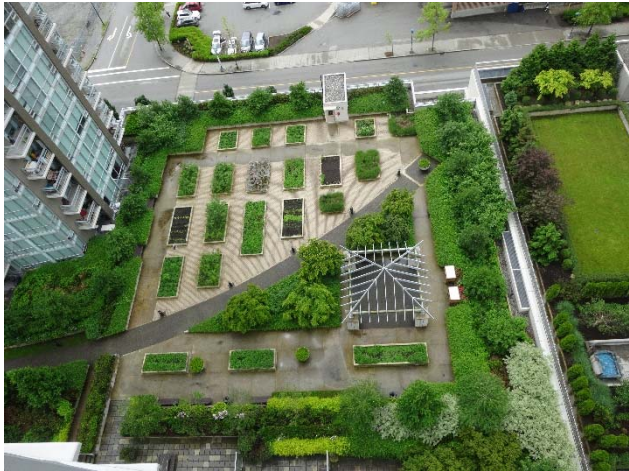
Areas with waterproofing membrane

Phase 2	\$ 1,660,350	2047	Full replacement.		
Phase 3	\$ 1,395,975	2049	Full replacement.		
<b>Preventative Maintenance</b>	Sometimes discontinuities within the waterproofing membrane can be economically repaired from the exterior. If not, the water ingress can be managed by sealing the leaking cracks in the concrete from the interior.				
<b>Remarks</b>	None.

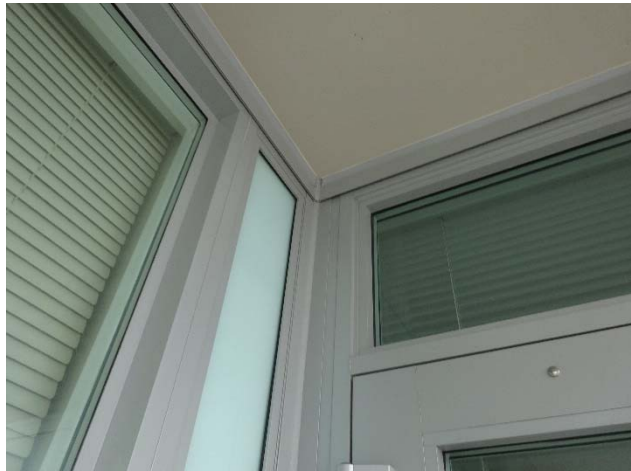
Caulking between door/windows frames and ceiling

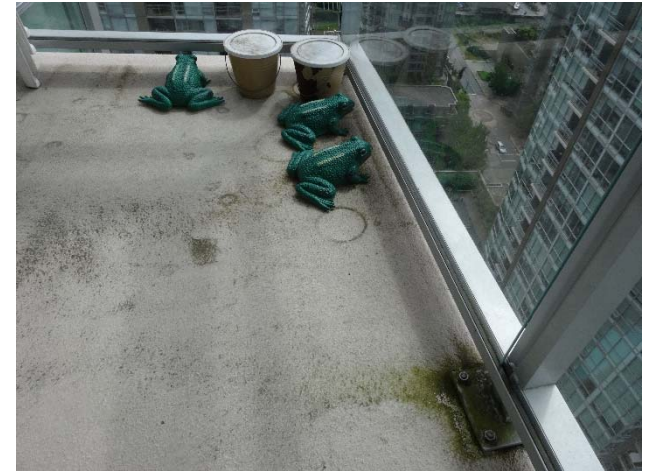
Liquid membrane on balcony decks

<b>Phase 3</b>	\$ 753,000	2038	Full replacement.		
<b>Preventative Maintenance</b>	Inspect every two years, patch locally.				
<b>Remarks</b>	None.

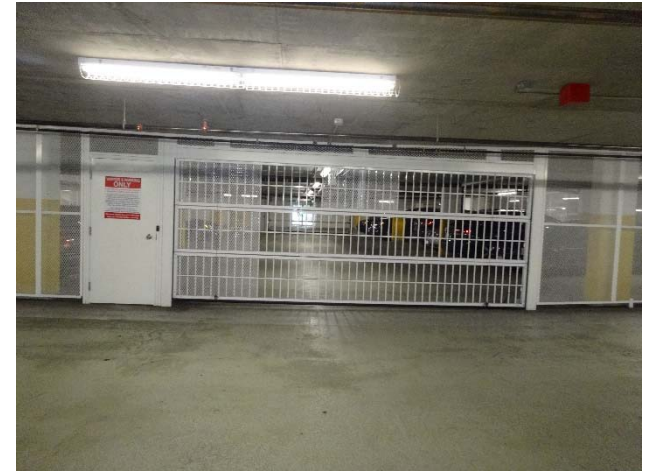
Interior garage door

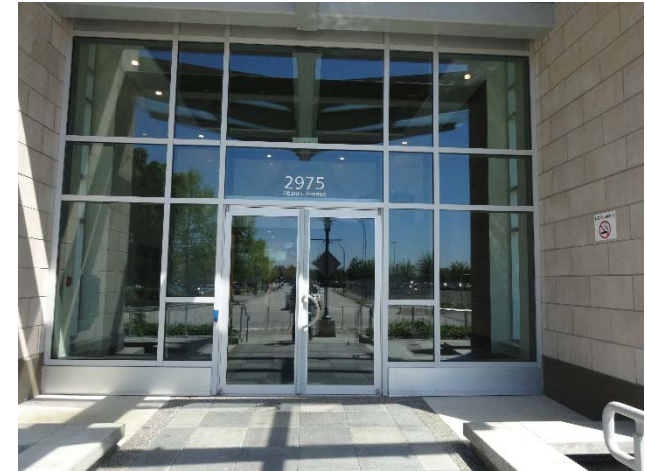
Main entrance door

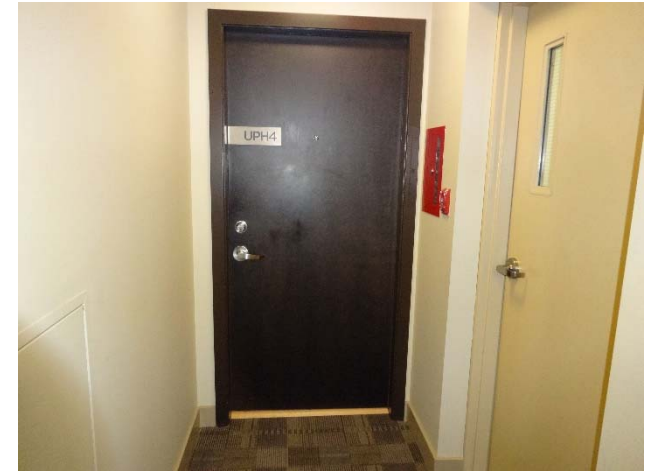
Unit entry door

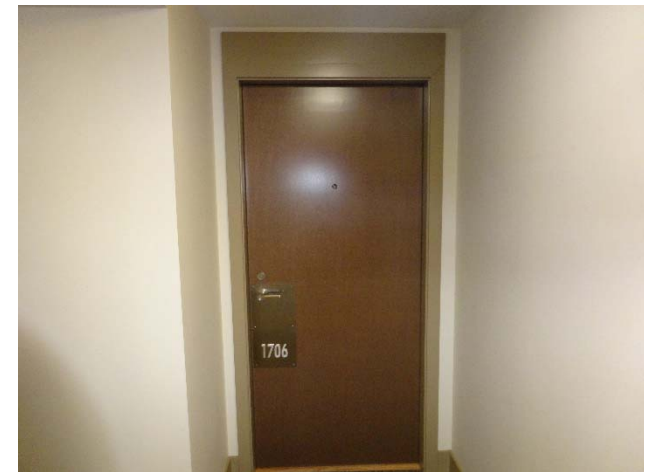
Unit entry door

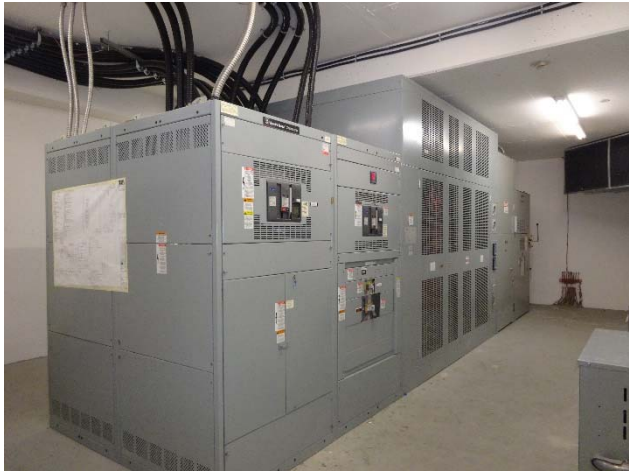
High voltage substation

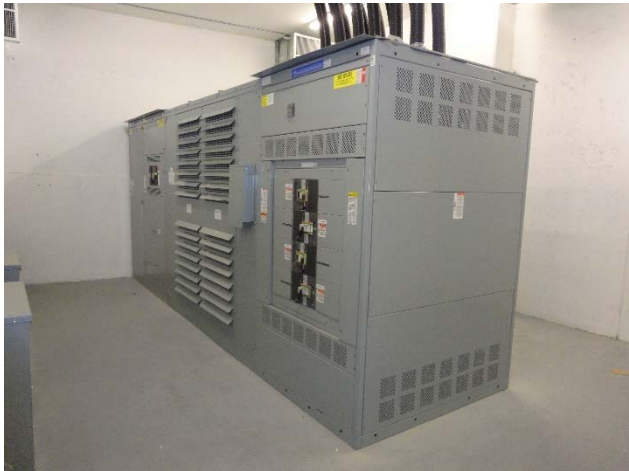
High voltage substation

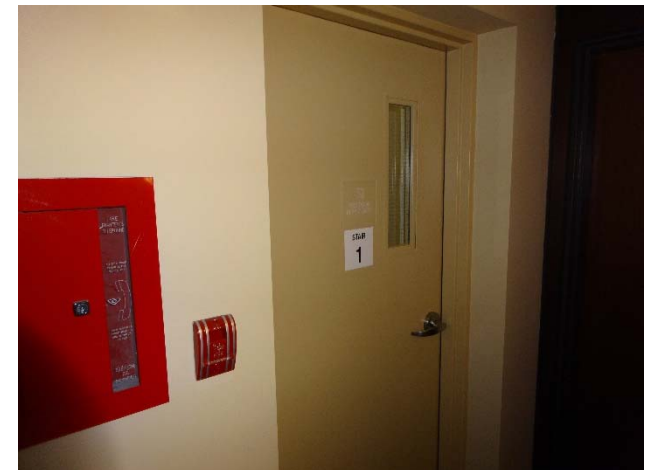
Emergency telephone both and pull station

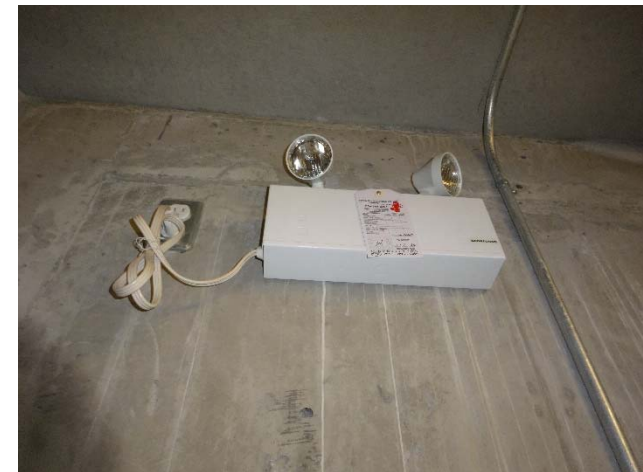
Emergency light fixtures with battery pack

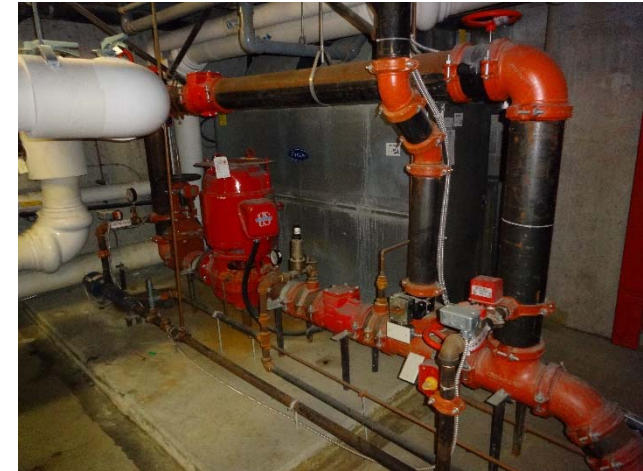
Fire pump assembly

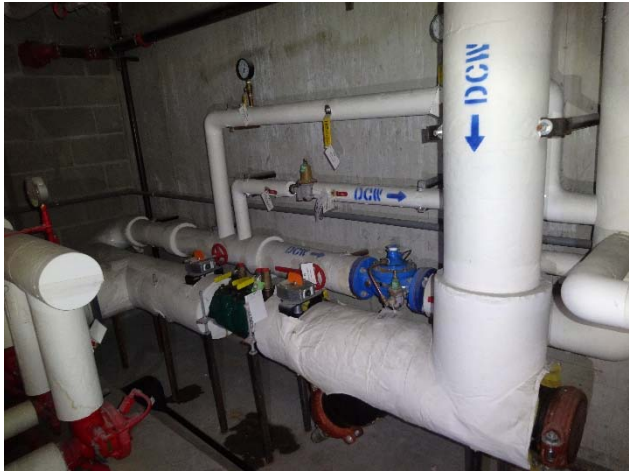
Water entry station

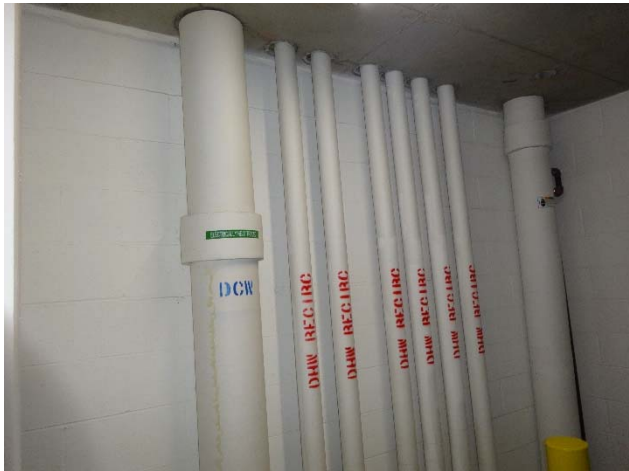
Water distribution piping

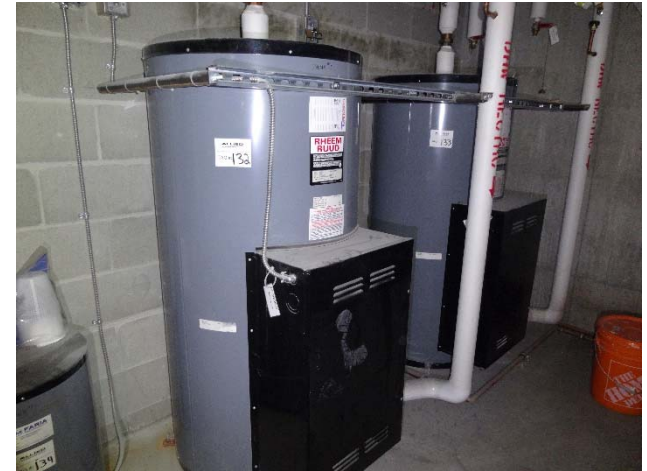
Electric water heaters

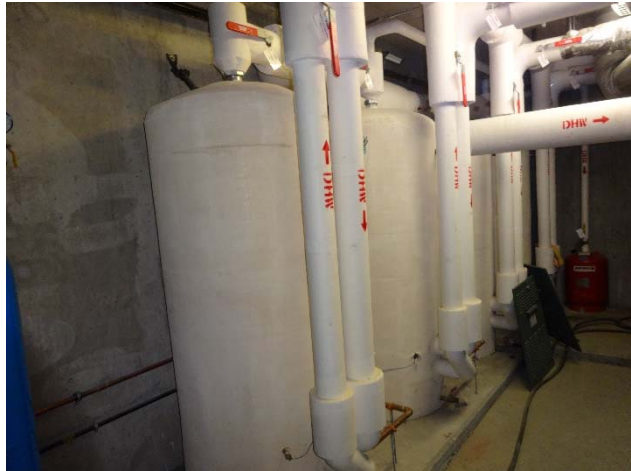
Hot water tanks

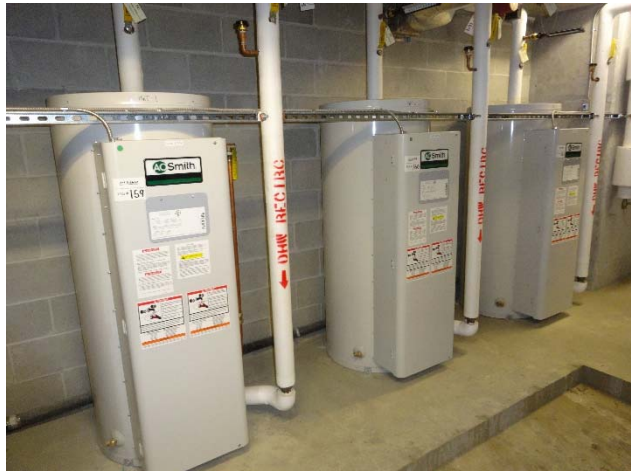
Hot water tanks

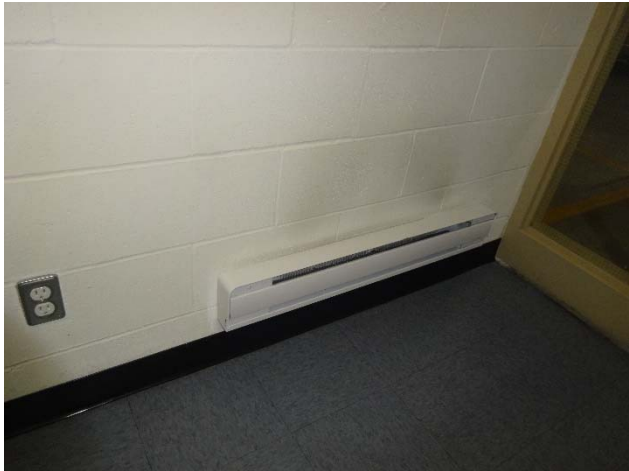
Electric baseboard heater on corridor

<b>Phase 2</b>	\$ 13,000	2042	Full replacement.		
<b>Phase 3</b>	\$ 13,000	2044	Full replacement.		
<b>Preventative Maintenance</b>	Vacuum the fins or vents once a year prior to the heating season. Electric baseboards with corroded, overheated connections or burnt-out elements should be replaced. Repair/replace faulty thermostats as needed.				
<b>Remarks</b>	None.

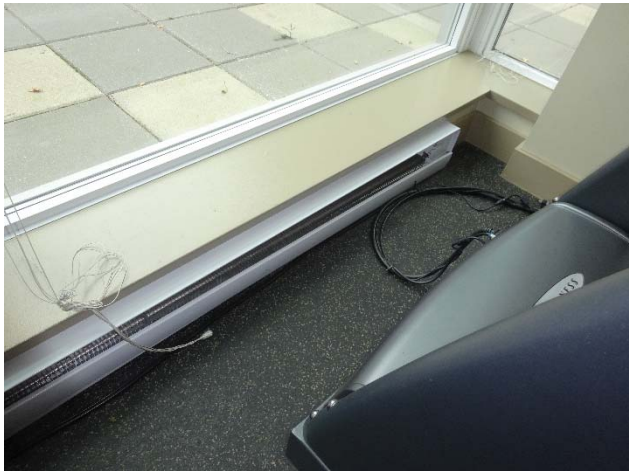
Electric baseboard heater in exercise room

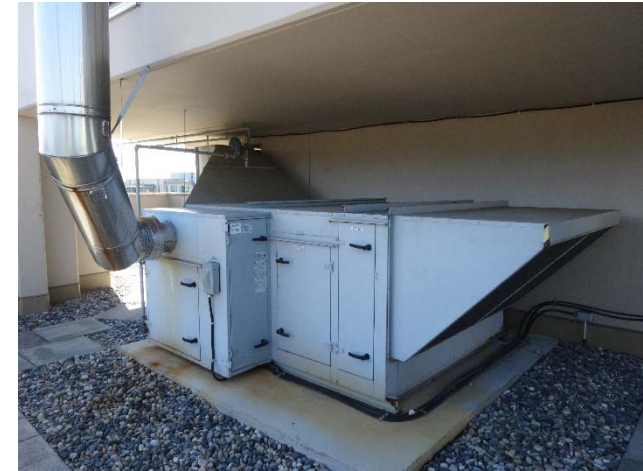
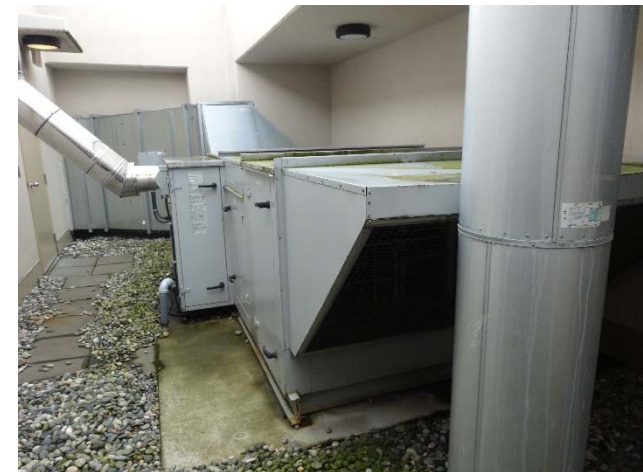
Make up air unit

<b>Preventative Maintenance</b>	Annual maintenance is provided by specialized personnel and should include: checking fan blades and dumpers for dirt accumulation and cleaning if necessary, checking fan bearing collar set screws for tightness, checking damper actuators for proper operation, checking belts for wear and adjusting tension or alignment, lubrication of bearings, checking and adjusting controls.				
<b>Remarks</b>	None.

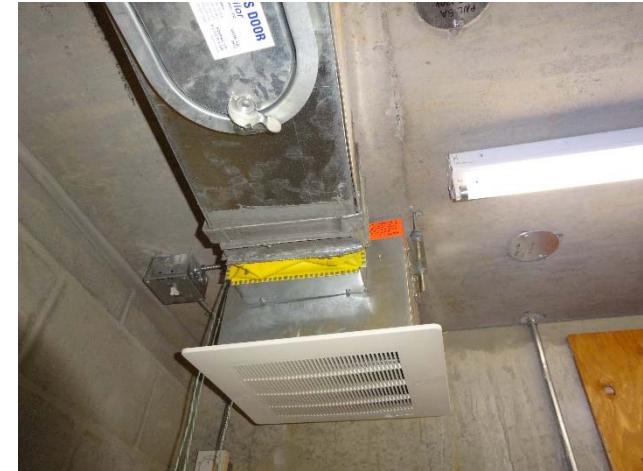
Exhaust fan in service room

<b>Phase 3</b>	\$ 10,000	2039	Full replacement.			
<b>Preventative Maintenance</b>	Check cleanliness of the fan, switch operation. Repair as required. Check fan belt tension, wear and alignment. Replace if necessary to ensure proper operation. Check and adjust the controls.					
<b>Remarks</b>	None.

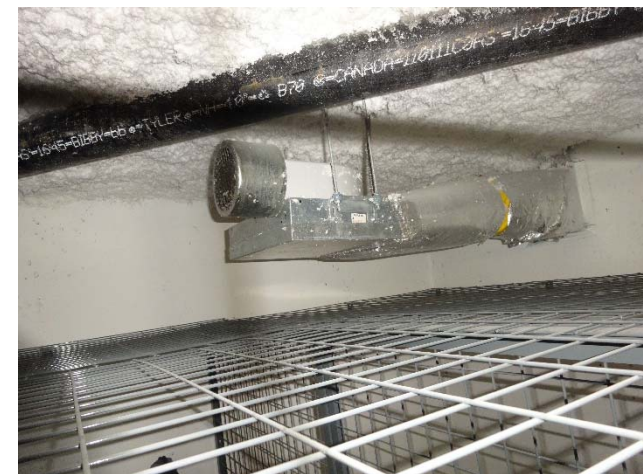
Exhaust fan in storage room

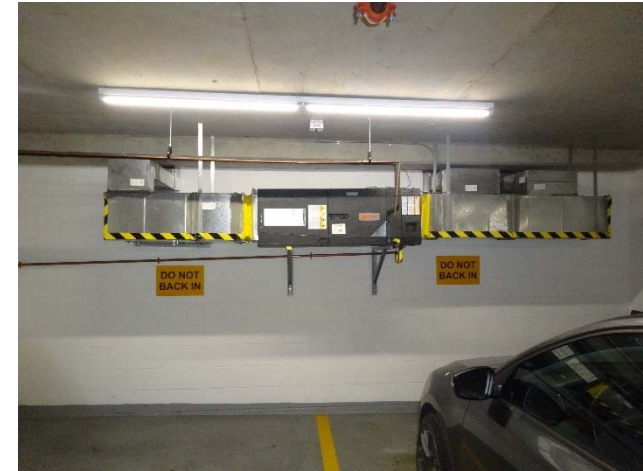
Transfer air unit

<b>Phase 3</b>	\$ 20,000	2037	Full replacement.		
<b>Preventative Maintenance</b>	Annual maintenance may include: checking blades for dust buildup and clean if necessary, checking fan RPM to design specifications, checking belt tension, wear and alignment, bearing collar set screws to make sure that they are tight, lubricate fan bearings and motor. Measure motor amperage using a C clamp amprobe. Increased current flow may indicate that bearings are seizing.				
<b>Remarks</b>	None.

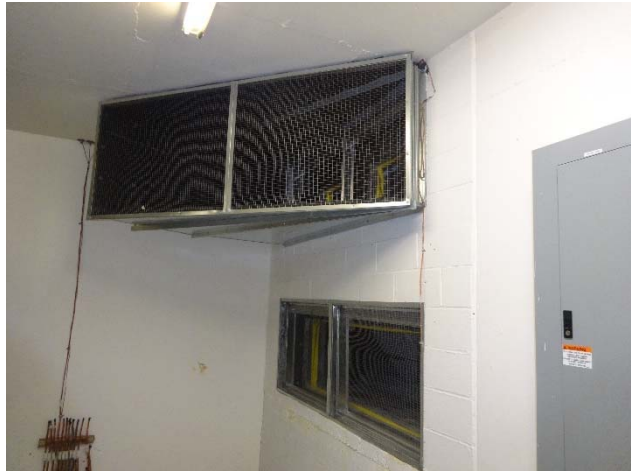
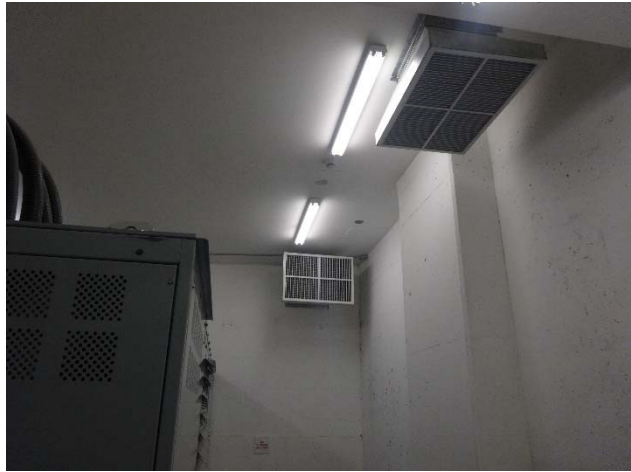
A/C fans in High Voltage room

<b>Phase 2</b>	\$ 35,000	2032	Full replacement.		
<b>Phase 3</b>	\$ 35,000	2034	Full replacement.		
<b>Preventative Maintenance</b>	Annual maintenance tasks may include: adjusting refrigerant charge, checking fan motor and compressor operation, checking controls, checking for excessive noise and vibration, inspection/replacement of air filters.				
<b>Remarks</b>	None.

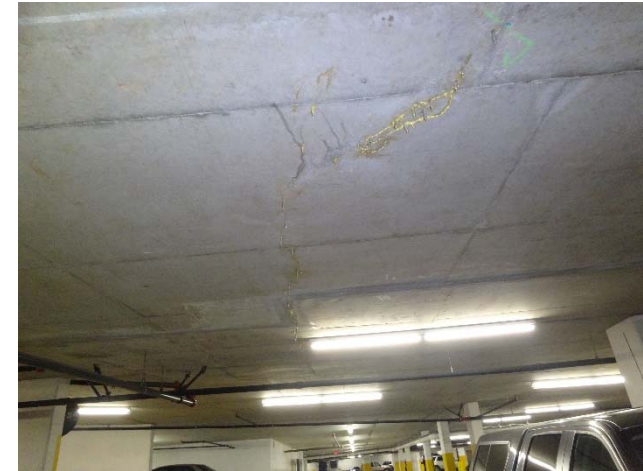
Light fixture in parkade

<b>Phase 2</b>	\$ 3,000	2027	Contingency every 7 years.		
<b>Phase 3</b>	\$ 3,000	2030	Contingency every 7 years.		
<b>Preventative Maintenance</b>	Maintenance service should be performed annually and typically include: removing of old lamps and cleaning the fixtures, inspecting wiring, contacts, terminals and sockets, installation of new lamps, putting back into service and testing the operation.				
<b>Remarks</b>	None.

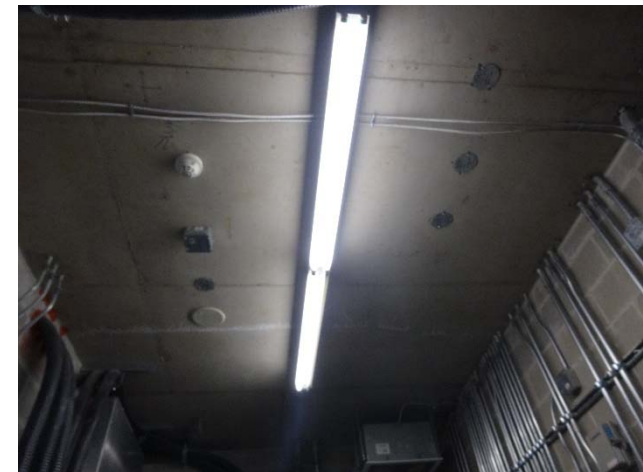
Light fixture in service room

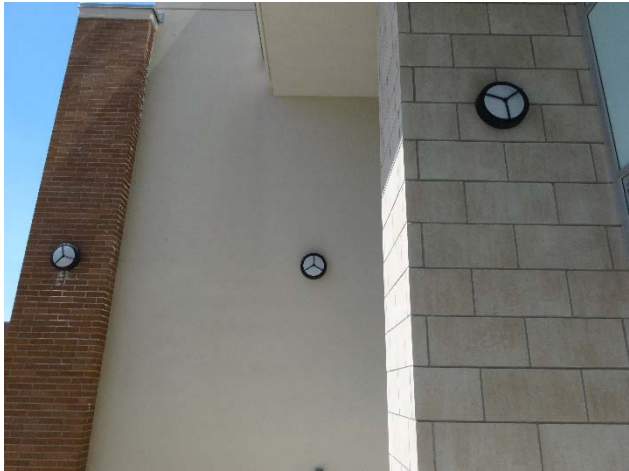
Light fixture on building facade

<b>Preventative Maintenance</b>	Maintenance service should be performed annually and typically include: removing of old lamps and cleaning the fixtures, inspecting wiring, contacts, terminals and sockets, installation of new lamps, putting back into service and testing the operation.				
<b>Remarks</b>	None.

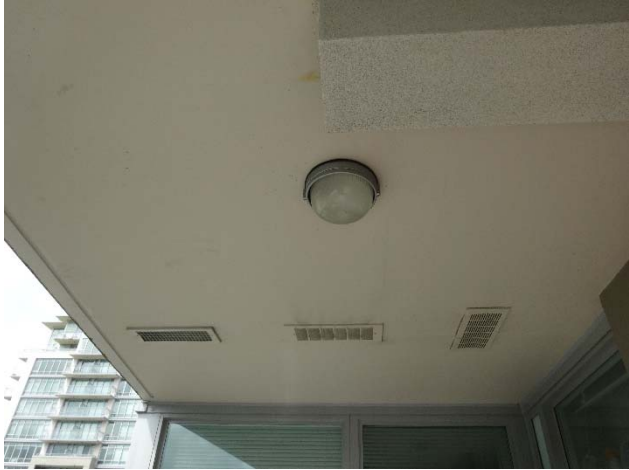
Light fixture on balcony

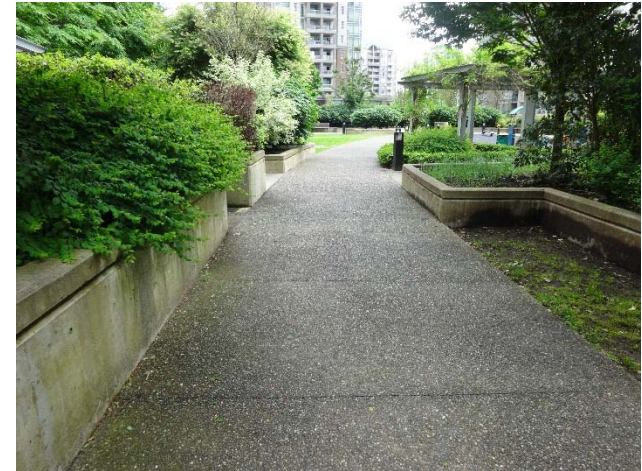
Pedestrian walkway on roof top garden

<b>Phase 2</b>	\$ 5,000	2027	Contingency every 7 years.		
<b>Phase 3</b>	\$ 5,000	2030	Contingency every 7 years.		
<b>Preventative Maintenance</b>	Stresses producing minor defects are constantly at work. Early detection and repair (patching, crack sealing, etc.) of minor defects is essential before they deteriorate into pavement failures requiring major repair expenditures.				
<b>Remarks</b>	None.

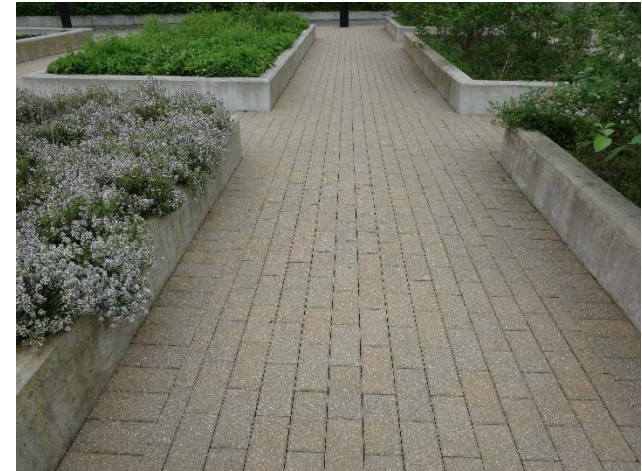
Pedestrian walkway on roof top garden

<b>Phase 3</b>	\$ 3,000	2030	Contingency every 7 years.		
<b>Preventative Maintenance</b>	Inspect every two years, repair as needed. Should some areas settle excessively, lift out the pavers in the low area and add sand to level the area out. Replace the broken units.				
<b>Remarks</b>	None.

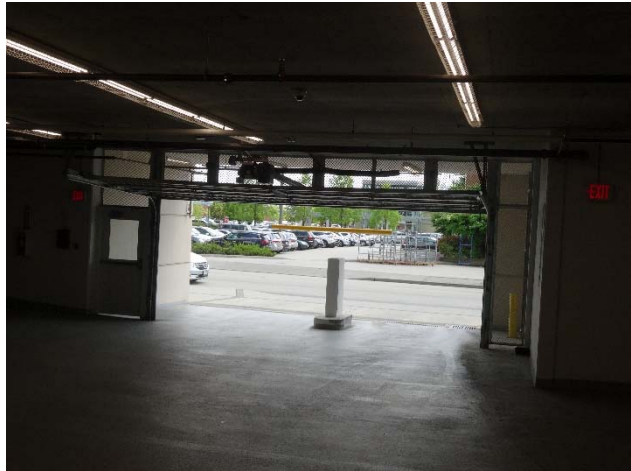
Concrete pavement in front of garage entrance

<b>Phase 2</b>	\$ 2,000	2027	Contingency every 7 years.		
<b>Phase 3</b>	\$ 2,000	2030	Contingency every 7 years.		
<b>Preventative Maintenance</b>	Stresses producing minor defects are constantly at work. Early detection and repair (patching, crack sealing, etc.) of minor defects is essential before they deteriorate into pavement failures requiring major repair expenditures.				
<b>Remarks</b>	None.

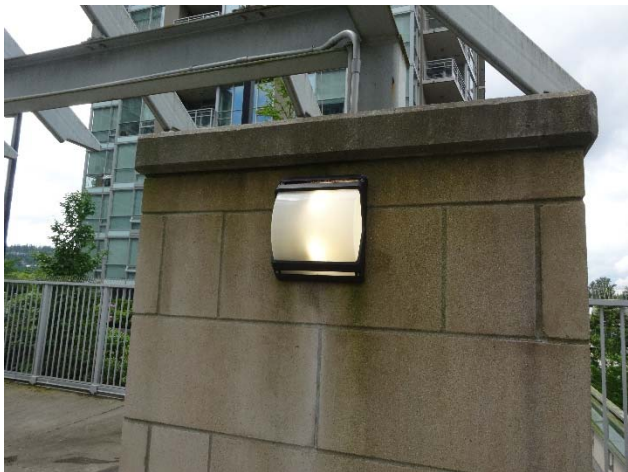
Light fixture on column

Reserve Component G40200101		Site lighting			
<b>Properties</b>	External lighting				
<b>Potential Deterioration</b>	Site lighting is generally replaced based on aesthetic and energy saving considerations and/or for better illumination of the areas served. Over time the corrosion may occur on the casing or discoloring and yellowing may occur on the lens.				
<b>Condition Analysis</b>	<b>Deterioration</b>	None apparent.			
	<b>Repair History</b>	Not available.			
<b>Overall Condition</b>		Good.			
Life Cycle Analysis	DOI	CA	EUL	EA	RUL
Phase 1	2009	8 years	Contingency	8 years	Contingency
Phase 2	2012	5 years	Contingency	5 years	Contingency
Phase 3	2014	3 years	Contingency	3 years	Contingency
Cost Analysis	Current Cost	Starting Year	Funding Method		
Phase 1	\$ 2,000	2024	Contingency every 7 years.		
Phase 2	\$ 2,000	2027	Contingency every 7 years.		
Phase 3	\$ 2,000	2030	Contingency every 7 years.		
<b>Preventative Maintenance</b>	Maintenance service should be performed annually and typically include: removing of old lamps and cleaning the fixtures, inspecting wiring, contacts, terminals and sockets, installation of new lamps, putting back into service and testing the operation.

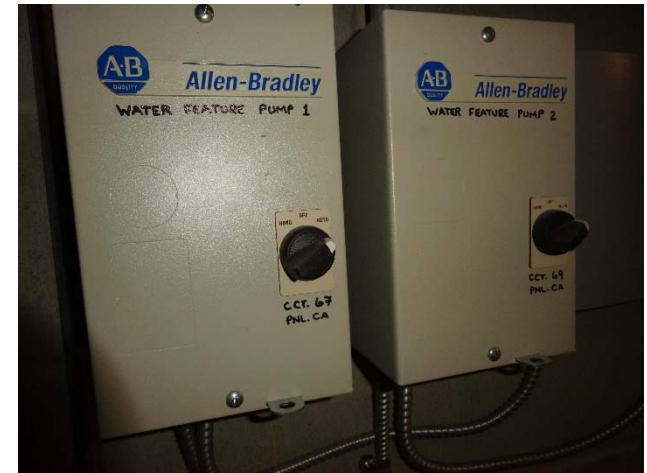
Water feature pumps

<b>Phase 3</b>	\$ 4,000	2028	Contingency every 7 years.		
<b>Preventative Maintenance</b>	Maintenance service should be performed semi annually, and typically includes: draining of the fountain. Some other maintenance operations include also: filter cleaning and repairs, inspection of pumps and piping. Special procedures at seasonal opening and closing should be followed.				
<b>Remarks</b>	None.

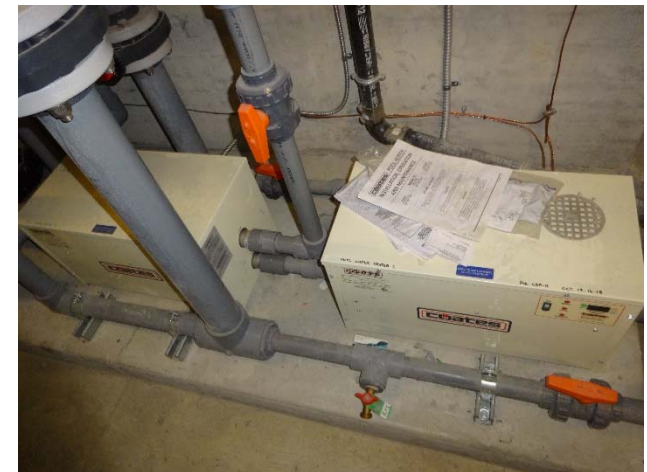
Water feature heaters
