10-YEAR STRUCTURAL WARRANTY REVIEW

Located at:
Grand Central One – 2978 Glen Drive, Coquitlam, BC

July 15th, 2019

File number: FSR-005-19-D
July 15th, 2019

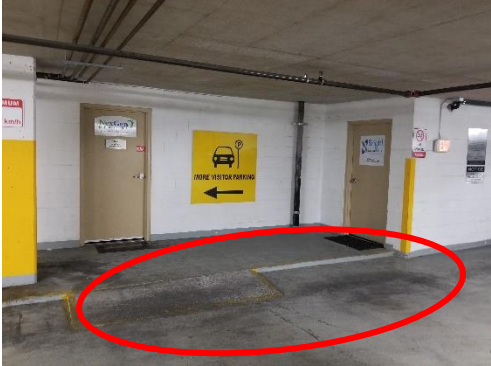
<p>4.4.1.3</p>

<p>Water ponding was observed and confirmed by the occupants of unit 102. A drain should be installed or re-sloping the deficient area to remove the water from there.</p> <p>Location: Back entrance of unit 102 located on Glen Drive Type: SDE Importance: Medium Action required: Further Investigation and Upkeep as needed</p>
<p>4.4.1.4</p>

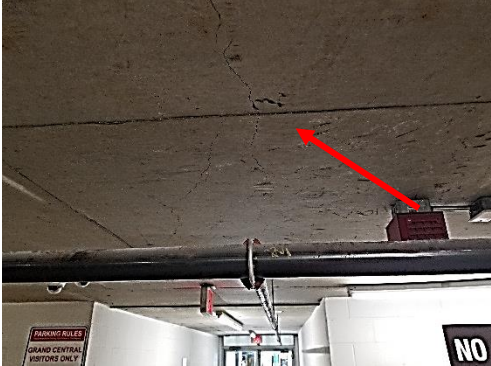
<p>This photo is representative of many of the areas on the ceiling for all of the suspended slabs. Many hairline cracks were observed, with no specific pattern identified, in many areas. These hairline cracks are very common in cast-in-place concrete elements.</p> <p>These cracks are usually from the shrinkage process as the concrete cures and comes to strength and typically are not a structural concern. However, they may and/or develop water ingress coming from them into the interior of the parkade and or other applicable areas in the building(s).</p> <p>For such leak occurrences, it is recommended to address the most noticeable cracks and/or their related external membrane or dampproofing details affecting them that may leak when they are noted by either concrete injection or if able topical membrane detailing for their proper upkeep as needed.</p> <p>Location: Ceiling of suspended slabs for all floors Type: NSD Importance: Low Action required: Monitor & Upkeep as needed</p>

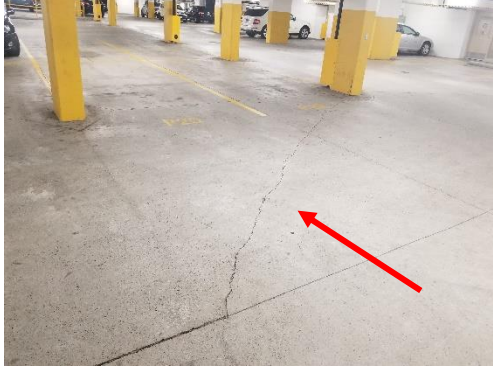
<p>4.4.1.5</p>

<p>Generally cracks on concrete slabs should be repaired at the minimum by acceptable crack sealing methodologies depending whether they are on the suspended parking slabs with a traffic bearing membrane or on the concrete slabs-on-grade of the parking garage. For slab-on-grade cracks, routing and proper caulking sealant is a maintenance repair option.</p> <p>The locations of the most excessive cracks at the time of the review are reported below.</p> <p>Locations: Concrete slab of P1. Stall # 65, from #4 to #30 and #40, from #14 to #19</p> <p>Type: NSD Importance: Medium Action required: Maintenance</p>
<p>4.4.1.6</p>

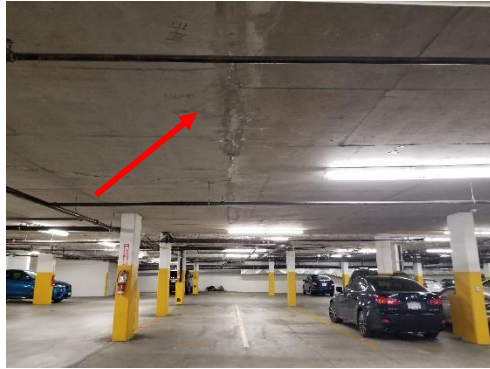
Photo C.- Notorious water ingress from the commercial parking level towards P1 level

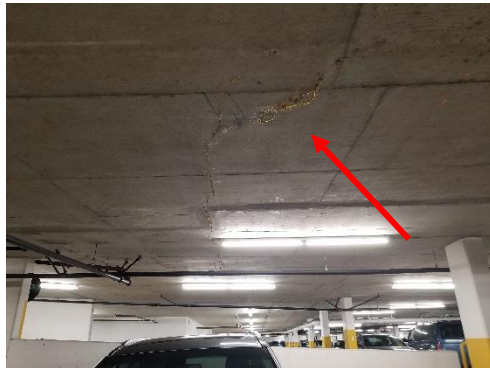
Photo D.- Crack possibly injected with polyurethane foam located beside the ramp which ends at P1

Major repairs were conducted by the owners to repair the concrete suspended slab and also replace the waterproofed membrane at the commercial parking areas (mostly) (photos D and E).

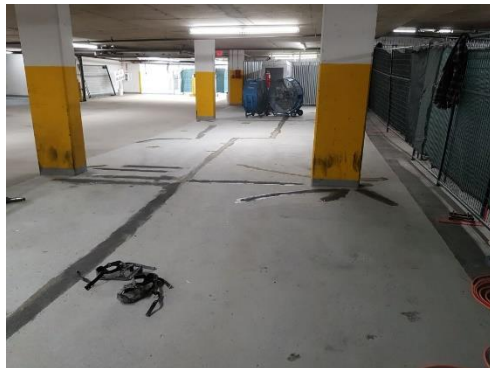
Photo E.- Concrete floor state after after removing the topping from several areas and ready for re-coating with waterproof membrane.

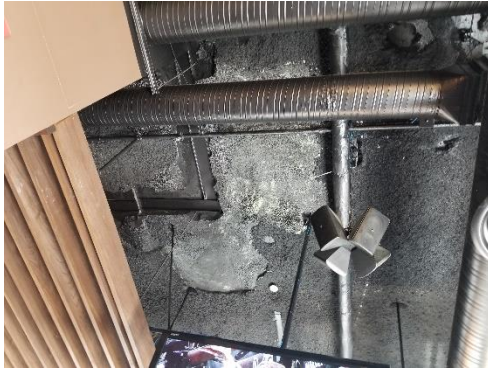
Photo A.- Exposed concrete slab in the ceiling of Urban Gate Restaurant

Signs of water ingress observed and confirmed by the occupant of the commercial unit located on the corner of The Hight St. and Atlantic Ave (southeast corner of the complex). Lack of insulation was noticed in a wide area of the ceiling. The occupant mentioned that water is leaking from the room located on the top (Photo A).

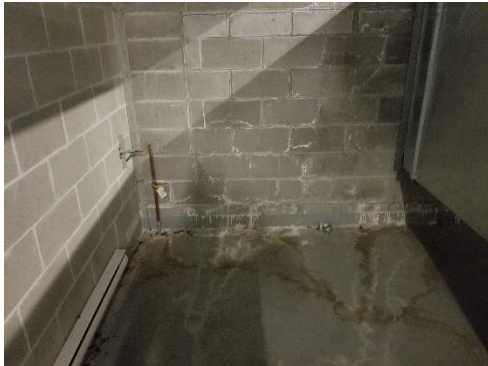
Photo B.- Efflorescence in concrete block firewall due to water ingress in the emergency generator room

The room located on top is the Emergency generator room and when we reviewed it, some clear signs of water and efflorescence were observed on the concrete block wall and the floor located on the east side of the interior of the room (Photo B).

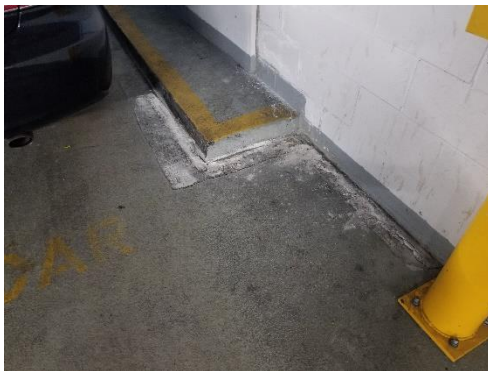
Photo C.- Efflorescence in concrete block firewall and concrete floor due to water ingress outside the emergency generator room

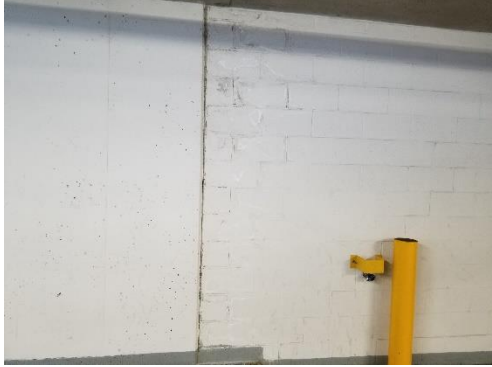
<p>Photo D.- Efflorescence due to water ingress on the control joint between a concrete wall and a concrete block wall</p>	
--	--	--

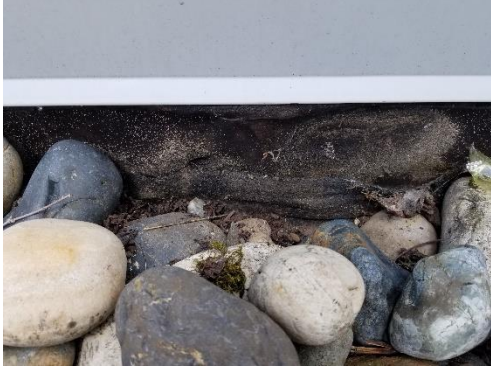
<p>4.4.3.2</p>

<p>This photo shows the lack of mineral protection or another mechanical layer to protect the membrane. It appears that the waterproof membrane was not protected with any mechanical protection and this deficiency may end it up getting the membrane pinched against the concrete elements and letting water infiltrate until the concrete slab or any cold joint.</p> <p>Since some water ingress is reported in many locations under this area. We do recommend conducting a membrane review to clarify the current state of the waterproof system.</p> <p>Location: 5th level in the south and southeast corner. Type: BE Importance: High Action required: Further Investigation and Upkeep as needed</p>
<p>4.4.3.3</p>

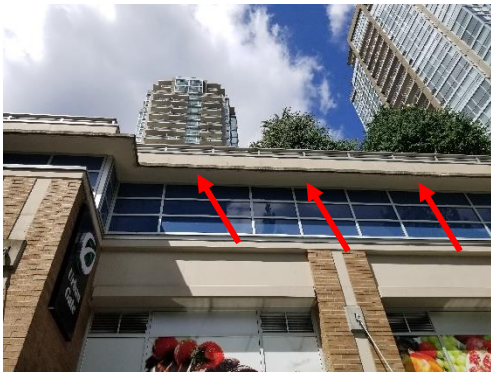
<p>These attached photos are showing examples of typical hairline cracks existing along the South perimeter wall of the building on level 5 (podium). This wall is facing Atlantic Ave.</p> <p>This kind of cracks are caused by shrinkage/thermal process of the concrete elements. These cracks are usually straight and even in width and commonly they do not represent a structural problem.</p> <p>However, since these cracks are exposed to direct rain may represent a building envelope concern because they may be a source of water ingress into the building or may contribute to deteriorating the paint coat of the walls facing outside the building.</p> <p>There is one particular crack that needs attention because it was observed to be approximately around 3 mm in width and has the potential to cause water ingress. Nevertheless, it is always recommended</p>

<p>to seal all these cracks with compatible sealant or even better by applying new paint coating after the sealant in order to stop, reduce or prevent water ingress.</p> <p>Location: 5th level in the south and southeast corner. Type: BE Importance: High Action required: Monitor & Upkeep as needed</p>
<p>4.4.3.4</p>

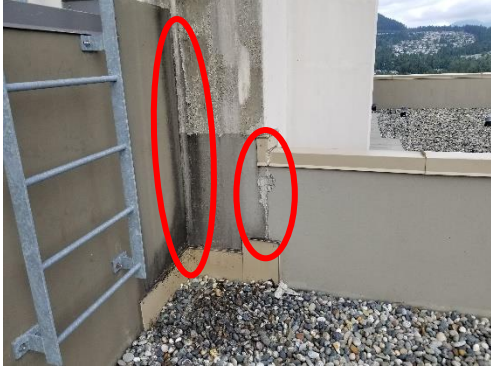
<p>This photo shows some exposed cold joints between two different concrete walls. Due to the width, position and the elements that are connected through these joints, we do not think they are a structural concern at this time. However, as mentioned before, these cold joints may represent a source of water ingress into the building.</p> <p>We recommend replacing the delaminated or missed caulking. We recommend installing vertical flashings to protect the area against direct sunlight and rain.</p> <p>Location: Southeast and southwest walls on the rooftop level.</p> <p>Type: NSD</p> <p>Importance: Medium</p> <p>Action required: Maintenance</p>
<p>4.4.3.7</p>

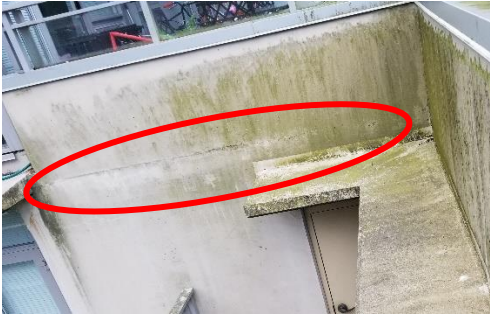
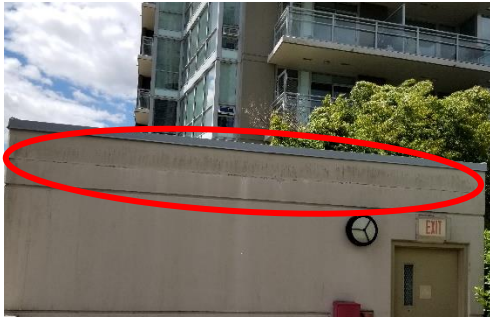
<p>These photos are showing potential signs of water ingress into the stairwells or parkade (from the services doors) and this particular unit (301). Further investigation (membrane review) and monitoring are suggested in order to prevent water ingress into the parkade or stairwells.</p> <p>Location: Beside unit 301 and several locations</p> <p>Type: NSD Importance: Low Action required: Further Investigation and Monitor</p>

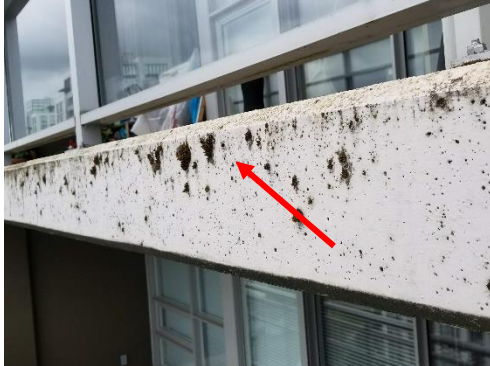
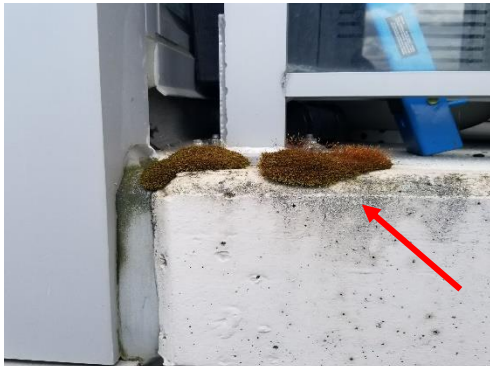
<p>4.4.3.10</p>

<p>These photos show possible lack of maintenance on the balconies. Moss growing and paint peeling are observed on the edges of the balcony decks.</p> <p>A recommended maintenance program should be conducted to remove all the organic matter from the building envelope. Some areas should be recoated to restore the waterproof system.</p> <p>Location: All the elevations being more critical the north elevation Type: BE Importance: Medium Action required: Maintenance</p>
<p>4.4.3.11</p>

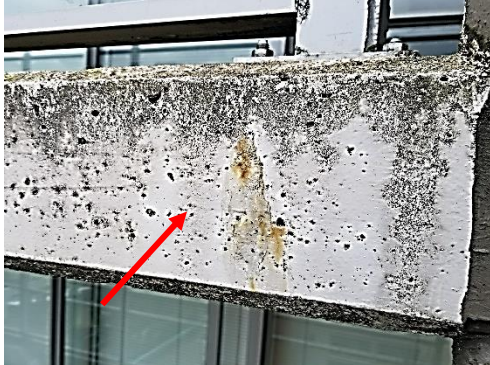
<p>This typical crack was observed in several locations. This type of crack is commonly observed on the edge of the balconies especially under the railings. This may be due to the closeness to the edge of the drilling needed to install the bolts for the railings.</p> <p>Although these hairline cracks do not usually represent a structural concern since shrinkage cracking at concrete is normal. Having them exposed to the weather without any waterproofing protection will lead to further deterioration.</p>

<p>Left unsealed and unrepaired, those cracks will develop deterioration and further damage.</p> <p>Location: All the elevations but being more critical the north elevation Type: SDE Importance: High Action required: Maintenance</p>
<p>4.4.3.12</p>

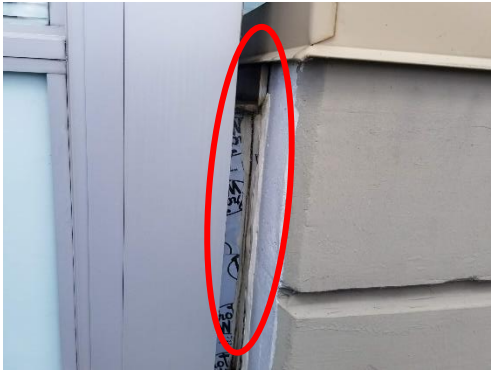
<p>This photo shows an example of missed flashing.</p> <p>Self-adhered membrane exposed to UV radiation. The self-adhered membrane must be protected against water and direct sunlight.</p> <p>Vertical flashing should be installed.</p> <p>Location: Multiple locations such as north elevation level 30, east elevation level 32 and 29 as the most notorious.</p> <p>Type: BE Importance: Low Action required: Maintenance</p>
<p>4.4.3.13</p>

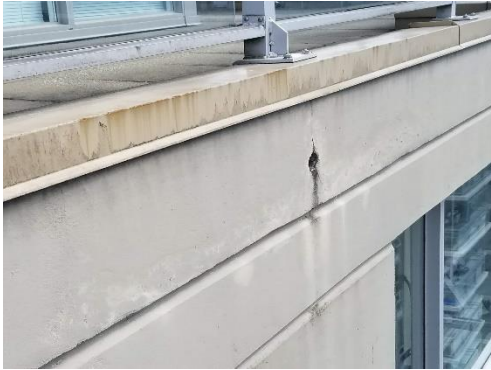
<p>Scupper or overflows drains were observed without proper extrude pipes. This leads to faster paint discoloration and may contribute to water ingress in some areas where raining water would not access normally.</p> <p>Location: Multiple locations such as level 19 on east elevation. Levels 6 and 7 on South Elevation.</p> <p>Type: BE Importance: Low Action required: Maintenance</p>

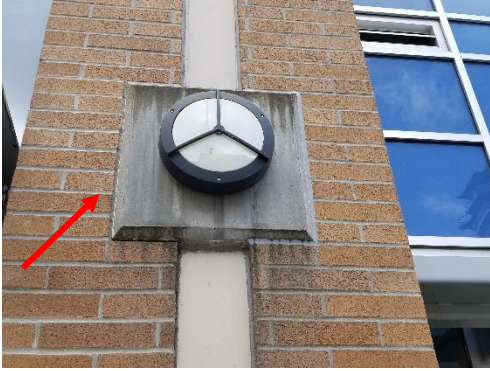
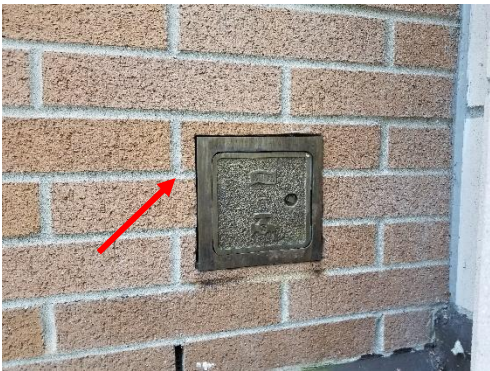
<p>Cracks in brick veneer and missed caulking may contribute to water ingress into the wall cavity. Even though in our opinion, these isolate deficiencies do not represent a structural concern for the cladding structure, they should be attended to and addressed in a maintenance program to prevent water ingress into the building.</p> <p>Location: Exterior cladding of the commercial units Type: BE Importance: High Action required: Maintenance</p>

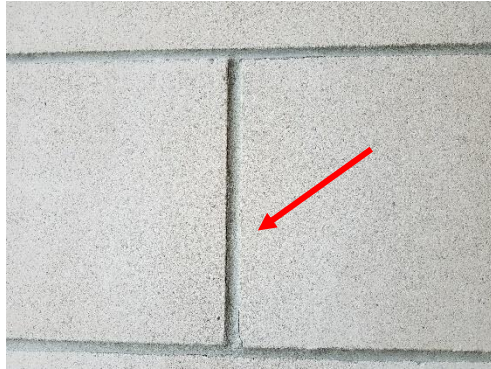
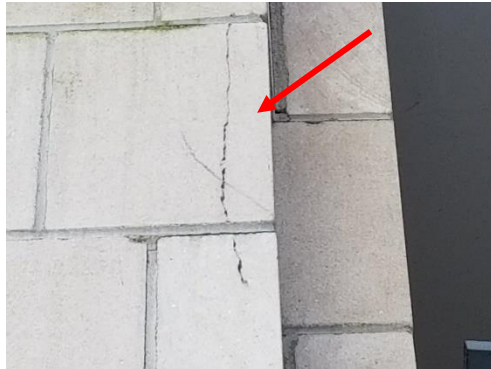
4.4.4.3

Cracks in stone veneer and missed caulking between the veneer and other elements may contribute to water ingress into the wall cavity. Even though in our opinion these isolate deficiencies do not represent a structural concern for the cladding structure, they should be attended and considered in a maintenance program to prevent water ingress into the building.

Location: Exterior cladding of the commercial units
 Type: BE
 Importance: High
 Action required: Maintenance

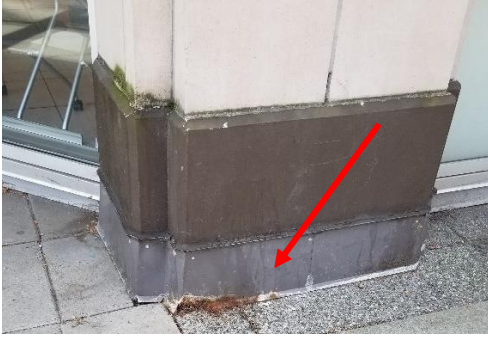
<p>Corroded flashing observed at the base of a concrete column. These flashings are part of the envelope building and it is always good practice to maintain all the elements in good shape. Recommended replacing as needed.</p> <p>Location: Unit located on the corner of Glen Drive and The High st. Type: BE Importance: Low Action required: Maintenance</p>

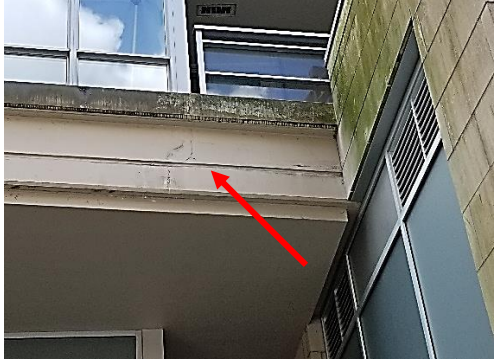
<p>Water ingress is reported in the unit. Further investigation is recommended to identify the source of the water ingress.</p> <p>The second photo shows the current state of the concrete ledge of the outside of the window. The horizontal surfaces or those ones with minimal slope must be always waterproofed to prevent water ingress into the building. This deficiency is widely explained in section 4.3 of this document.</p> <p>The third photo shows the location of widely open crack on the bottom of the window.</p> <p>Location: Unit 301 Type: BE Importance: High Action required: Further Investigation, Monitor and Upkeep as needed</p>

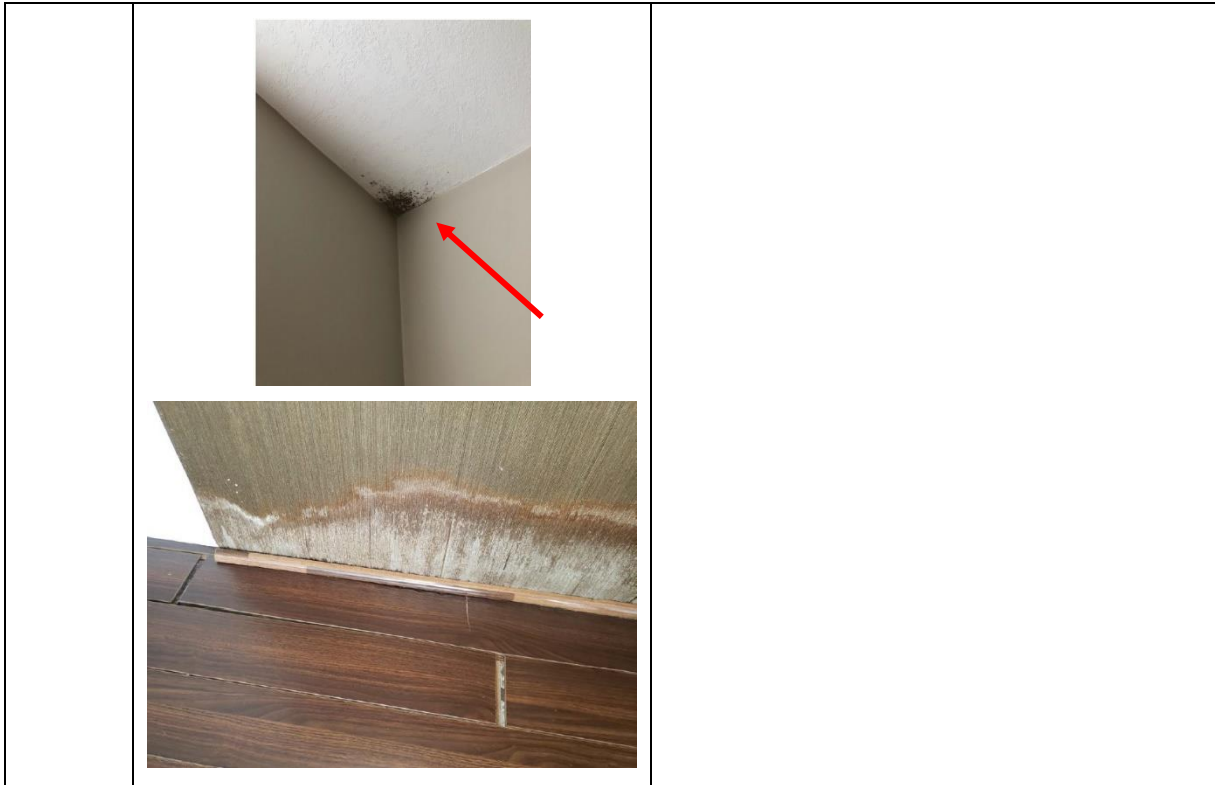
<p>4.4.5.14</p>	 	<p>The attached photo shows an example of small blisters and soft drywall areas on the ceiling reported by the occupant. We recommend monitoring and a possible further investigation in case the deficiency increases since it may be a result of water ingress in the washroom fan duct.</p> <p>Location: Unit 1201 Type: NSD Importance: Low Action required: Further Investigation and Monitor</p>
<p>4.4.5.15</p>	 	<p>Water ingress and condensation in windows and walls are reported by the occupant/owner of some units.</p> <p>Since this review was conducted in the summertime, it was not possible to encounter the suitable conditions for condensation in the unit 1201. However, some signs of this possible deficiency are observed on the surface of the baseboard and the window stool (first two photos).</p> <p>The third, fourth and fifth photos were taken by the occupant of the unit 2606 in the previous winter season. We observed possible mould/mildew spores growing on the ceiling and wall corner.</p> <p>We recommend further investigation, upkeep as needed and monitoring during winter time where the weather conditions are suitable to observe condensation inside the units.</p> <p>Location: Unit 1201, 2606 (reported) Type: BE Importance: High Action required: Further Investigation and Monitor</p>

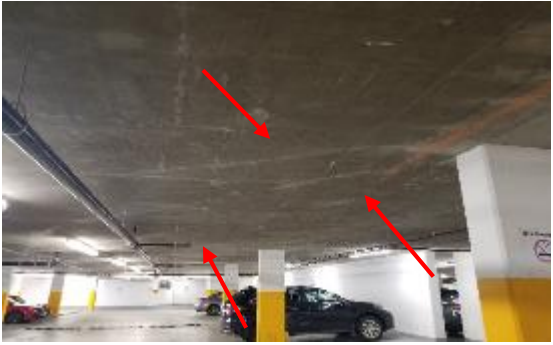
<p><u>OBSERVATION</u> Multiple cracks with efflorescence staining was observed on the ceiling of the suspended slab of the ground level of the parkade.</p> <p><u>LOCATIONS</u> Parkade Level 1; All around the parkade</p> <p><u>RECOMMENDATION</u> Remove efflorescence and monitor to show frequency and extent. Further investigation is recommended if the water ingress is still active.</p> <p><u>CATEGORY</u> Monitor.</p>

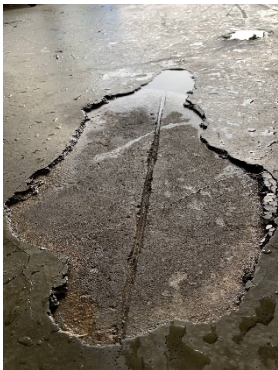
<p>Photo A.- Concrete delamination on the commercial parking</p>	<p><u>OBSERVATION</u> The following photos show a major deficiency in the commercial parking and its related ramp towards level 2 and the garbage loading bay.</p> <p>Photo A is showing a sample of some areas located on the commercial parking and the garbage loading bay. Concrete and membrane delaminations were documented prior to being repaired during 2019.</p> <p>As a part of the repair project undertaken in 2019 to repair this widespread deficiency at the commercial parking and numerous other locations of the parkade, some cracks/cold joints were discovered when the concrete delaminations started to show. This structural deficiency in the concrete slab entails other deficiencies related to water ingress. In the opinion of the writer, these water ingress into the parkade would not exist if the concrete delamination has never happened and hence the waterproof</p>

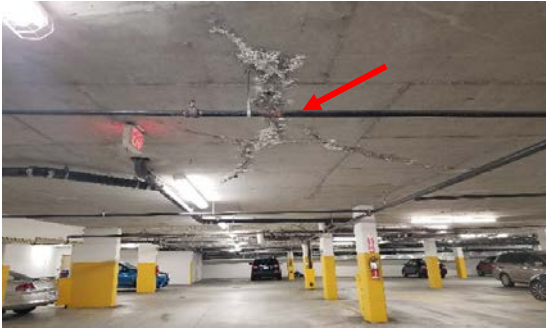
Photo B.- Notorious water ingress from the commercial parking level towards P1 level

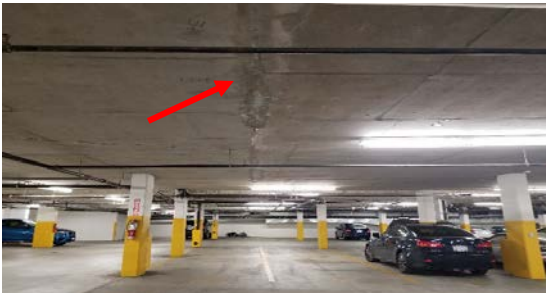
Photo C.- Notorious water ingress from the commercial parking level towards P1 level

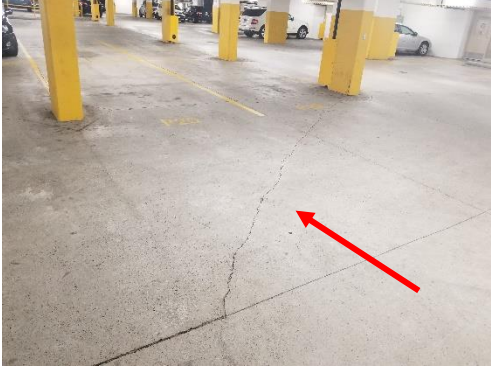
<p>4.4.1.5</p>

<p>Generally cracks on concrete slabs should be repaired at the minimum by acceptable crack sealing methodologies depending whether they are on the suspended parking slabs with a traffic bearing membrane or on the concrete slabs-on-grade of the parking garage. For slab-on-grade cracks, routing and proper caulking sealant is a maintenance repair option.</p> <p>The locations of the most excessive cracks at the time of the review are reported below.</p> <p>Locations: Concrete slab of P1. Stall # 65, from #4 to #30 and #40, from #14 to #19</p> <p>Type: NSD Importance: Medium Action required: Maintenance</p>
<p>4.4.1.6</p>

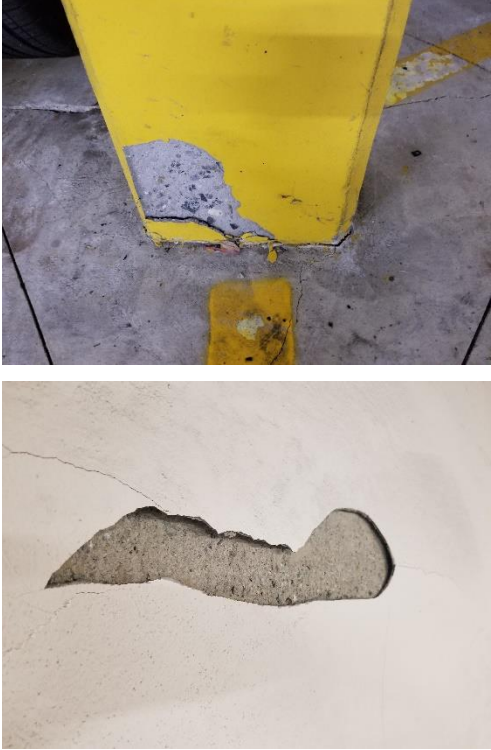
<p>4.4.1.7</p>

<p>These photos are intending to show failures by delamination in concrete elements. It appears that some concrete patches located on the column base and one of the walls of the parkade ramp towards P1 are popped-up.</p> <p>We recommend conducting further review and monitoring and/or upkeep as needed.</p> <p>Location: Column in P1 and southeast parkade ramp towards P1</p> <p>Type: SDE Importance: Medium Action required: Further Investigation and Upkeep as needed</p>
<p>4.4.1.8</p>

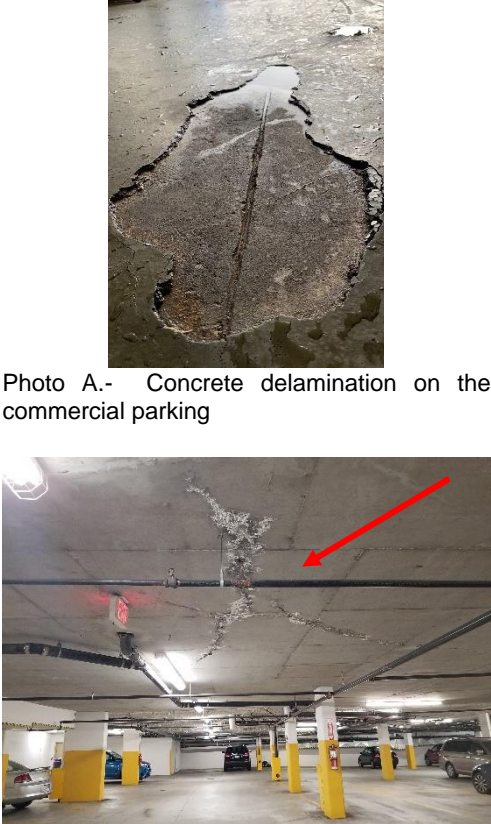
<p>Photo A.- Concrete delamination on the commercial parking</p> <p>Photo B.- Notorious water ingress from the commercial parking level towards P1 level</p>	<p>The following photos show a major deficiency in the commercial parking and its related ramp towards level 2 and the garbage loading bay.</p> <p>Photo A is showing a sample of some areas located on the commercial parking and the garbage loading bay. Concrete and membrane delaminations were documented prior to being repaired during 2019.</p> <p>As a part of the repair project undertaken in 2019 to repair this widespread deficiency at the commercial parking and numerous other locations of the parkade, some cracks/cold joints were discovered when the concrete delaminations started to show. This structural deficiency in the concrete slab entails other deficiencies related to water ingress. In the opinion of the writer, these water ingress into the parkade would not exist if the concrete delamination has never happened and hence the waterproof membrane have not been disintegrated/delaminated (Photos B and C).</p>

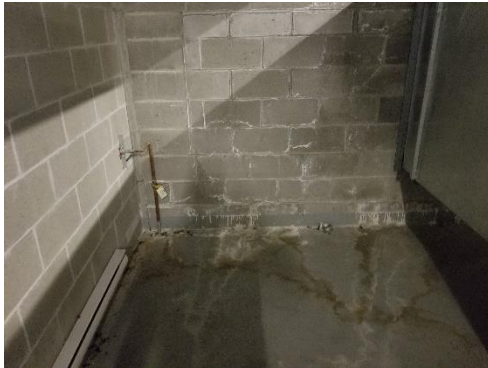
Photo B.- Efflorescence in concrete block firewall due to water ingress in the emergency generator room

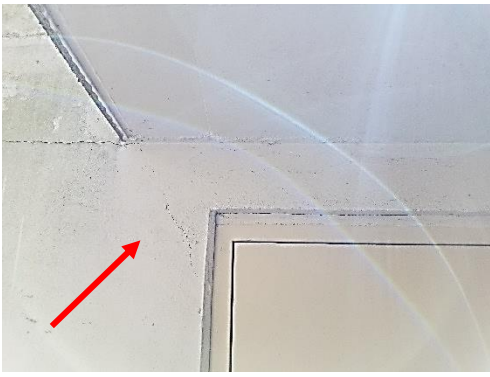
<p>4.4.2.2</p>	 	<p>Numerous cracks like this were observed in the stairs ramps of all of the levels. In our opinion, this deficiency does not represent a structural concern.</p> <p>Location: Stairwells Type: NSD Importance: Low Action required: Upkeep as needed</p>
<p>4.4.2.3</p>	 	<p>Numerous cracks in the concrete block fire walls were observed at several locations. Repair as needed in order to restore the fire stop system.</p> <p>Location: - Stair 2, level 2 - Stair 3, level 2 Type: NSD Importance: Medium Action required: Maintenance</p>
<p>4.4.2.4</p>	 	<p>Hairline cracks observed on the concrete header of some levels. They are not seen as structural problems. At this point, we don't see any action required unless water ingress is observed on the cracks located on the outside.</p> <p>Location: - Stair 2, level 1, 2, and 3 - Rooftop entrance - Service area (2nd level) on the north side</p>

<p>Type: NSD Importance: Low Action required: Upkeep as needed</p>
<p>4.4.2.5</p>

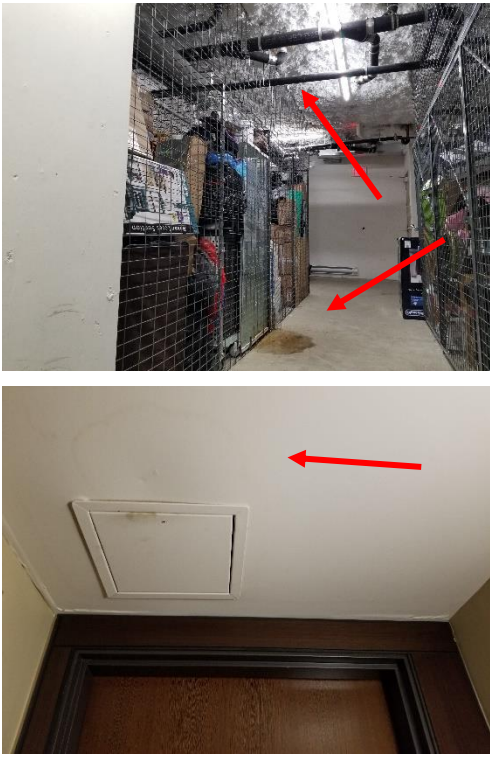
<p>Water ingress observed on the ceiling.</p> <ul style="list-style-type: none"> - It appears that the water ingress in the storage room is coming from the drainage system, however, further investigation is recommended in order to certainly know the source of the water ingress. - Unknown source of water ingress in the ceiling of the corridors. Further investigation is recommended. <p>Location:</p> <ul style="list-style-type: none"> - Corridor ceiling in front of the units 2307, 1501, 1506 - Media Center ceiling - Storage parking 1 at #91 and #53 <p>Type: ML Importance: Medium Action required: Further Investigation and Maintenance</p>
<p>4.4.2.6</p>

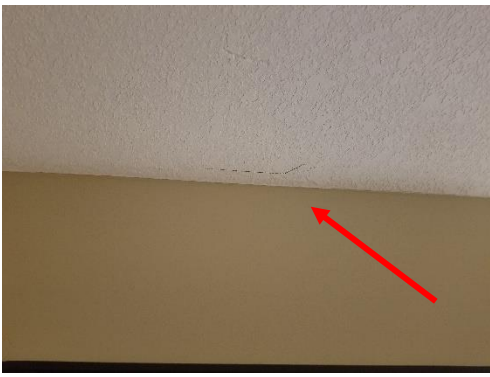
<p>Detached drywall tape was observed.</p> <p>Location: Level 31, Level 30 (all units), level 29 (unit 204, 2902, 2901, 2907), level 28 (unit 2804, 2801, 2802), level 27 (unit 2704, 2702, 2706), level 26 (unit 2604, 2605, 2603, 2601), level 22 (all units), level 19 (unit 1905), level 18 (unit 1805), level 8 (unit 805).</p> <p>Type: ML Importance: Low Action required: Upkeep as needed</p>

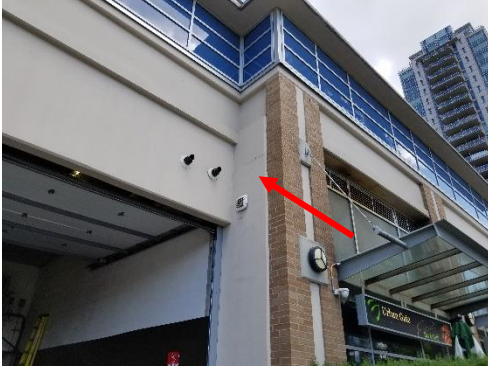
<p>4.4.4.7</p>

<p>This photo is showing the location of a cold joint where water has drained-out the paint and the concrete patch. Signs of water ingress are observed.</p> <p>Location: Garbage room on Atlantic Ave. Type: BE Importance: Low Action required: Maintenance</p>
<p>4.4.4.8</p>

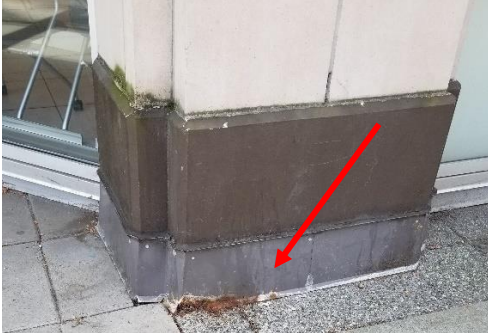
<p>Corroded flashing observed at the base of a concrete column. These flashings are part of the envelope building and it is always good practice to maintain all the elements in good shape. Recommended replacing as needed.</p> <p>Location: Unit located on the corner of Glen Drive and The High st. Type: BE Importance: Low Action required: Maintenance</p>

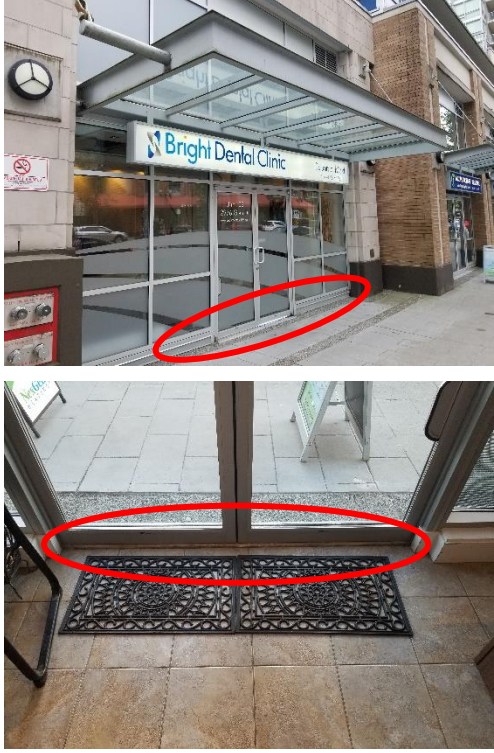
<p>4.4.5.4</p>

<p>All commercial units reported periodic and re-occurring water ingress at the ground floor, from exterior sources. This deficiency should be further investigated and attended since water ingress into the units and especially at entrance doors may become a risk for their occupants and belongings.</p> <p>We presume that attending the precede deficiency (gutters maintenance program) may aid to minimize this situation, but in the case this does not happen, further investigation should be conducted.</p> <p>Location: Commercial units Type: BE Importance: High Action required: Further Investigation, Monitor and Upkeep as needed</p>
<p>4.4.5.5</p>

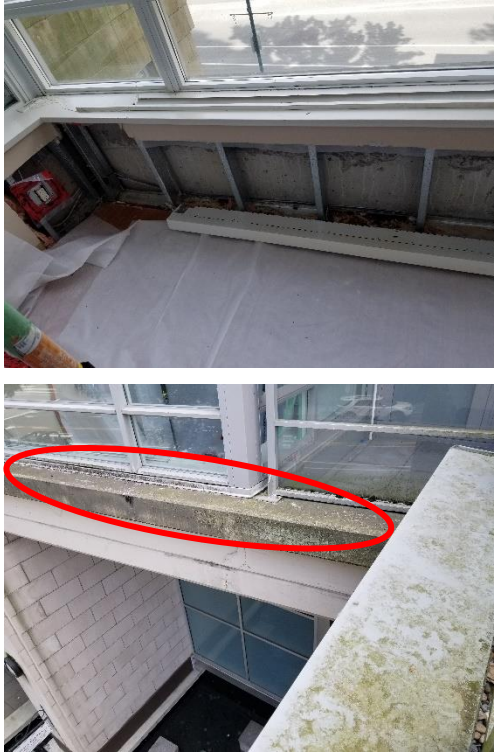
<p>Water ingress is reported in the unit. Further investigation is recommended to identify the source of the water ingress.</p> <p>The second photo shows the current state of the concrete ledge of the outside of the window. The horizontal surfaces or those ones with minimal slope must be always waterproofed to prevent water ingress into the building. This deficiency is widely explained in section 4.3 of this document.</p> <p>The third photo shows the location of widely open crack on the bottom of the window.</p> <p>Location: Unit 301 Type: BE Importance: High Action required: Further Investigation, Monitor and Upkeep as needed</p>

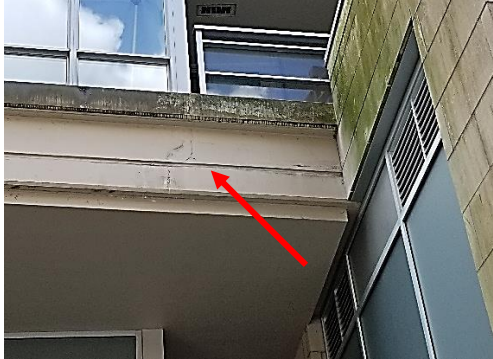
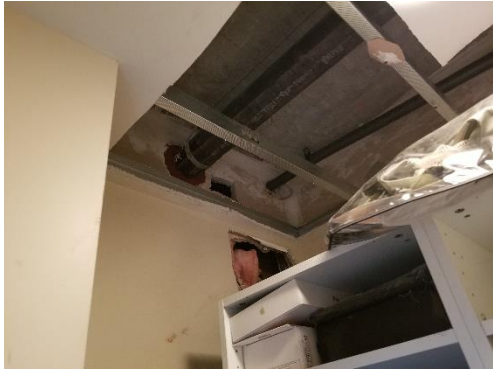
<p>4.4.5.6</p>

<p>Water ingress was reported into the unit. Based on the occupants' comments, water is constantly dripping/leaking from the cast-iron pipe. The occupants reported that this problem has happened several times in different locations of the unit. Further investigation is recommended in order to detect the source of the problem and if the system meets the British Columbia Building Code.</p> <p>Location: Unit 3203 Type: ML Importance: High Action required: Further Investigation, Monitor and Upkeep as needed</p>
<p>4.4.5.7</p>

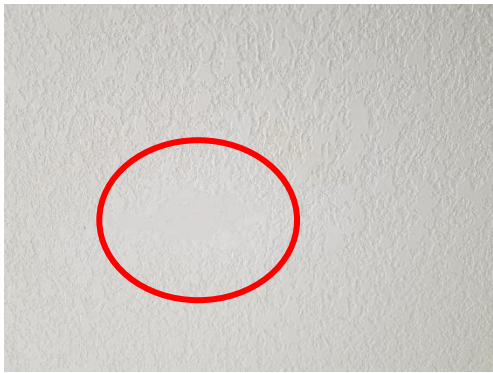
<p>Water ingress through the ceiling of the master bedroom was reported. It appears that water is dripping over the middle of the bed when the dryer machine is on. A leak investigation is recommended to detect the source of the problem which is suspected to be from the dryer vent.</p> <p>Location: Unit 2802 Type: ML Importance: High Action required: Further Investigation, Monitor and Upkeep as needed</p>

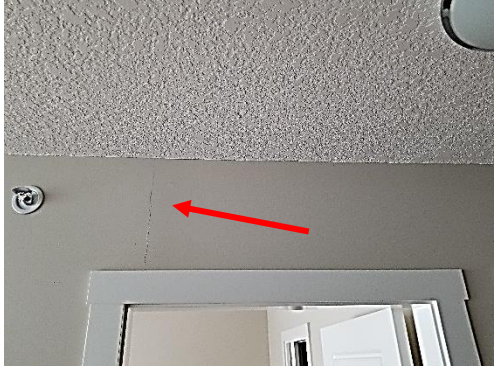
<p>4.4.5.11</p>

<p>Vertical hairline cracks in drywall were observed. These isolated cracks usually may not represent a structural problem unless in addition to other deficiencies show evidence of further damage.</p> <p>Location: Interior of the units Type: NSD Importance: Low Action required: Upkeep as needed</p>
<p>4.4.5.12</p>

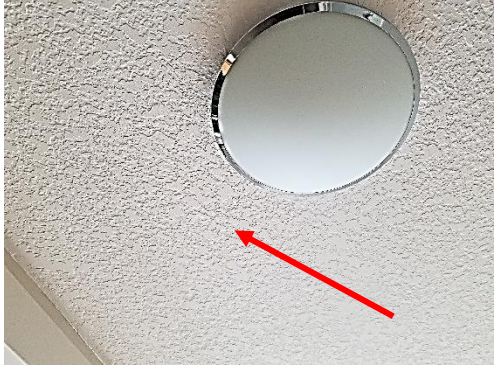
<p>The attached photo shows an example of the crack reported by the occupant. However, these hairline cracks are very common in concrete elements and usually are the result of shrinkage. Commonly, these hairline cracks do not represent a structural problem and no attention is required unless other deficiencies like water leaking are observed.</p> <p>Location: Interior of the units Type: NSD Importance: Low Action required: Upkeep as needed</p>
<p>4.4.5.13</p>

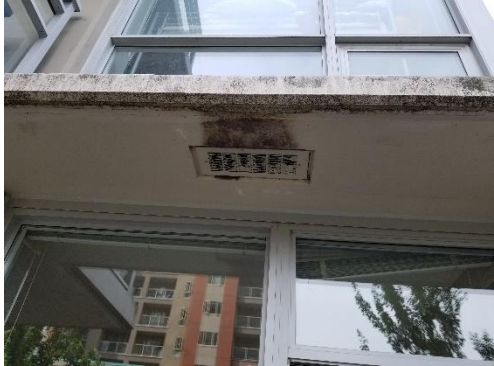
<p>Organic material like mould, mildew and moss is observed in several dryer vents, balcony edges, scuppers, etc. Even though these problems are not structural damage or concern, they should be attended and removed from the building envelope.</p> <p>This organic material commonly grows in almost any kind of surfaces when they experience long wet periods and shady conditions that do not allow the surfaces to dry out easily.</p> <p>We suggest including this deficiency as a part of the maintenance program.</p> <p>Location: All around the building envelope especially the north elevation Type: BE Importance: Medium to High Action required: Maintenance</p>
