**Re: The Metropolitan – 5885 Olive Avenue, Burnaby
Garage Evaluation**

Sense's Project No. 18R085L

We are pleased to provide the following report summarizing the findings of our Garage Evaluation at The Metropolitan.

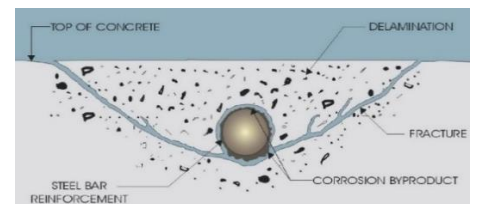
Photo 9: Diagram of concrete delamination at corroded reinforcement.

Concrete damage on the underside of the garage suspended slab of P1 and P2 is widespread with evidence of leakage. Also supported by the chloride testing results, chloride has penetrated past the reinforcement depth. Most of the concrete damage and leakage is concentrated along cracks that extend the width of the drive aisle and into the parking stalls. Based on our sounding survey, approximately 1% of the total suspended slab area has delaminated concrete.

At several locations, the concrete damage has caused concrete to spall from the underside of the slab, exposing the reinforcing steel. There are several locations where the concrete has delaminated, appears loose, and could eventually fall. There is also concrete delamination on the topside of the slab.

Installation of waterproofing on the topside of the suspended slab is recommended to mitigate ongoing leakage and concrete deterioration. Concrete repairs should be completed where the concrete is damaged and/or deteriorated, prior to installing the waterproofing. Concrete repairs include removing and repairing delaminated concrete, cleaning the steel of corrosion, and installing new concrete. We recommend these repairs be completed within the next 5 years.

Further, as the suspended slabs have been un-protected for a long period of time, there could be a high risk of corrosion continuing even after repairs are completed. Installing a waterproofing coating could act to trap moisture and chlorides in the slab and accelerate corrosion if corrosion potentials are high. As such, we recommend completing half-cell testing to check the active corrosion potential in the slabs before completing any repairs. Half-cell testing is an electrochemical technique commonly used to assess the severity of corrosion in reinforced concrete structures. Should we find active corrosion potentials are high, we would recommend steps to dry out the slab to reduce corrosion potentials before installing a waterproofing coating.

Should the Strata choose to phase and/or defer concrete repairs, the Strata should engage a contractor to locate and remove loose concrete from the underside of slabs, as there is a considerable amount, to reduce the risk of concrete falling on pedestrians and/or vehicles, until a repair project can be completed.
