Re: The Metropolitan, 5885 Olive Avenue, Burnaby
Building Enclosure Evaluation

Sense's Project No. 18R085A

BUILDING ENCLOSURE EVALUATION FOR
THE METROPOLITAN
5885 OLIVE AVENUE, BURNABY

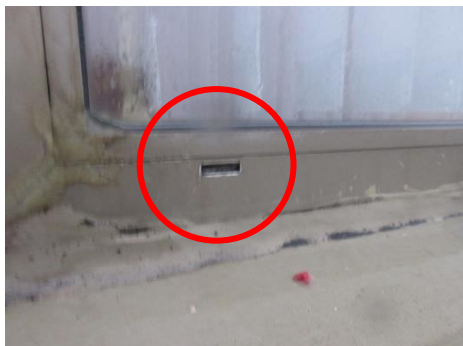
The presence of window drain holes is generally inconsistent throughout the window assemblies reviewed. Drain holes were generally present on the exterior of the window frames at the sills but varied at higher sections of the window assemblies. Drain holes at the interior side of the windows was also inconsistent throughout the building. At some locations there were drain holes through the framing of the condensation track, and at other locations there was no visible interior drain hole. At some locations where there were interior drain holes, some Owners have sealed over or blocked them, as they reported that the drain holes were actually allowing large amounts of water to make its way to interior side of the windows, rather than draining the water out.

Photo 16: Typical exterior window drain hole at window sill.

In order to better understand how the windows, manage water and the effectiveness of the drain holes, we recommend completing window testing as discussed in 3.1.2.1 above, including removing some of the exterior window components to better review the intended drainage paths through the window assemblies.

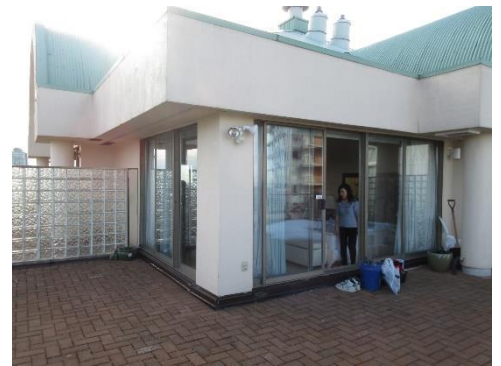
- There is an active leak into PH-03's upper level bathroom which comes from the open joints at the arched window frames.
- There was an active leak into PH-01 master bedroom which was caused by poor waterproofing tie-in details at the sliding door sill.

Photo 27: PH-1 master bedroom sliding door

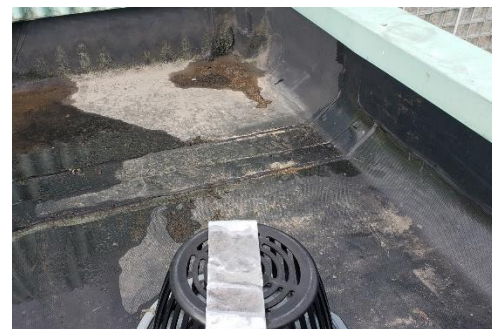
The membrane around the drain was repaired as part of the PH-1 leak repair work completed in Summer 2019, to address the leakage.

Photo 29: Gutter drain above PH-1 sliding door head

We recommend regularly checking all gutter drains, and the condition of the membrane around the gutter drains in order to identify any potential issues which may result in leakage. This review should be completed as part of any regular exterior maintenance work completed around the building.

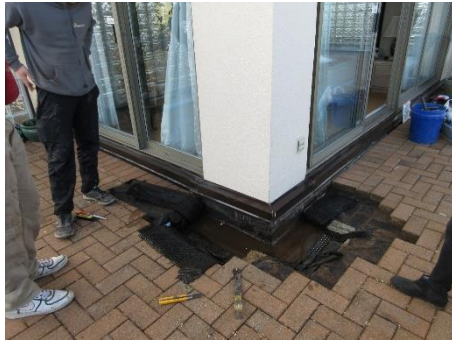
Photo 32: PH-1 upper roof deck opening.

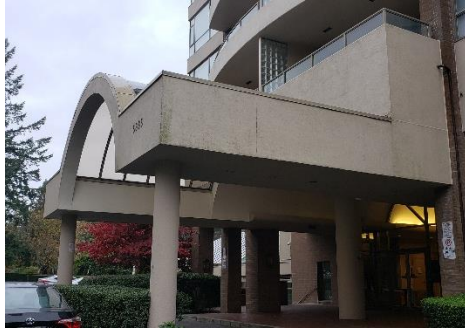
Further, one of the curved acrylic sheets is also cracked, and has a hole in it, which is generally unsightly given its location over the building's entrance. The Strata should consider replacing the damaged sheet to restore the aesthetics of the building's entrance way.

Photo 37: Canopy over the front entrance

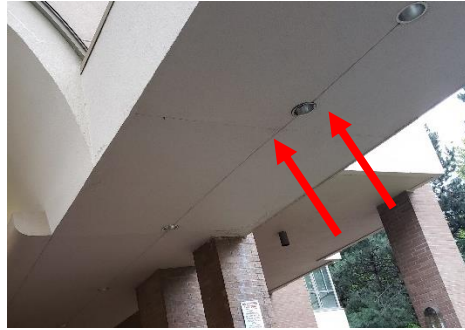
- Canopy roofs appear to be actively leaking, causing stucco on the soffits to blister.

Photo 38: Canopy roof soffit

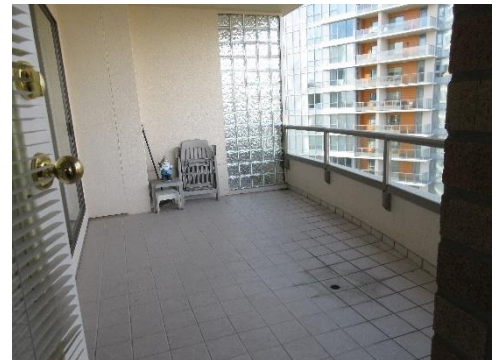
The balcony membrane is generally failed at balconies where the membrane is exposed. Failure of the membrane leaves the concrete balcony structure exposed to leakage and damage from water. As the building structure is post-tension, it is important to maintain protection over the concrete to minimize the risk of future leakage, and damage to the post-tensioning cables embedded in the slabs. However, there was little water leaking through balcony slab and minimal amounts of visible concrete damage observed at balconies reviewed. Based on review of the balcony soffits, the concrete does not appear to contain many cracks. Minimal cracking of the structure helps reduce leaks as water can not readily travel through the concrete structure if cracks are not present.

Photo 39: Typical balcony with tile finish.

As it appears the slabs have been exposed for some time, due to failure of the membrane at many balcony locations, the Strata should have the post-tensioning reviewed to better understand the current condition of the building structure. Should the Strata have already had this work completed, a copy of the report should be forwarded to *Sense Engineering* to determine if further review of the post-tensioning system is required.

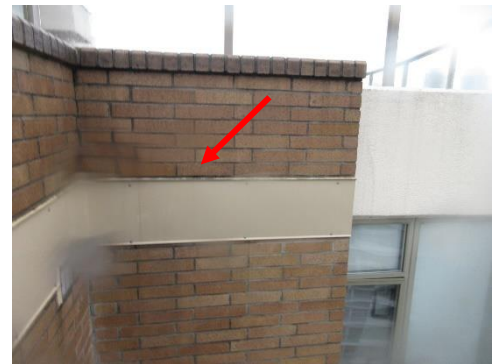
There are sheet metal wall flashings over brick veneer cladding at every floor. After our initial review of the masonry, it was not clear whether the flashing was installed to cover issues such as cracks in the masonry or to address leakage.

Photo 49: Wall flashing over brick veneer cladding.

Typically, brick veneer cladding is supported by a metal angle at every floor, and there is a gap below the metal angle to allow for building movement. The gap is typically sealed and does not get covered with flashing. As there were concerns that the wall flashing may be concealing brick and mortar cracking related to compression issues in the masonry, we removed two flashing panels to check the concealed condition of the masonry.
