3010.10**Shawnoaks Targeted Condition Assessment****January 23, 2008****REGARDING Recreation Building Condition Assessment**

RDH Building Engineering Ltd. (RDH) was retained by Rancho Property Management to assess the condition of the building enclosure at the Shawnoaks Recreation Building and provide a brief letter report discussing our findings. This letter report has been written for an audience familiar with the Shawnoaks Recreation Building and the ongoing building enclosure concerns.

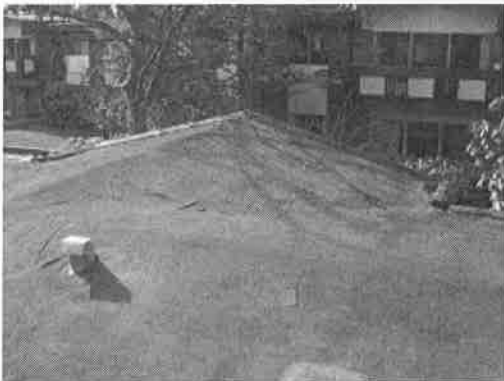
Fig. 1.4.1. Typical Roof Assembly on pyramid roof

The roof over the common area is a vaulted pyramid with approximately 4' of overhang providing good protection for the wall assemblies. The roof consists of 6" x 12" beams resting on structural steel columns and connected at the apex with a structural steel bracket. These beams are in filled with 2" x 8" purlins and covered with structural wood planking. The original built-up roof (BUR) membrane has been overlaid with glass ply roofing felt, likely during previous repair work (Error! Reference source not found.).
