# RDH Building Engineering Limited

**JOB NAME:** Pacific Point

No. of Copies	Item	Description
1	Building Envelope Condition Assessment Pacific Point – VR 2540	Additional colour copy of CA as requested.

**APPENDIX D – EXTERIOR OBSERVATIONS**

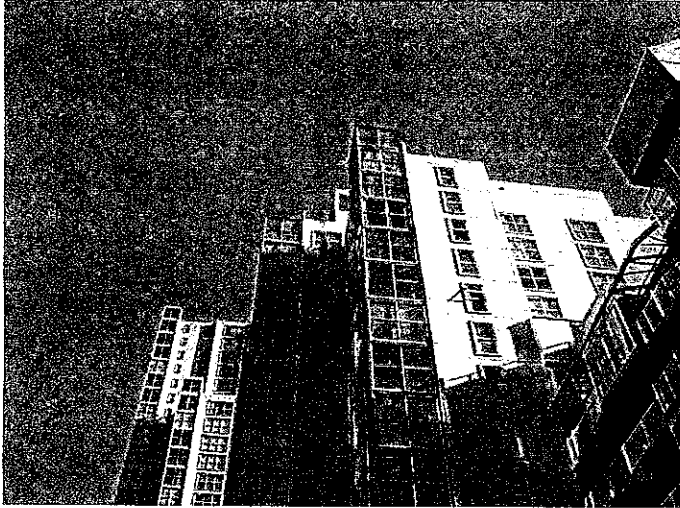
### Drop 1 – North Tower - South Elevation - (Photo A00-01 & A00-02)

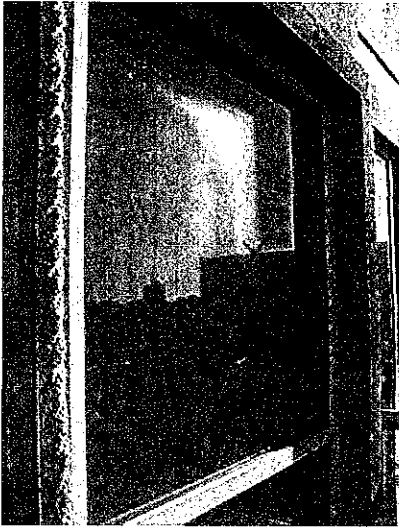
- Several of the sealed units on the windows observed from drop #1 have visible moisture between the glass panes. (Photos A01-01 to A01-03)
- Metal panels are present at the jamb of the window-wall assembly and over the slab locations adjacent to drop #1 (west side of drop #1). It appears that the vertical and horizontal segments of the metal panels are butted together with no mechanical connection between the panels. Sealant is present over the metal panel segment joints in a "bandage joint" sealant configuration. The sealant at these locations does not appear to be the same type of sealant as at most other locations. It appears that this sealant has been installed more recently. At some locations reviewed, adhesive and/or cohesive sealant failures were observed. It was confirmed, at a few locations, where cohesive failures are present that there is no bondbreaker beneath the bandage joints. (Photos A02-01 to A02-03)

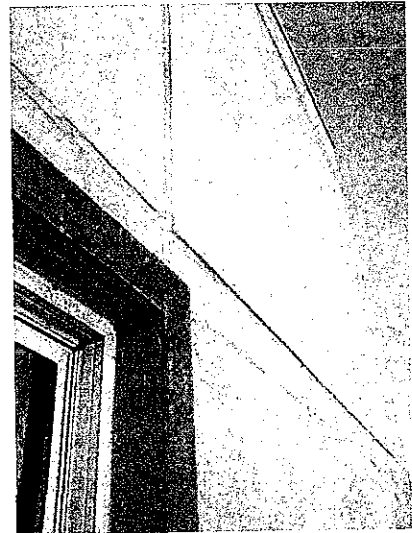
C05.01

- The joint sealant between the EIFS panels appears to be in better condition (less failures) than the sealant between the windows and the EIFS cladding. (Photos C05-01 & C05-02)
