Park Place Estates
Strata Plan NW 2969
13725 – 72A Avenue,
Surrey, BC

Levelton Consultants Ltd.

The Owners, Strata Plan NW 2969, retained Levelton Consultants Ltd. (LCL) to prepare a Depreciation Report (DRP) for Park Place Estates, located at 13725 72A Avenue, Surrey, BC.

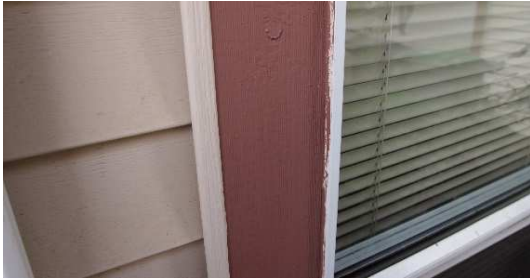
Wood Trims

- Wood trims are in generally good condition. A maintenance program to replace decayed trims was performed in 2013. A maintenance program to replace decayed trims could be implemented every 8 years.

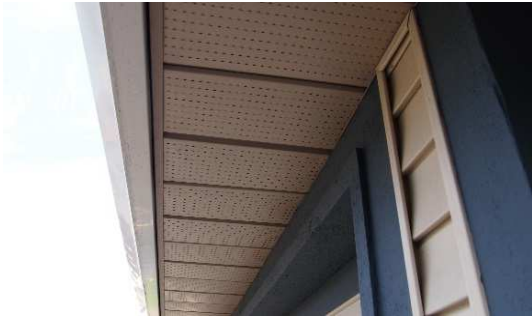
Soffit

- The soffit is in generally good condition.

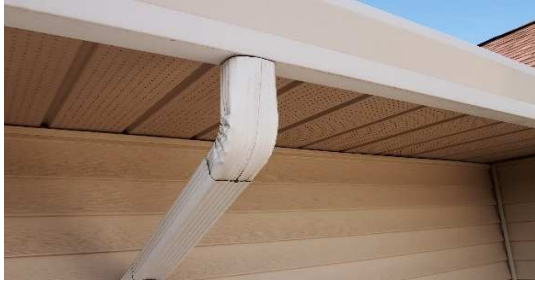
Gutters and Leaders

- Strata member reported that leaks were observed at some locations. Maintenance has been performed on an as needed basis and drop outlets were replaced in 2012. If leakage becomes systemic, a full replacement should be considered.

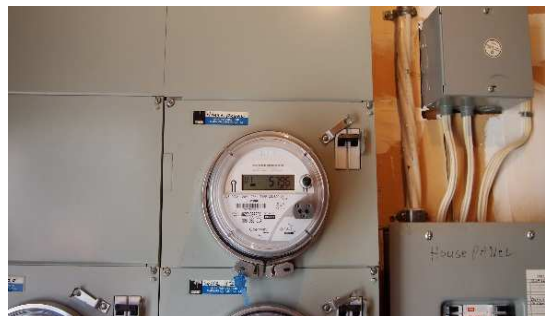
Electrical Distribution

The electrical equipment, based on our visual review, was clean, dry and free of physical damage.

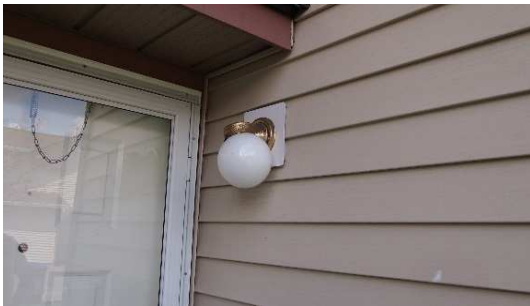
Exterior Lighting

The lighting components visible for our review were properly installed, free of signs of physical damage and appeared to be fully functional.

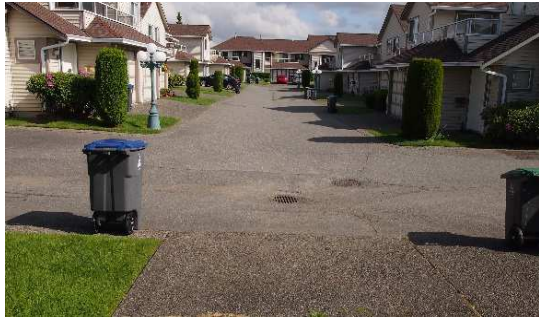
- Road is in good condition.

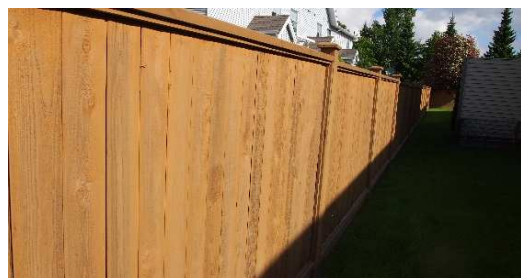
Perimeter Fences

- Perimeter fences are in generally good condition. Service life can be reviewed during 3-year update.

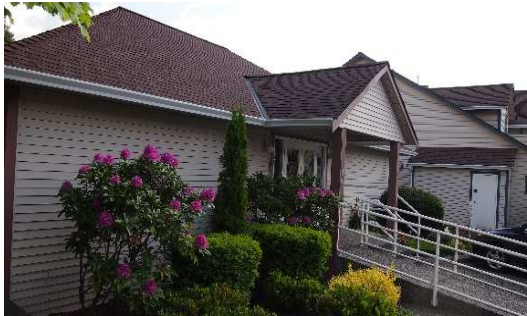
Club House

- Carpets and interior paint are in generally good condition. The replacement costs are to update the interior finishes/components. The interior painting was completed in 2013.

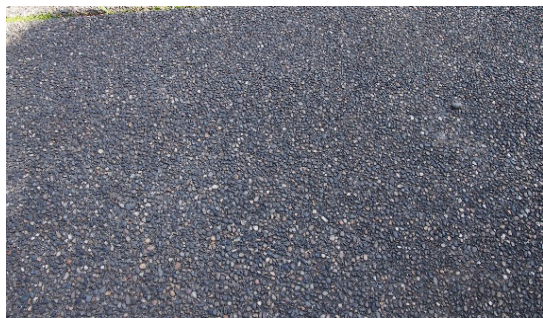
Concrete Driveways and Patios

- Concrete driveways and patios are in generally good condition.
- Replace when damaged.

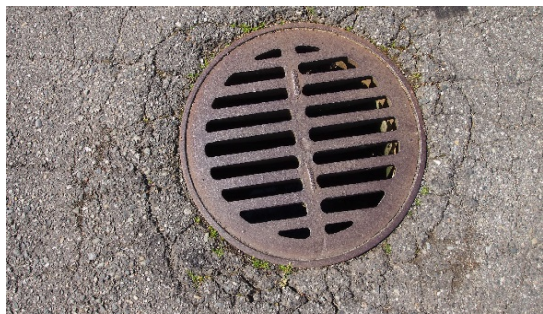
Underground Systems

- No reports or issues have been reported with regards to the underground systems.
