FACILITY CONDITION REPORT

Strata Complex LMS 1978
2711 to 2733 East Kent
Vancouver, BC
V6G 2K5

File No.: P06-106

July 31st, 2006

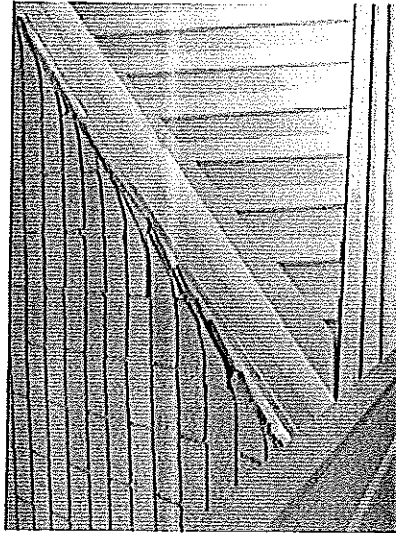
090

- Repair of perimeter membrane at scupper location. (P. 087,088)
- Shingles with minor curling at eaves. (P. 089,090)
