Depreciation Report Update

Langara Court
333 Wethersfield Drive, Vancouver, B.C.

Prepared for The Owners, Strata Plan VR 519

By Touwslager Engineering Ltd.

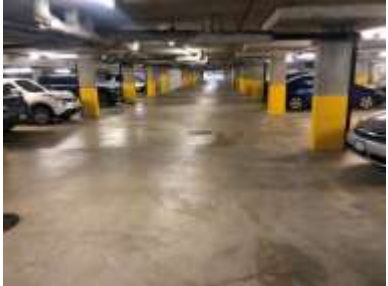
ASSET	PHOTOGRAPHS
<p>1.0 STRUCTURE Including parking garage and wood frame residential structure.</p>	
<p>Parking Garage Structure Reinforced Concrete Current Age: 41 years Assumed Lifespan: 75+ years with repairs every 10 years Repair Date: 2020, 2030, 2040 Allowance for concrete repairs: \$5,800</p>

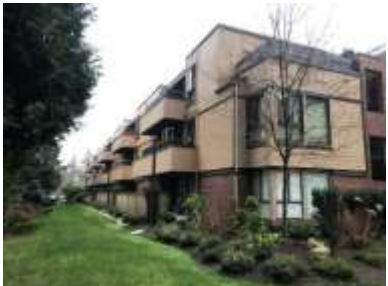
<p>Residential Structure Wood Frame Current Age: 41 years Assumed Lifespan: 50+ years with repairs every ten years Repair Dates: 2021, 2031, 2041 Allowance: \$11,600 for unforeseen decay, etc.</p>

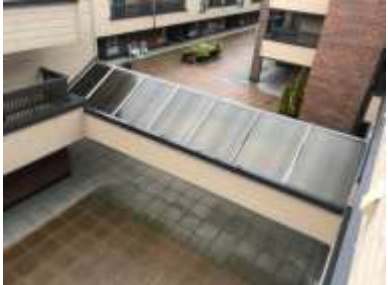
<p>Courtyard Canopy Steel, wood frame, and glass canopy Current Age: 41 years Assumed Lifespan: 40 years Replacement Date: 2021 Replacement Cost: \$87,000</p>

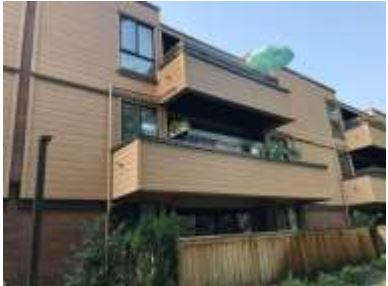
<p>2.0 BUILDING ENVELOPE Including balconies, decks, roofs, windows, wall cladding, and waterproofing of the parking garage.</p>	
<p>Recently Repaired Balconies (10) Location: Units 312 and 412, Units 313 to 416 Current Age: 3 years, 1 year Assumed Lifespan: 15 years for membrane, 30 years for rebuild Replacement Date: 2031 for membrane and 2046 for rebuild Replacement Budget: \$100,000 in 2031 and \$350,000 in 2046</p>

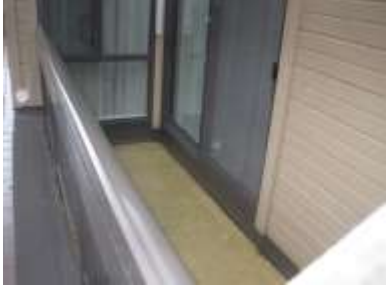
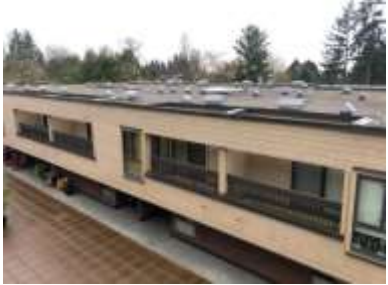
<p>Other Repaired Balconies (17) Location: North side of south building, facing the courtyard (16) and Unit 205 (1) Current Age: Approximately 7 years on average Assumed Lifespan: 15 years for membrane, 30 years for rebuild Replacement Date: 2025 for membrane and 2040 for rebuild Replacement Budget: \$170,000 in 2025 and \$510,000 in 2040</p>

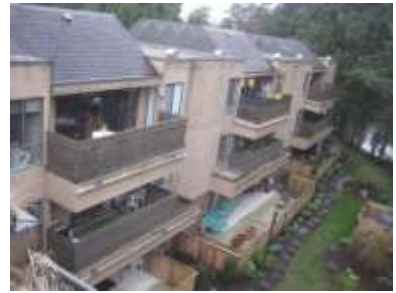
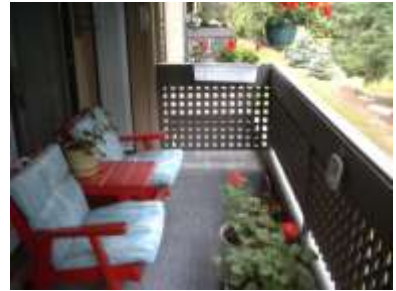
Older Balconies (13)

Location: South side of south building (except Unit 205) (7) and north side of north building (Units 309 to 411) (6)
Current Age: varies
Assumed Lifespan: 15 years for membrane, 30 years for assembly
Replacement Date: Rebuild half in 2020 and half in 2022
Replacement Date: New membrane in 2036
Replacement Budget: \$540,000 in 2020, \$630,000 in 2022, plus \$130,000 in 2036

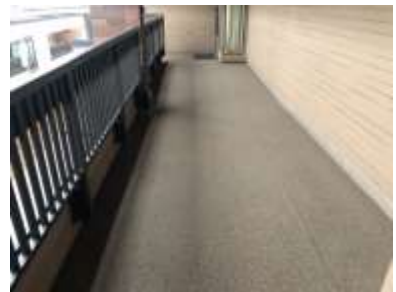
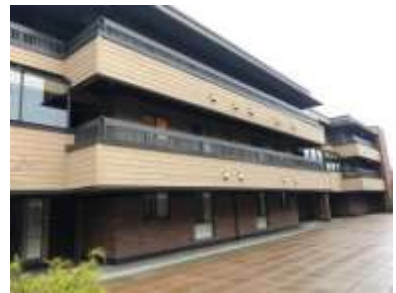
Walkways

Current Age: 7 years
Assumed Lifespan: 15 years for membrane, 30 years for rebuild
Replacement Date: 2025 and 2040 (to match balcony timing)
Replacement Budget: \$215,000 and \$400,000 respectively

Targeted Repair on Fourth Floor
Replacement Date: 2019
Replacement Cost: \$25,000

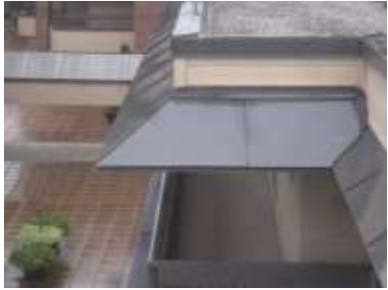
<p>Walkway Roof Edge Canopy Wood frame and sheet metal cladding Current Age: 6 years Assumed Lifespan: 50 years Replacement Date: 2061 Replacement Budget: not applicable</p> <p>Painting Lifespan: 25 years Repainting Date: 2036 Repainting Allowance: \$7000</p>

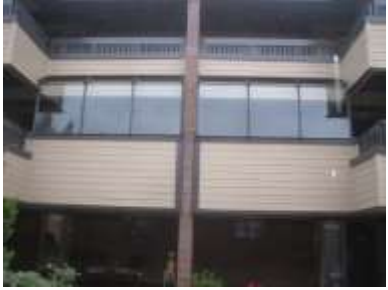
<p>Walkway Glazing System Metal frame and glass Current Age: 6 years Assumed Lifespan: 50 years Replacement Date: 2061 Replacement Budget: not applicable</p> <p>Painting Lifespan: 25 years Repainting Date: 2036 Repainting Allowance: \$9000</p>

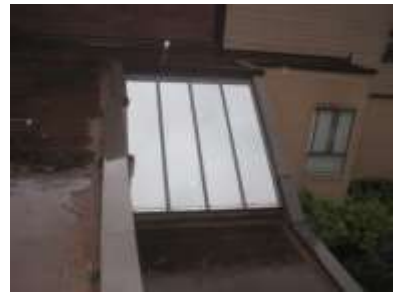
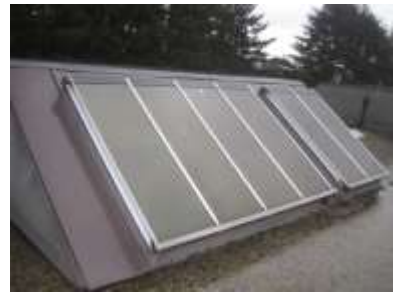
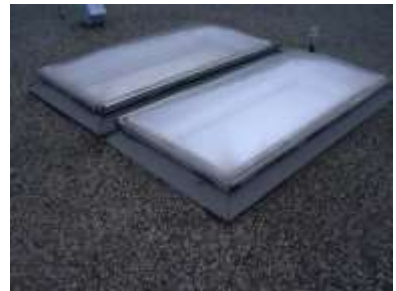
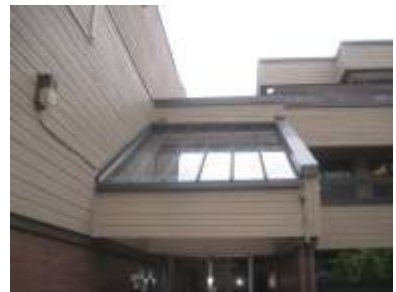
Skylights

Flat roof and sloped roof type, glass and/or plastic
Current Age: varies
Assumed Lifespan: 20 years
Replacement Date: varies
Frame and Details Repairs Allowance: \$23,000 in 2025
Frame and Details Repairs Allowance: \$23,000 in 2040

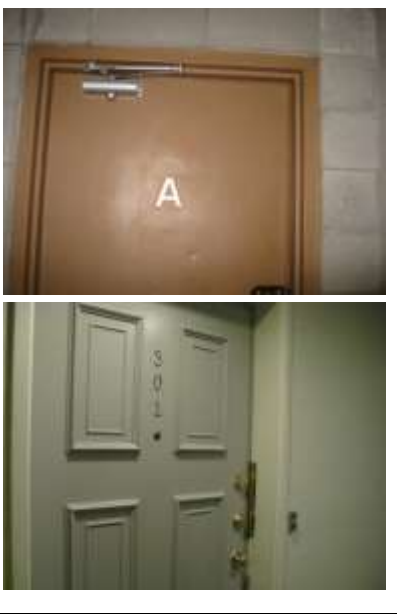
<p>Miscellaneous Hinged Doors Various types Current Age: 41 years but varies Assumed Lifespan: 50+ years Replacement Date: varies Replacement Allowance: \$5800 every five years starting in 2021</p>

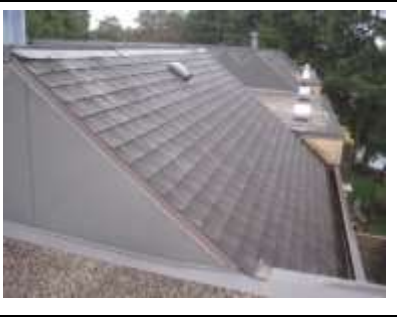
<p>Sloped Shingle Roofing Current Age: 13 years assumed Assumed Lifespan: 20 years Replacement Date: 2023 and 2043 Replacement Budget: \$23,000</p>

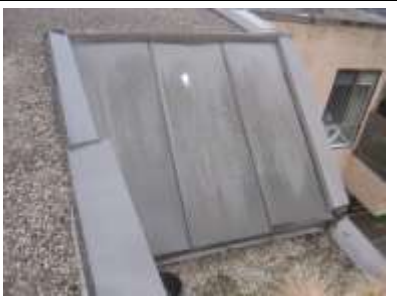
<p>Sloped Metal Roofing Current Age: 41 years estimated Assumed Lifespan: 50 years Replacement Date: 2026 Replacement Budget: \$28,000</p>

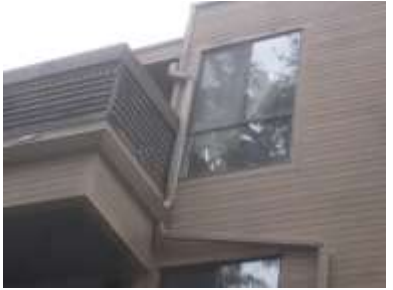
<p>Downspouts and Gutters Prepainted 5" Aluminum Current Age: varies but most are approximately 6 years Assumed Lifespan: 25 years Replacement Date: 2038 Replacement Budget: included with balcony, deck, and walkway repairs</p>

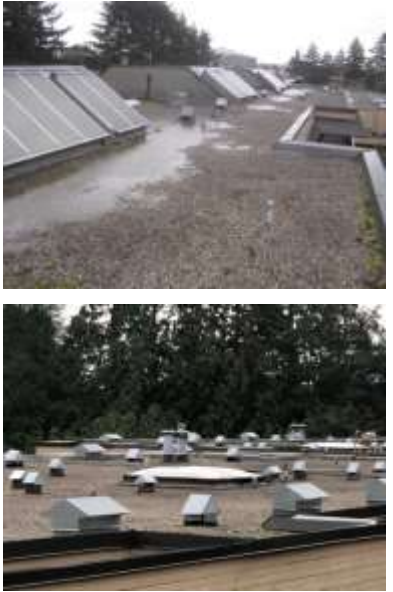
<p>North and South Building Flat Roofs Built up tar and gravel Current Age: approximately 19 years Assumed Lifespan: 20 years, then 25 years once renewed Replacement Date: Extended to 2022 based on high maintenance lately to extend its life, then 2047 Replacement Budget: \$465,000</p>

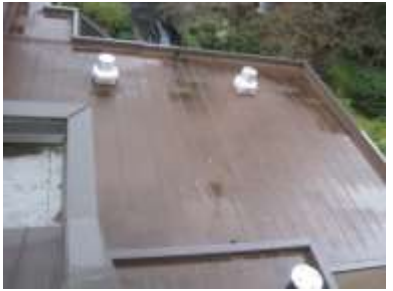
<p>Swimming Pool Flat Roof Areas SBS Torch-on Current Age: 6 years Assumed Lifespan: 25 years Replacement Date: 2038 Replacement Budget: \$40,000</p>

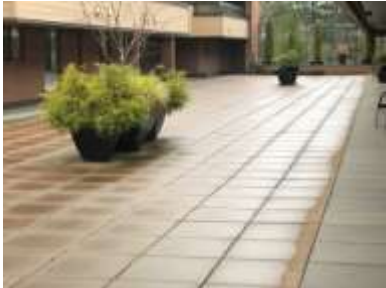
<p>Parking Garage Waterproofing in Courtyard SBS membrane, drains, and reuse of most pavers. Current Age: 9 years Assumed Lifespan: 30 years Replacement Date: 2040 Replacement Budget: \$670,000 in 2040</p>

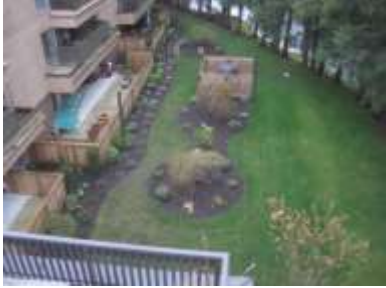
<p>Parking Garage Waterproofing Northwest Corner SBS membrane, drains, and all landscaping above. Current Age: 4 years Assumed Lifespan: 30 years Replacement Date: 2045 Replacement Budget: \$390,000 in 2045</p>

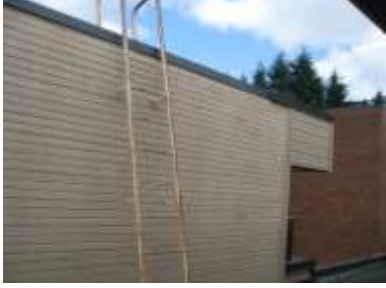
<p>Painting Wood siding Current Age: varies Assumed Lifespan: 8 to 12 years Replacement Date: one-quarter 2020, half in 2024, one quarter in 2030 Replacement Budget: \$25,000 in 2020 and \$50,000 in 2024, \$25,000 in 2030, \$25,000 in 2032, \$50,000 in 2036, \$25,000 in 2042, \$25,000 in 2044</p>

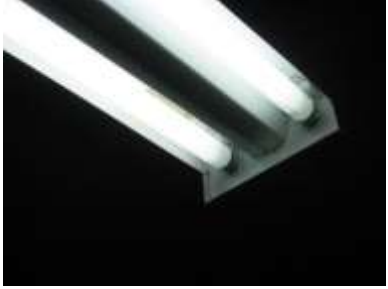
<p>3.0 POWER DISTRIBUTION Including breaker boxes, generators, emergency power supply, emergency lighting, heat tracing systems, and surge protection systems.</p>	
<p>Parking Garage Lighting Ballast Ballasted florescent lighting Current Age: varies Assumed Lifespan: 10 years Replacement Date: varies Replacement Budget: maintenance</p>

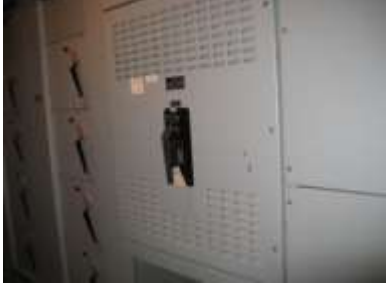
<p>Miscellaneous Electrical Circuit breakers, wiring, transformers, raceways wiring, conduit, fused disconnects, etc., including common areas and inside suites. Current Age: 41 years Assumed Lifespan: 25 to 60 years Replacement Date: every three years plus 2026 and 2041 Replacement Allowance: \$40,000 in 2026 and \$75,000 in 2041 plus \$2000 every two years starting 2020</p>

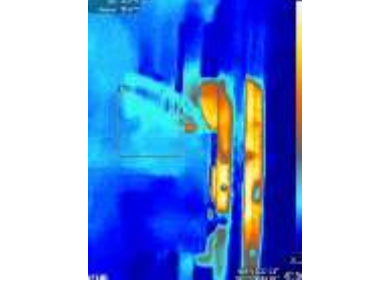
<p>Thermal Imaging Thermal Imaging Scan of 56 main breakers, 11 disconnects, 2 house panels Current Age: new Assumed Timing: 2 years Rescan Date: 2020 and every two years. Rescan Allowance: \$2000</p>

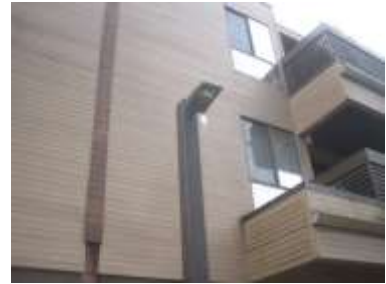
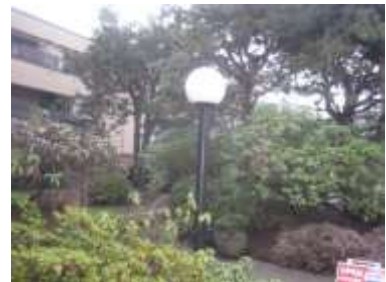
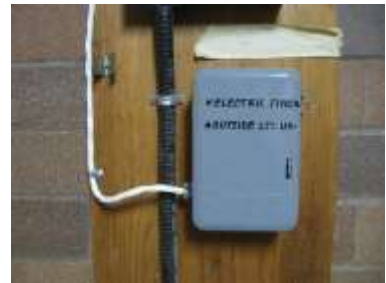
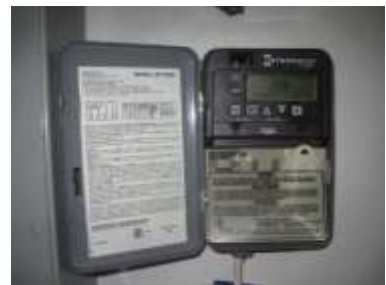
Exterior Lights and Timers

Various styles

Current Age: varies. Approximately half of the lights replaced in 2015.

Replacement Date: 2020 and 2040

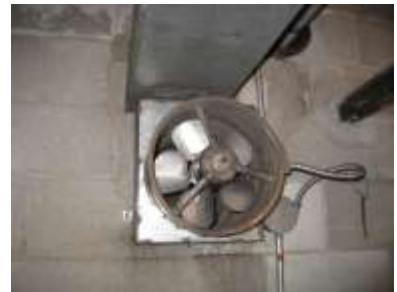
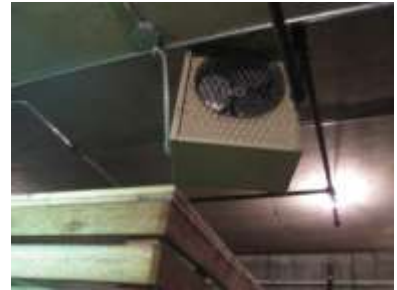
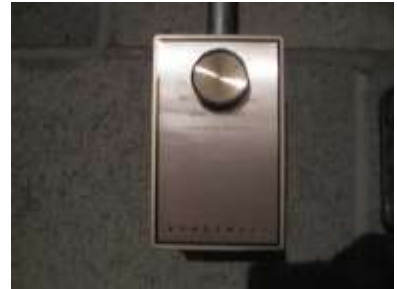
Electric Fans and Humidistats

Replacement Dates: 2021 and every five years.

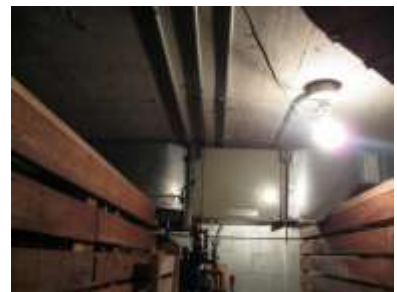
Duct Heater

Current Age: unknown but older

Replacement Date: 2021 and 2041

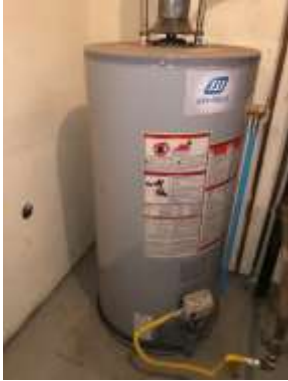
<p>5.0 PLUMBING AND WATER SUPPLY SYSTEMS Including boilers.</p>	
<p>Water Heater John Wood gas fired Current Age: 5 years Assumed Lifespan: 10 years Replacement Date: 2024, 2034, and 2044 Replacement Budget: \$1700</p>

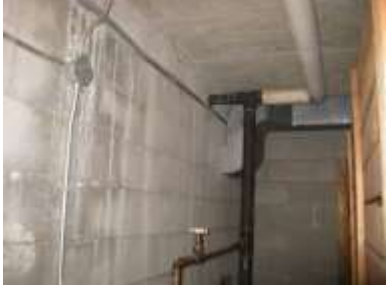
<p>Pressure Reducing Valve for Hot Water Tank Not observed Current Age: assumed original Assumed Lifespan: 20 years Replacement Date: 2024 and 2044 Replacement Budget: \$1000</p>	<p>No Photo</p>
<p>Water Supply Piping to Dwelling Units, Water Supply Valves, and Backflow Preventers Copper pipe Current Age: 41 years Assumed Lifespan: 40+ years Replacement Date: 2024 Replacement Budget: \$650,000</p>

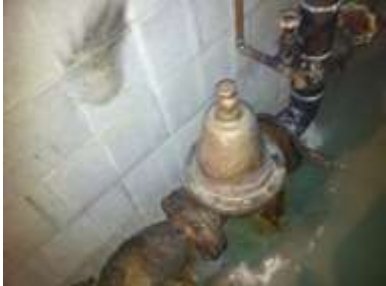
<p>Pressure Relief Valves Current Age: 41 years Assumed Lifespan: 40 years Replacement Date: 2020 or have it assessed by plumber Replacement Budget: \$3500</p>

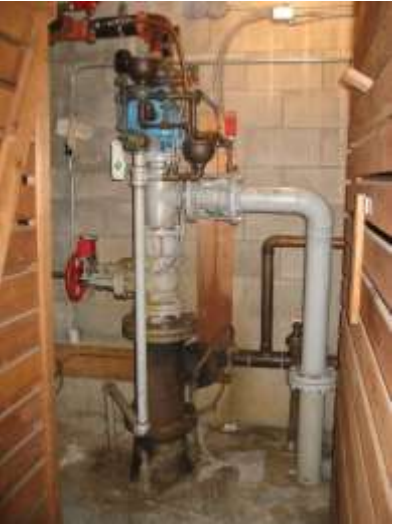
<p>6.0 FIRE PROTECTION Including sprinklers, backflow preventers, fire alarm system, fire alarm monitoring, and smoke detectors.</p>	
<p>Dry Pipe Sprinkler Valve System Current Age: 41 years Assumed Lifespan: 40 to 50 years for system Replacement Date: 2022 Replacement Budget: \$10,000</p>

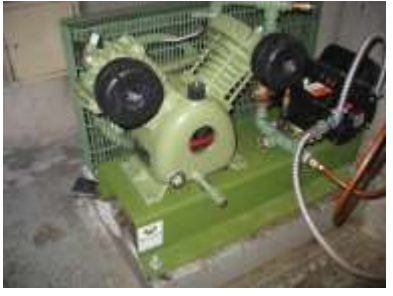
<p>Dry Sprinkler System Compressor & Motor Swan SVU-201 / Hubbell. Current Age: 5 years Assumed Lifespan: 15 years Replacement Date: 2028 and 2043 Replacement Budget: \$2700</p>

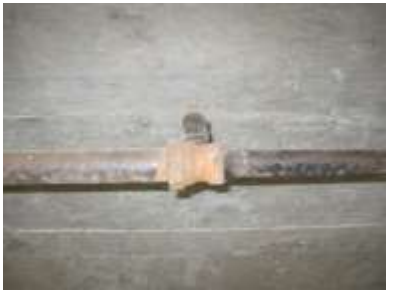
<p>Dry Sprinkler Heads and Pipe Joints Current Age: varies Assumed Lifespan: 25 years Replacement Date: 20% every five years starting 2020 Replacement Budget: \$2900 each time</p>

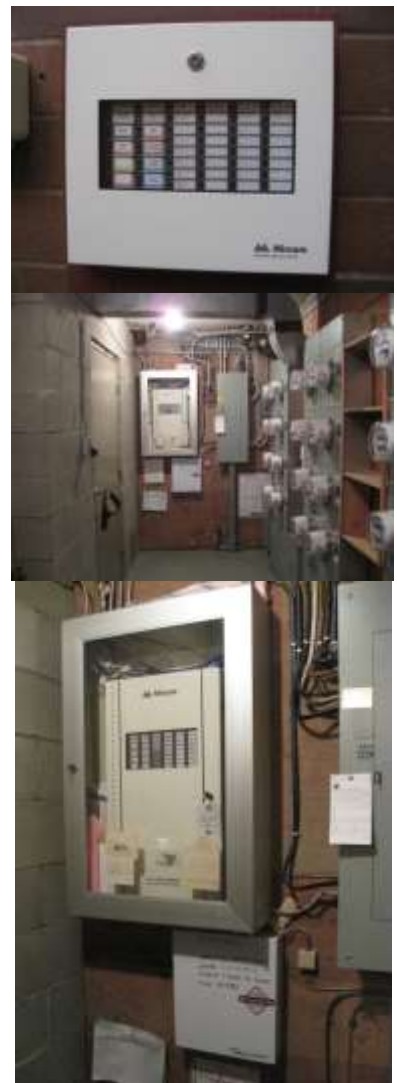
Mircom 1000 Fire Alarm Annunciator Panels at front door
Mircom 1000 Fire Alarm Annunciator Panel in south utility room
Other parts
Current Age: 7 years
Assumed Lifespan: 25 years
Replacement Date: 2037
Replacement Budget: \$7,000

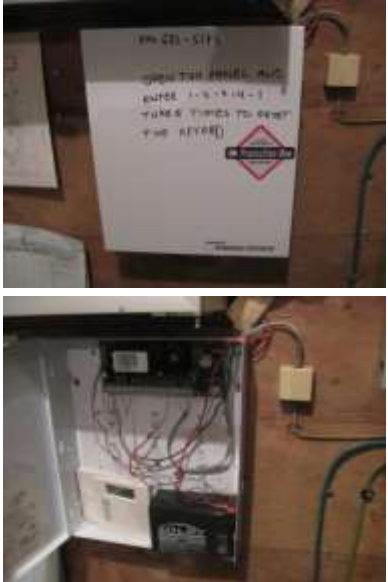
<p>Fire Alarm Monitoring Communicating device, fire alarm monitoring transmitter Current Age: unknown Assumed Lifespan: 25 years Replacement Date: 2020 and 2045 Replacement Budget: \$1200</p>

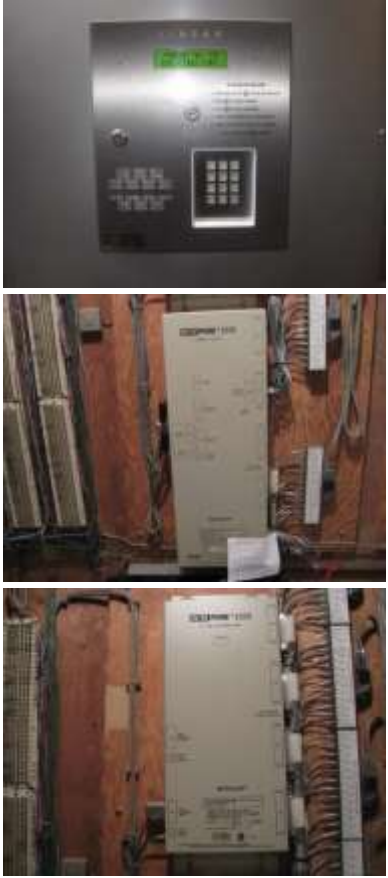
<p>7.0 SECURITY SYSTEMS Including intercom</p>	
<p>Enter Phone System (2) L Linear AE-500 with Enterphone 2000 panel in electrical room Current Age: 4 years Assumed Lifespan: 15 years Replacement Date: 2030 and 2045 Replacement Budget: \$14,000</p>

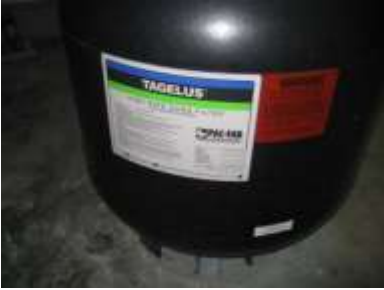
<p>Swimming Pool Filter PacGab TA 60 Current Age: 14 years Assumed Lifespan: 18 years Replacement Date: 2022 and 2040 Replacement Budget: \$1400</p>

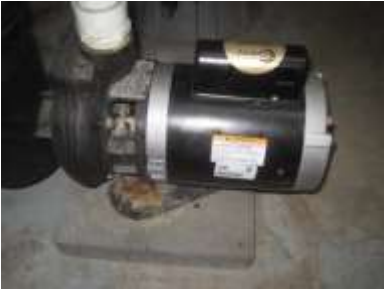
<p>Swimming Pool Pump Century Centurion B121 Switchless Motor Current Age: unknown Assumed Lifespan: 15 years Replacement Date: 2021 and 2036 Replacement Budget: \$1000</p>

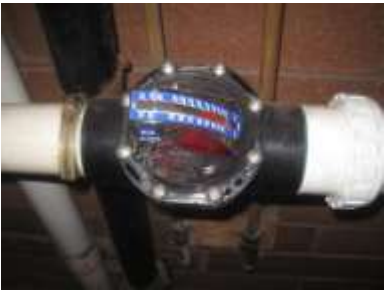
<p>Swimming Pool Flow Meter NSF-50 CCS-12485 Flow Meter Current Age: 6 years Assumed Lifespan: 10 years Replacement Date: 2023, 2033, and 2043 Replacement Budget: \$300</p>

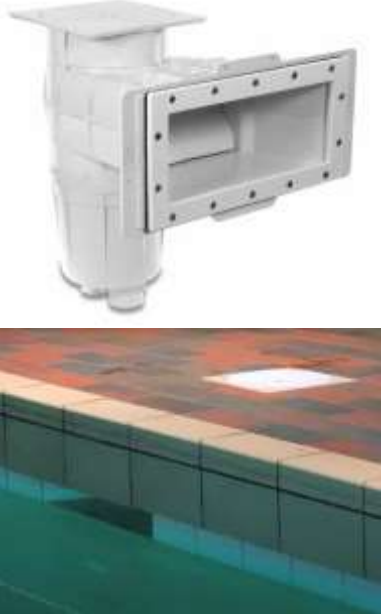
<p>Swimming Pool Skimmer (2) Jacuzzi WWFL Current Age: 41 years Assumed Lifespan: 35 years Replacement Date: 2020 Replacement Budget: \$3200</p>

<p>The image shows a white plastic swimming pool skimmer. The top part is a separate piece with a flat top and a rectangular opening. The bottom part is a vertical pipe with a flange. Below, a photograph shows the skimmer installed in a pool deck, with a circular opening in the deck and a green pool edge.</p>
<p>Swimming Pool Heating System Rheem P-M266A-EN-C Current Age: 6 years Assumed Lifespan: 12 years Replacement Date: 2026 and 2038 Replacement Budget: \$4600</p>

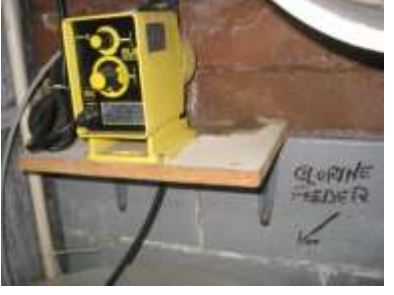
<p>Swimming Pool Sanitizer System LMI Liquid Chlorine Pump Current Age: 16 years Assumed Lifespan: 10 years Replacement Date: 2020, 2030, and 2040 Replacement Budget: \$800</p>

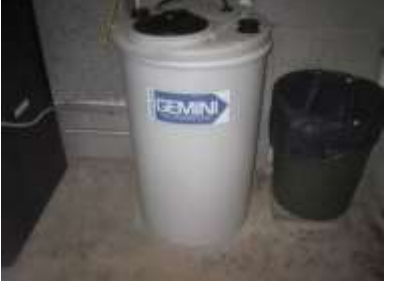
<p>Swimming Pool Liquid Chlorine Containment Tank Gemini Dual Containment System – Liquid Chlorine Current Age: 2 years Assumed Lifespan: 10 years Replacement Date: 2025, 2035, and 2045 Replacement Budget: \$700</p>

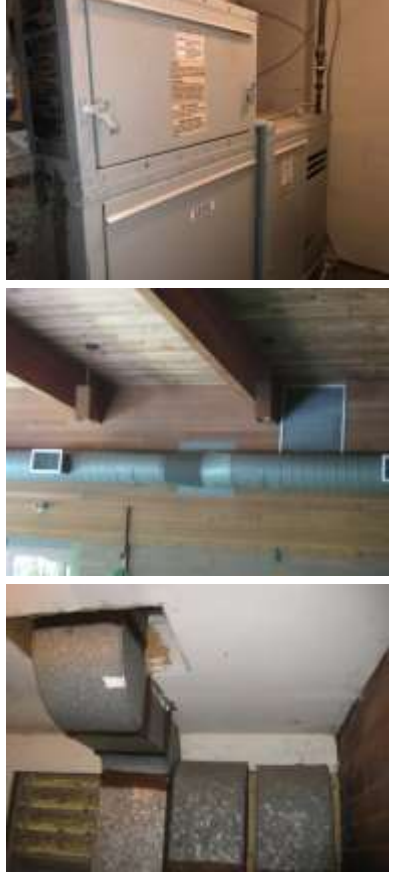
<p>Mechanical Air Handling Unit and System Engineered Air system, ducting, dampers, etc. Current Age: 3 years for air handling unit, 39 years for ducting Assumed Lifespan: 25 years Replacement Date: 2041 Replacement Budget: \$30,000</p>

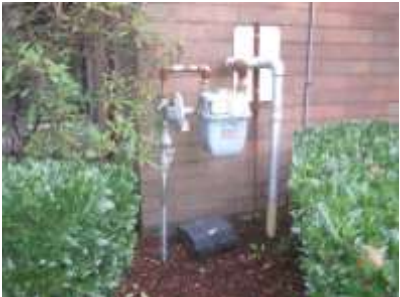
14.0 NATURAL GAS DISTRIBUTION	
Supply Piping and Shutoff Valves Pipes and valves at pool area Current Age: 41 years Assumed Lifespan: 50+ years Replacement Date: 2027 Replacement Allowance: \$6000

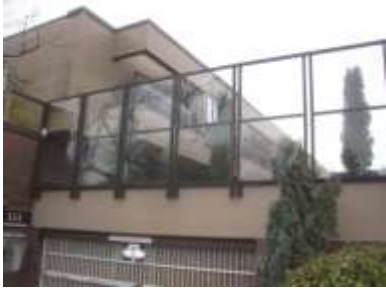
<p>Courtyard Guard Aluminum frame and glass Current Age: 6 years Assumed Lifespan: 30 years Replacement Date: 2040 Replacement Budget: \$9000</p>

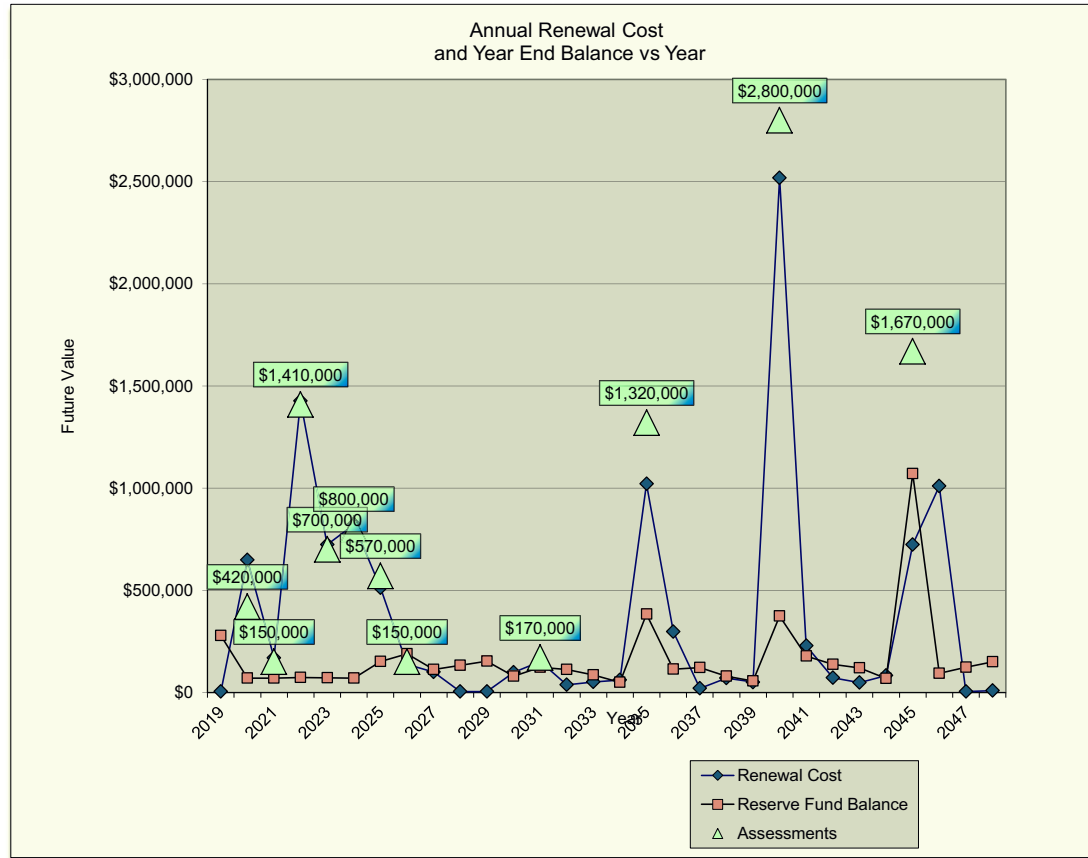
Starting Value of the Contingency Reserve Fund: \$252,920
 Savings Rate, i: 2.47%
 Recommended Annual Contribution: **\$18,000 +2%/yr**
 or One Time Contribution: \$7,905,120

The starting value of the contingency reserve fund plus one year of interest was added to Report Year 1.
 Special assessments are shown on graph and the year is highlighted in the table.

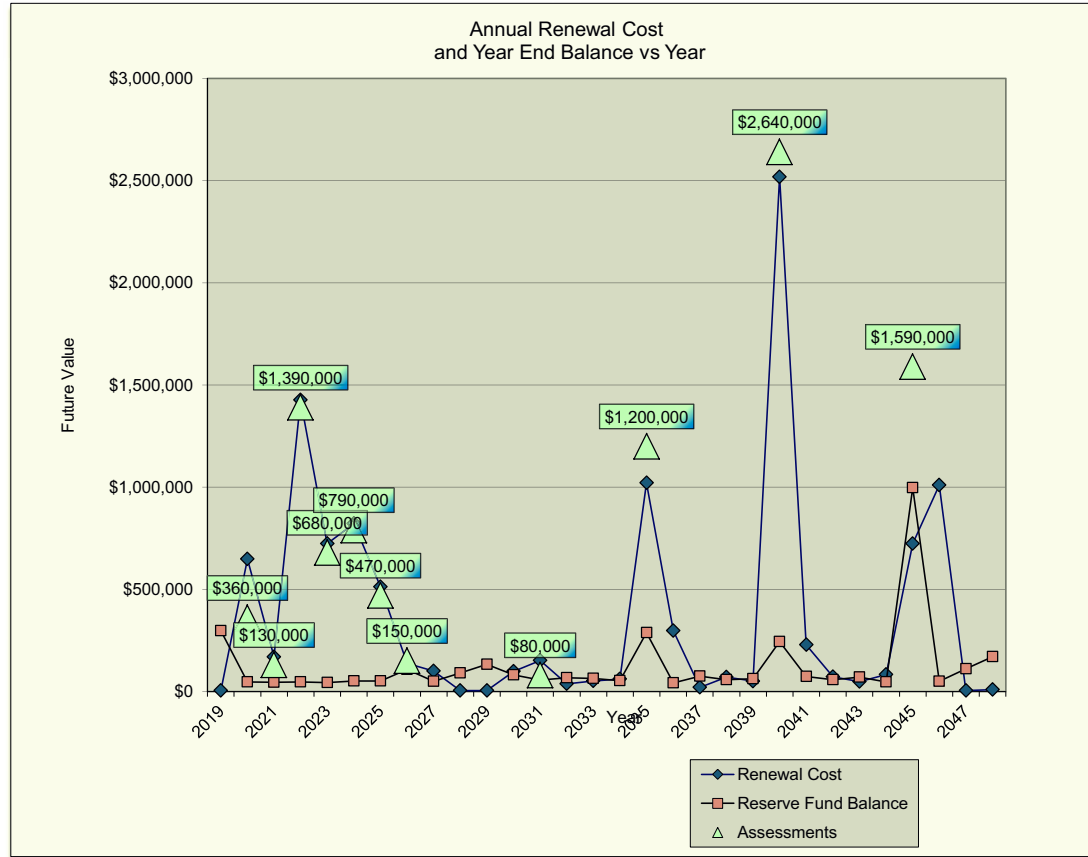
Starting Value of the Contingency Reserve Fund: \$252,920
 Savings Rate, i: 2.47%
 Recommended Annual Contribution: **\$36,000 +2%/yr**
 or One Time Contribution: \$7,905,120

The starting value of the contingency reserve fund plus one year of interest was added to Report Year 1. Special assessments are shown on graph and the year is highlighted in the table.

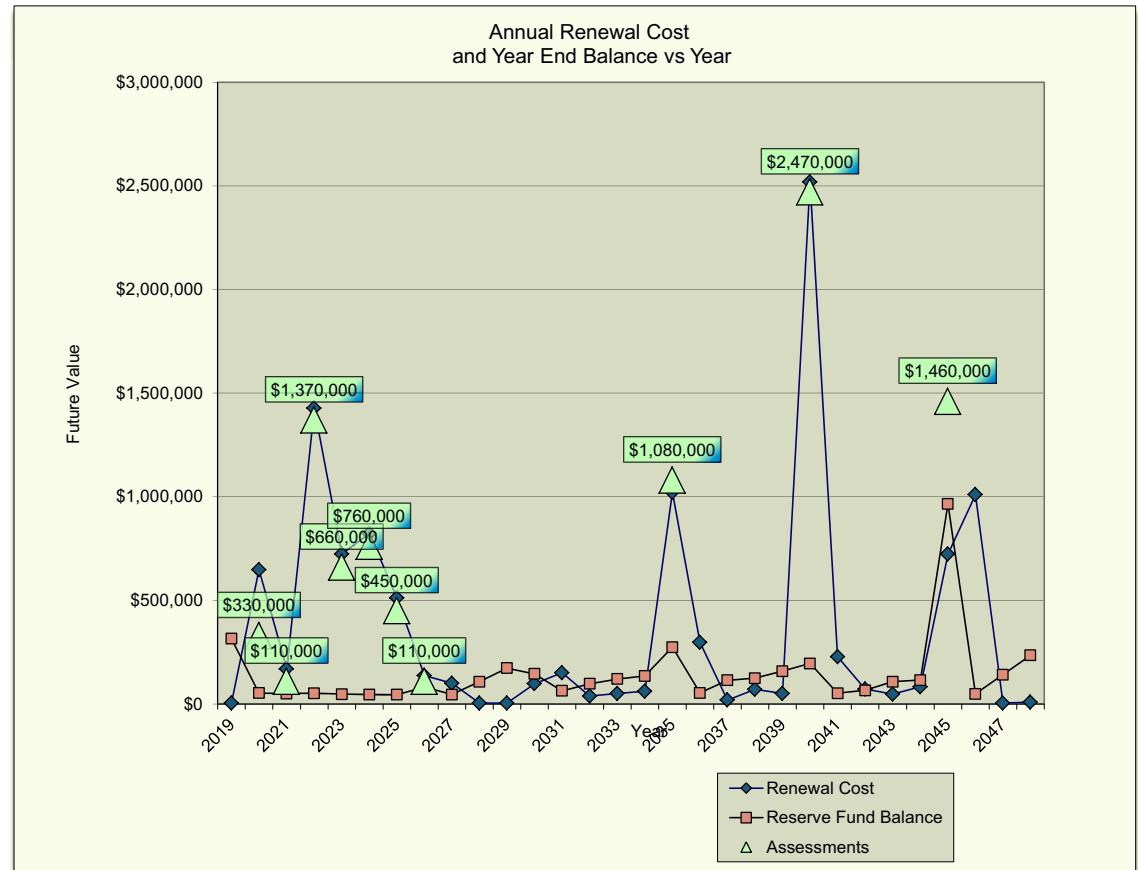
Starting Value of the Contingency Reserve Fund:	\$252,920	Number of Dwelling Units:	56
Savings Rate, i:	2.47%	Rate of Escalation, e:	2.00%
Recommended Annual Contribution:	\$54,000 +2%/yr	average per unit per month:	\$80 plus the annual increase
or One Time Contribution:	\$7,905,120	average per unit:	\$141,163

The starting value of the contingency reserve fund plus one year of interest was added to Report Year 1. Special assessments are shown on graph and the year is highlighted in the table.
