# INSPECTOR...

## Chimneys

## Chimneys and their venting

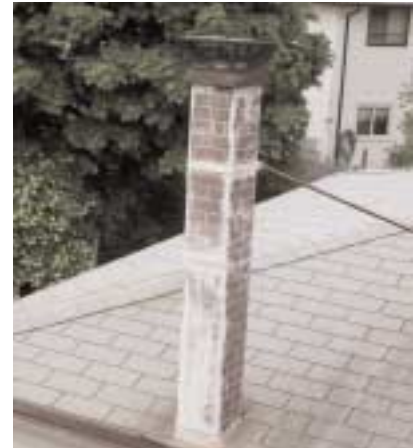
I have noticed that there are damaged bricks on my chimney above the roof line. What has caused this and what needs to be done to correct it?

A chimney is designed to exhaust products of combustion from a fuel-burning appliance to the exterior of the building. A masonry chimney is typically built on its own footing and foundation with brick or concrete block on the exterior. Post 1940's a clay tile liner was usually installed inside the masonry to protect the brick and mortar from the exhaust gases. Flaking sometimes occurs on a masonry chimney due to the moisture in the exhaust gases that is a product of combustion. The moisture gets absorbed into the brick and freezes in the winter when the warm exhaust gases stop flowing out the chimney. When water freezes it expands and over time and this freeze-thaw cycle leads to deterioration of the brick, clay tile, and mortar. The damage is usually located at the top portion of the chimney for many reasons. The top portion of the chimney is the most exposed area and therefore the most vulnerable to weather. Moisture may also enter the top portion of the chimney from the exterior if the cap is cracked or missing. As well, once the exhaust gases reach the top of the chimney, they may have cooled sufficiently for the moisture to condense, making the concentration of moisture higher at the top.

Once flaking has occurred, the brick requires replacement to prevent further deterioration.

This requires the services of a qualified mason. Depending on the level of deterioration, the repairs may be costly, since the chimney may have to be completely rebuilt from the roof line up.

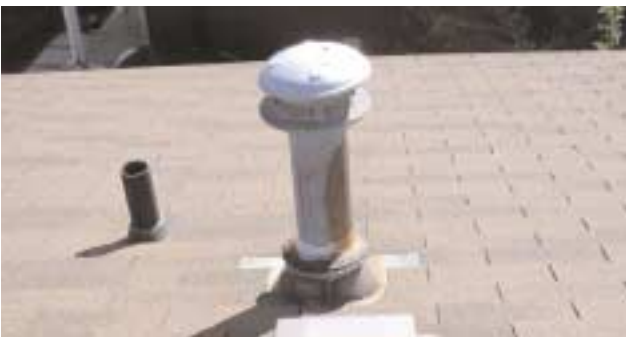
- Wood burning fireplaces generally do not require a metal liner, however wood burning stoves and fireplace inserts do require that a stainless steel liner be installed because of the potential for chimney fires. A clay tile liner is not capable of withstanding the heat of a chimney fire like a stainless steel liner is, so most wood stove and fireplace insert manufacturers make the chimney liner a requirement of proper installation.
- As discussed above, flaking brick is a common occurrence on brick chimneys of almost any age and should be addressed to prevent further deterioration.
