# Depreciation Report

NWS 222 – Wiltshire House

**RE: Depreciation Report for Strata Plan NWS 222  
File No. NW222DR25**

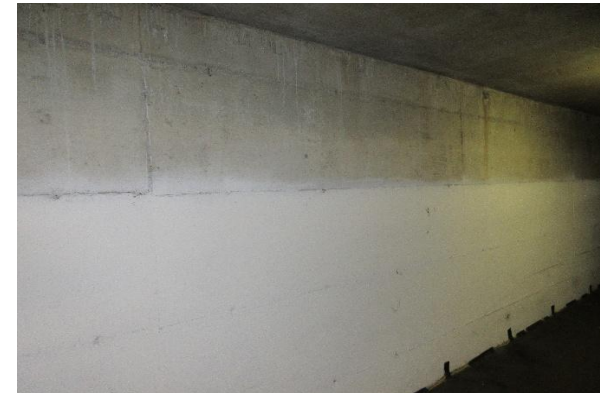
Foundation walls

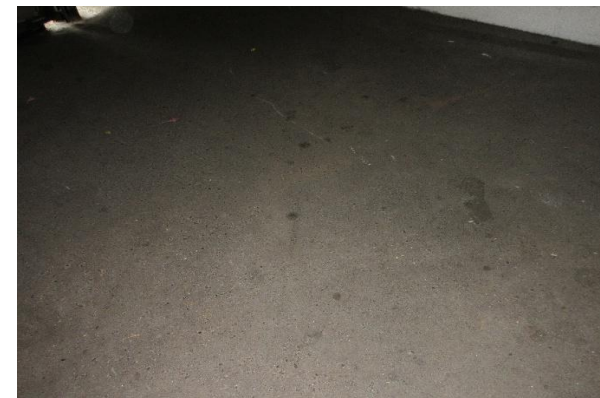
Parkade slab-on-grade

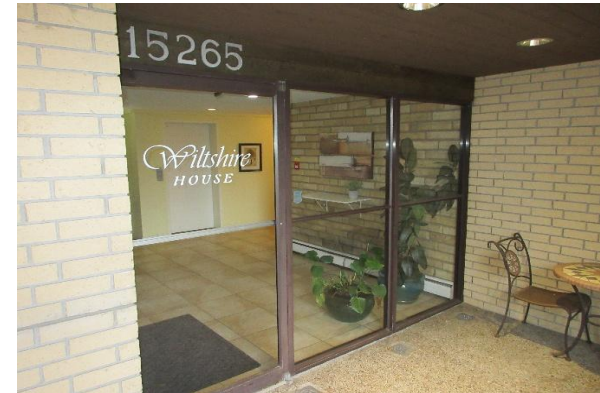
| Remarks | This component has exceeded its typical average lifespan and it is recommended to plan for full replacement in the near future. | | | | |

Aluminum glass swinging main entrance door

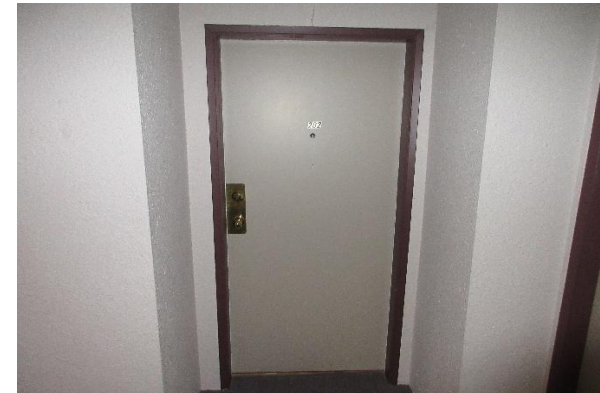
| Condition Analysis | Deterioration | Peeling paint on wooden unit entry doors was observed in isolated locations. | | | |

Wooden unit entry door

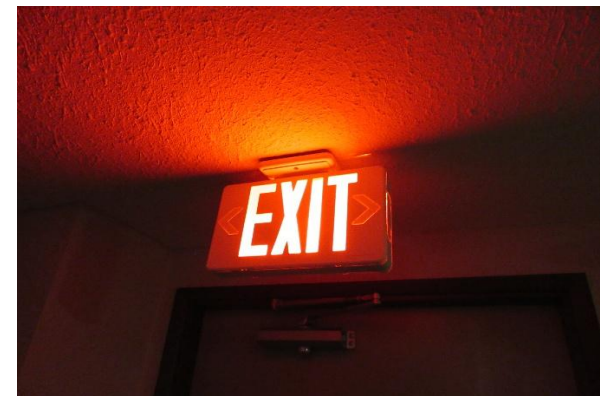
Exit sign

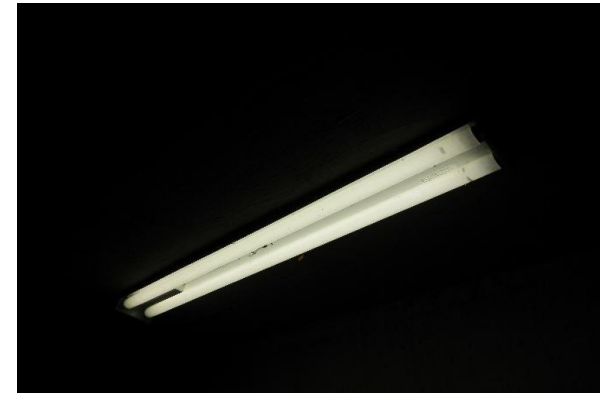
Parkade light fixture

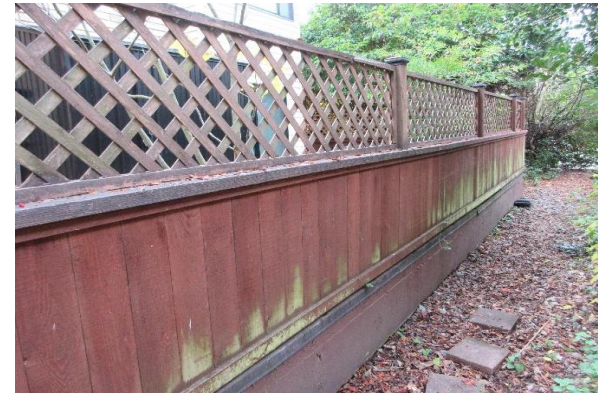
Wooden fencing

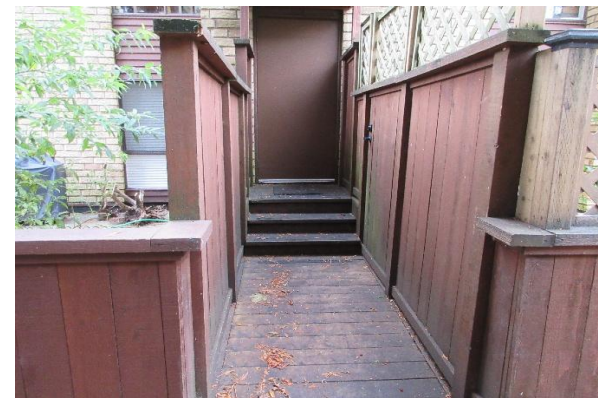
Wooden fencing

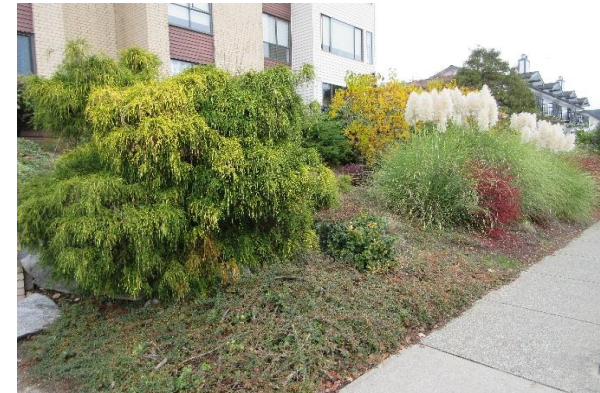
Plants

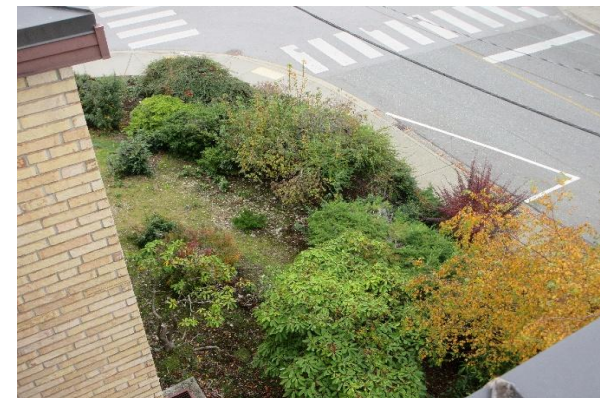
Plants
