THE DONOVAN
1055 RICHARDS STREET
VANCOUVER, BC
PROPERTY CONDITION
ASSESSMENT
FEBRUARY 25, 2011

OMICRON PROJECT NO. 10-10-221

**Re: Property Condition Assessment
1055 Richards Street, Vancouver BC**

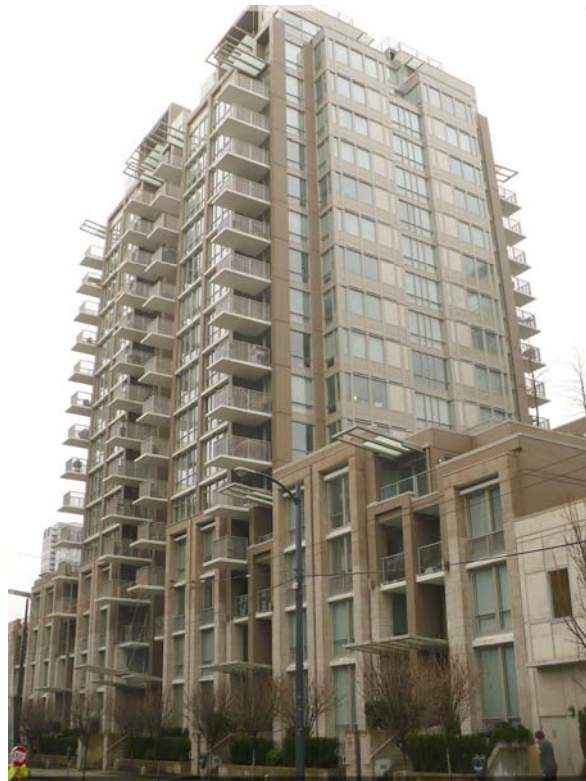
PHOTO A-2

- 2.3 There is a cracked concrete paver on one penthouse deck (**Photo A-2**); **replace cracked paver.**
- 2.4 Saddle transitions have been detailed with self-adhered membrane (SAM) extending up the wall with metal flashing installed above. The SAM extends beyond the flashing in at least one location and has been inappropriately painted (**Photo A-3**). Metal flashings have been wrapped around the wall at a few locations. Saddle flashings have been typically left open at the edge (**Photo A-4**). It is inappropriate to leave SAM exposed and to leave open edges at flashings. **We recommend installing pre-formed prefinished metal closure wrap that extends around the wall with a gum pocket to receive caulk at returns to the face of the wall.**

Cracked concrete
paver.

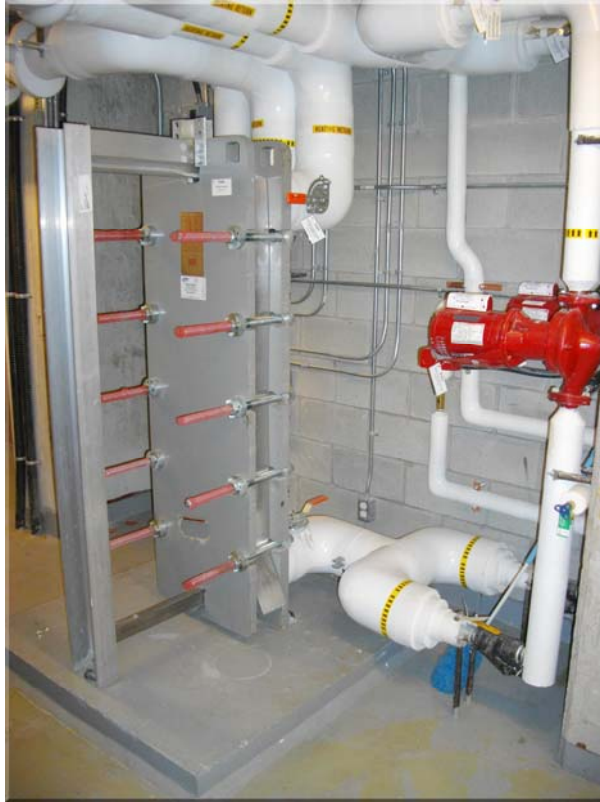
PHOTO M-1

Ground source heat pump heat exchanger with circulating pump.

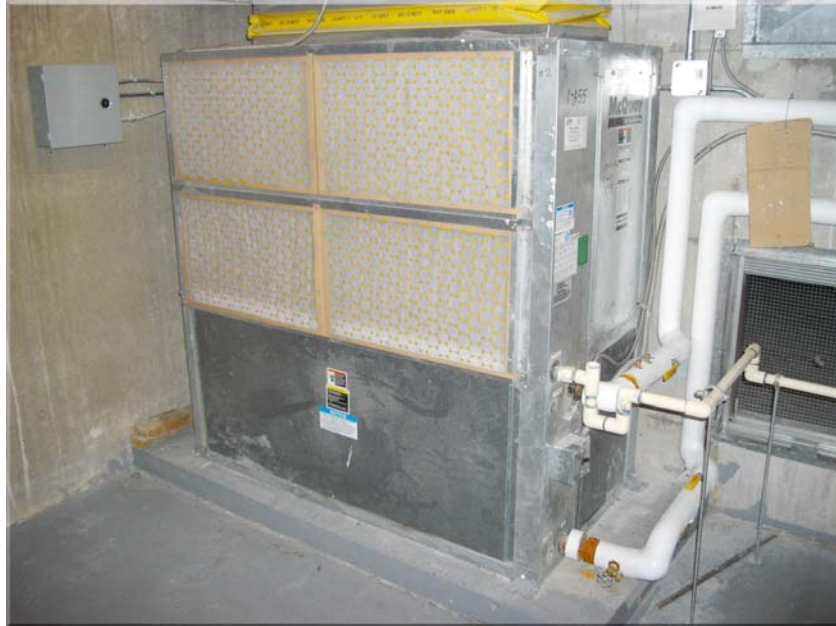
PHOTO M-3

Electrical room heat pump.

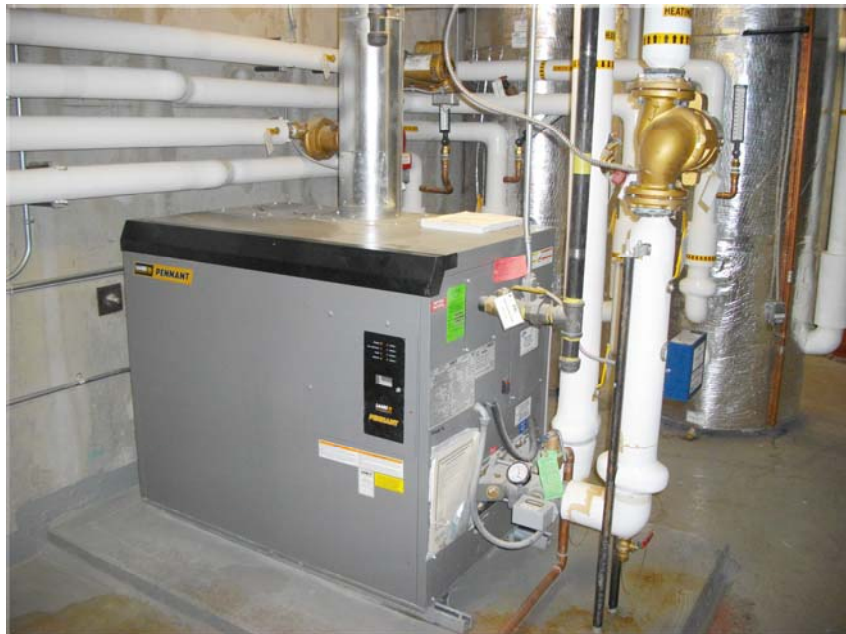
PHOTO M-4

Heating water boiler and recirculation pumps.

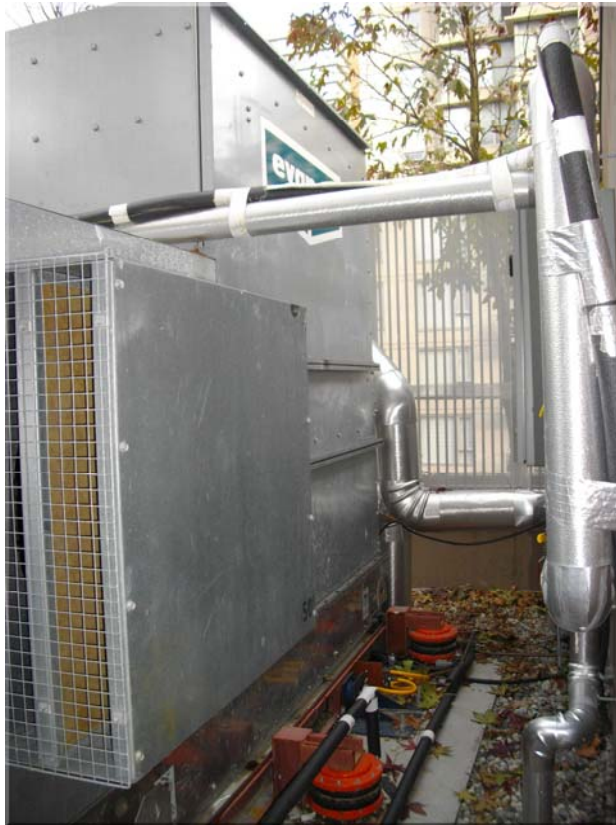
PHOTO M-5

Cooling tower.

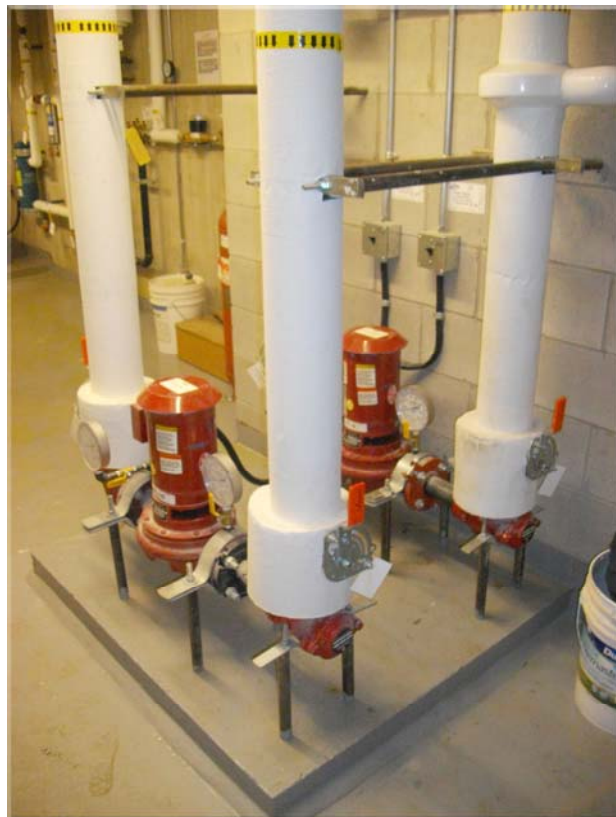
PHOTO M-6

Condenser water
loop pumps.

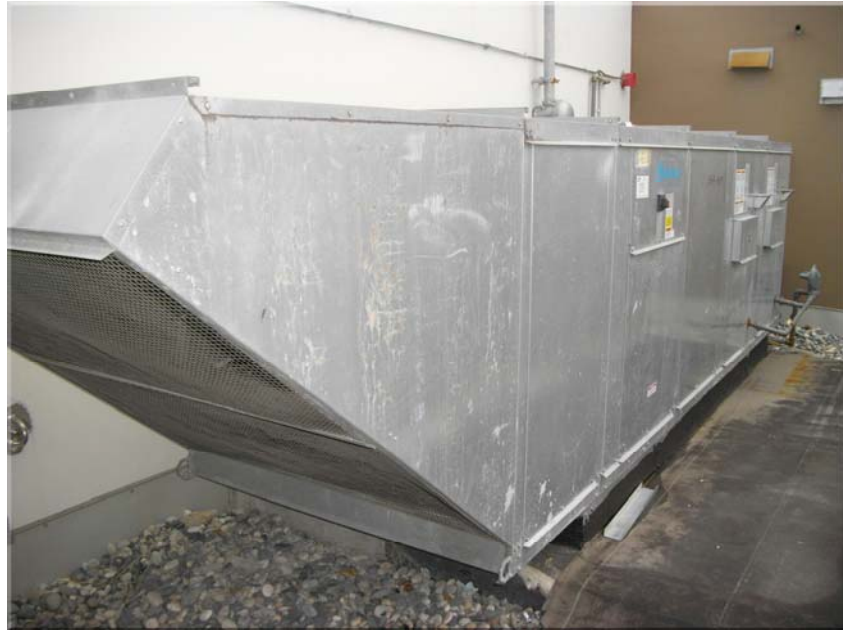
PHOTO M-7

100% outdoor air
corridor
pressurization
rooftop unit.

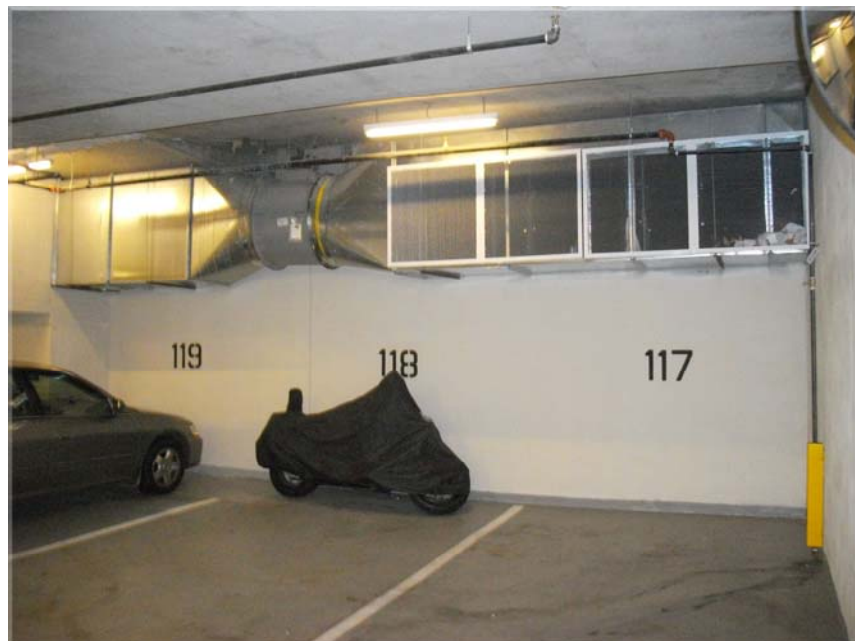
PHOTO M-8

Parkade exhaust fan.

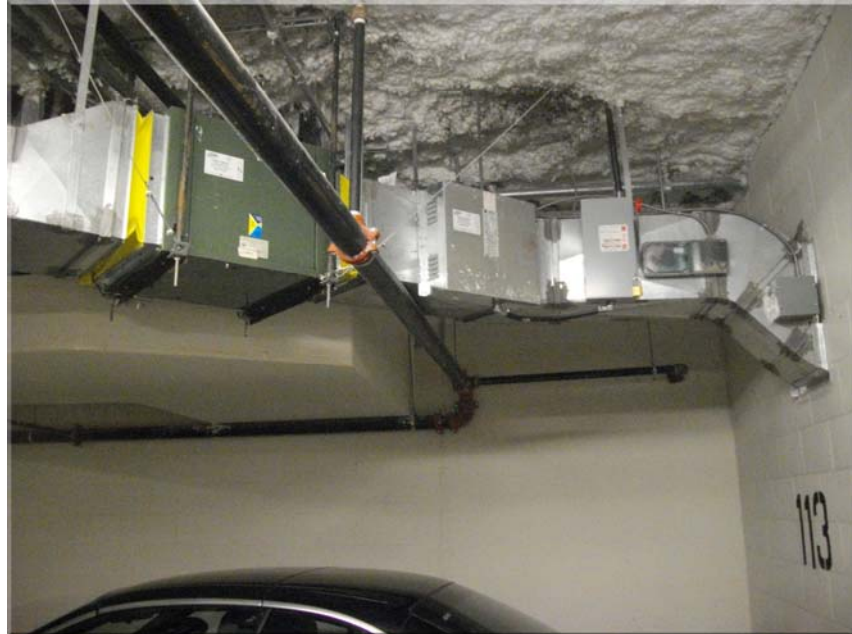
PHOTO M-9

Typical inline fan.

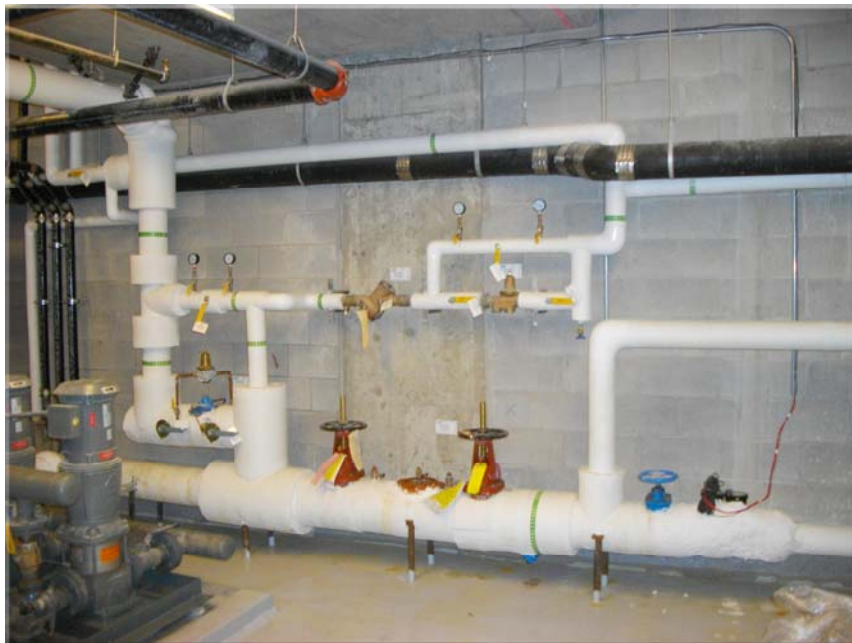
PHOTO M-10

Water entry station.

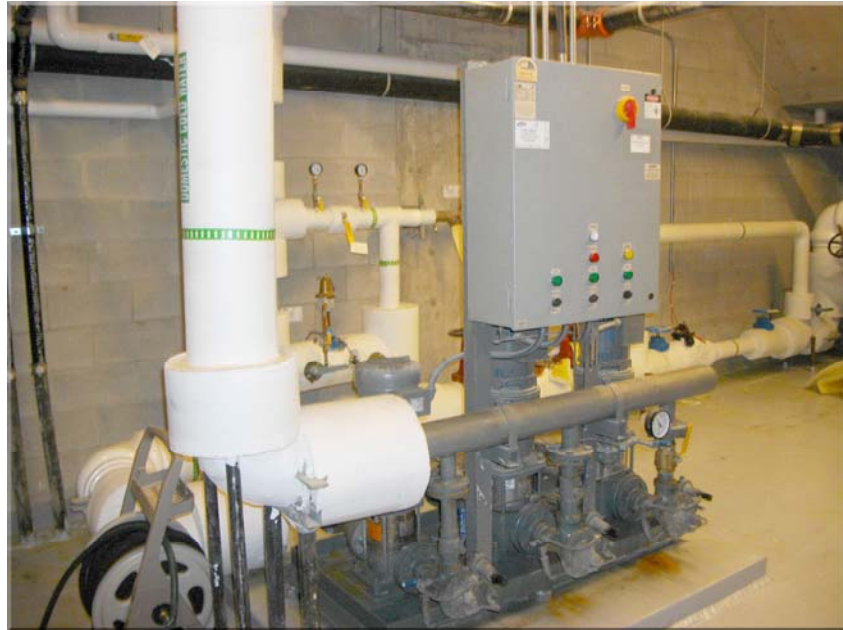
PHOTO M-11

Domestic water
booster pump.

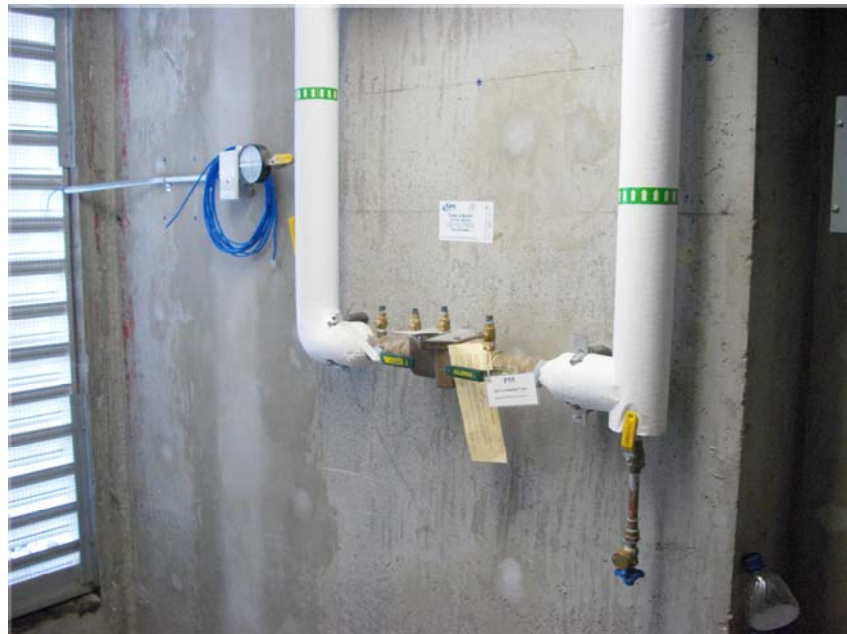
PHOTO M-12

Boiler backflow
preventor.

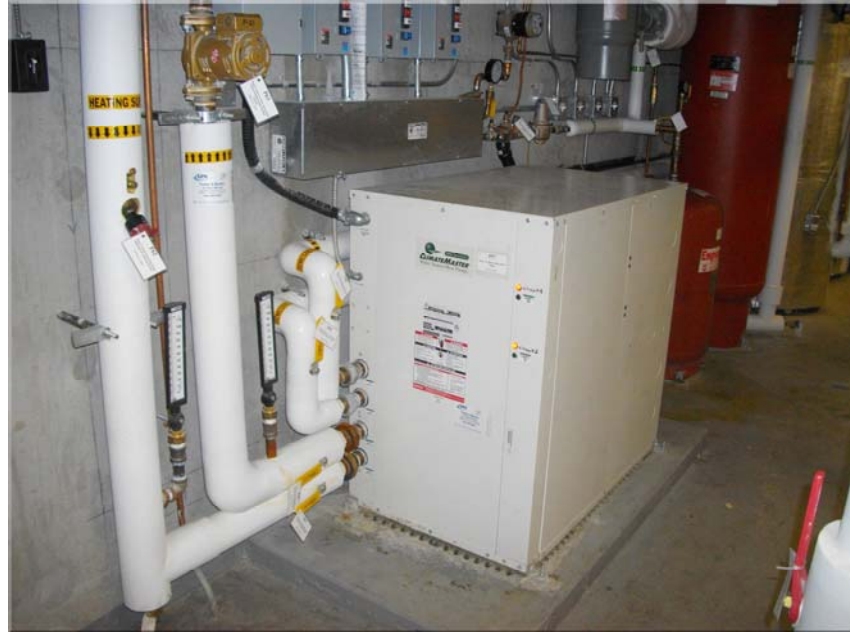
PHOTO M-13

Domestic hot water
heat pump.

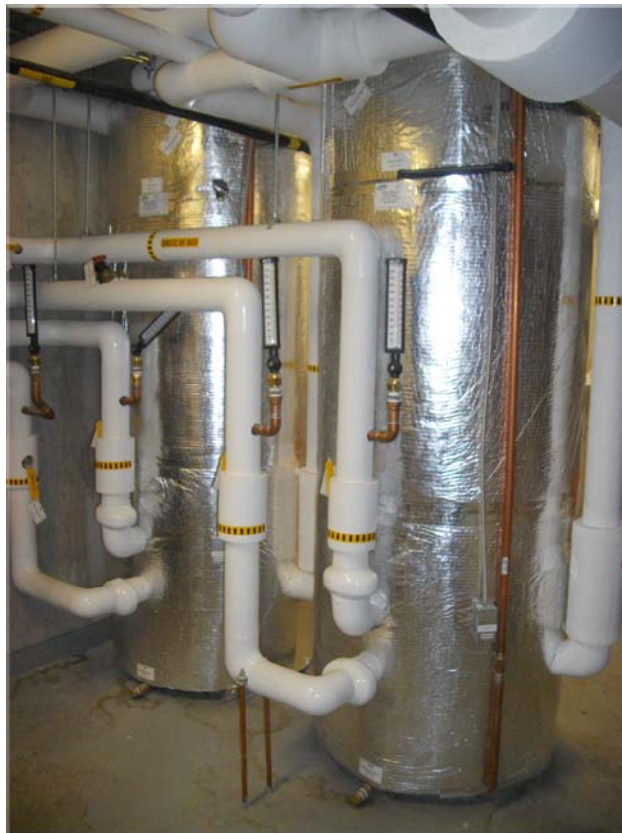
PHOTO M-14

Domestic hot water
storage tanks.

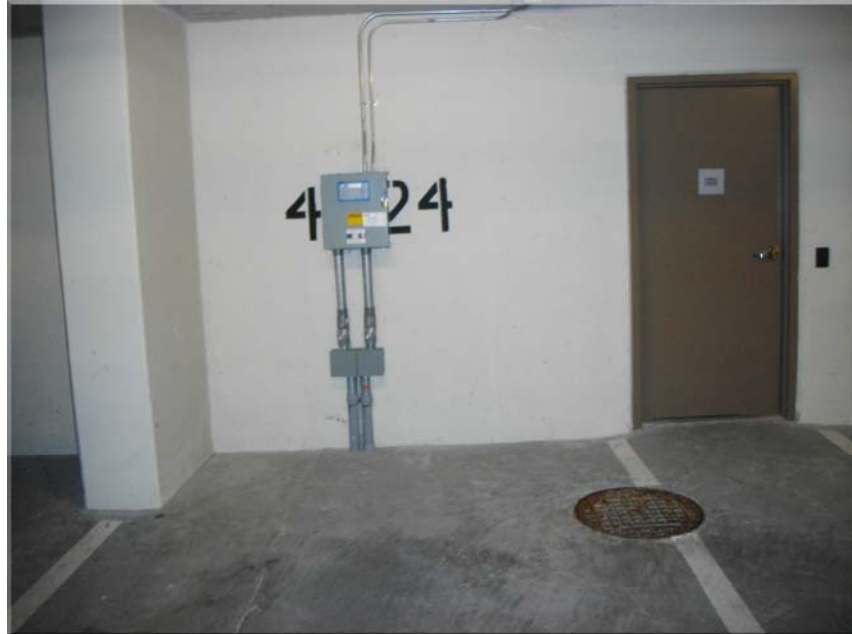
PHOTO M-15

Typical sump with
control panel.

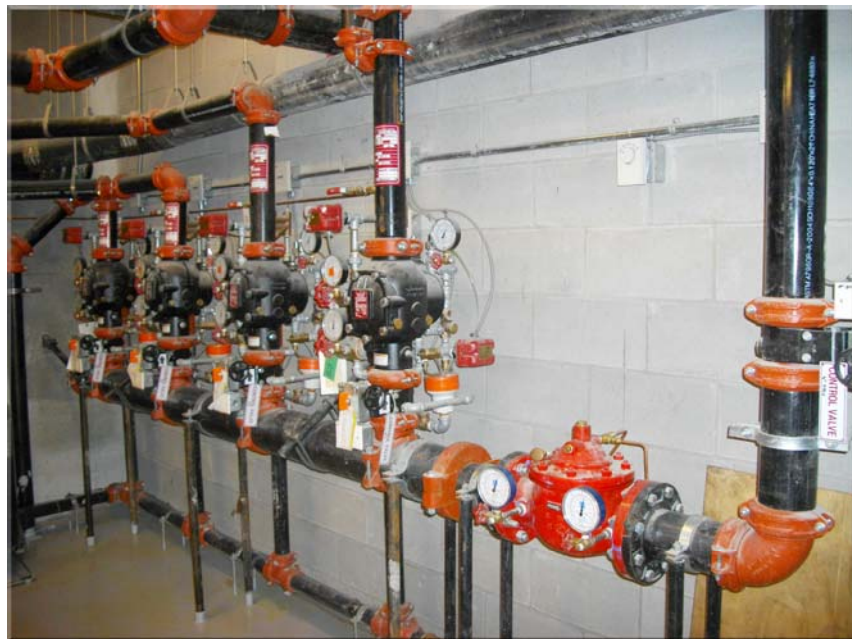
PHOTO M-16

Sprinkler tree.

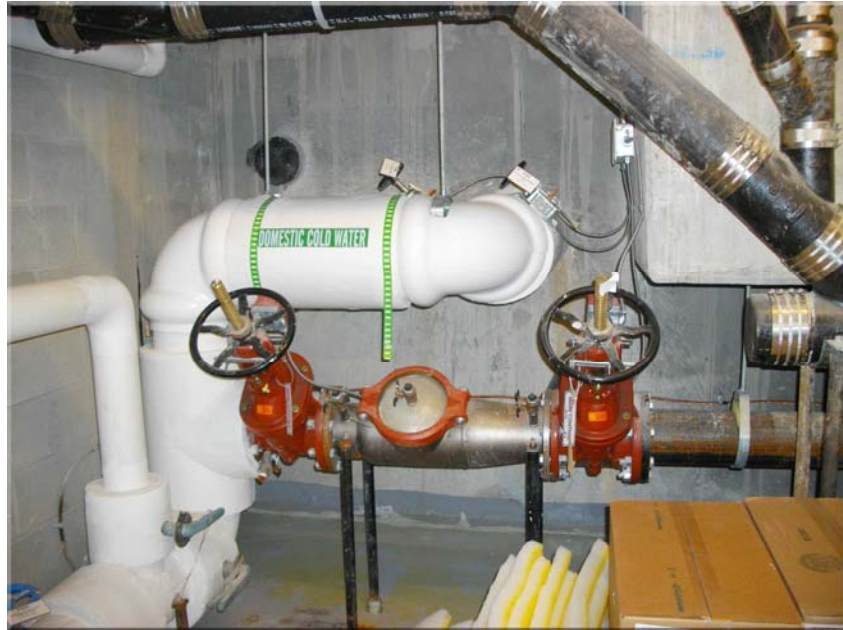
PHOTO M-17

Sprinkler double
check valve.

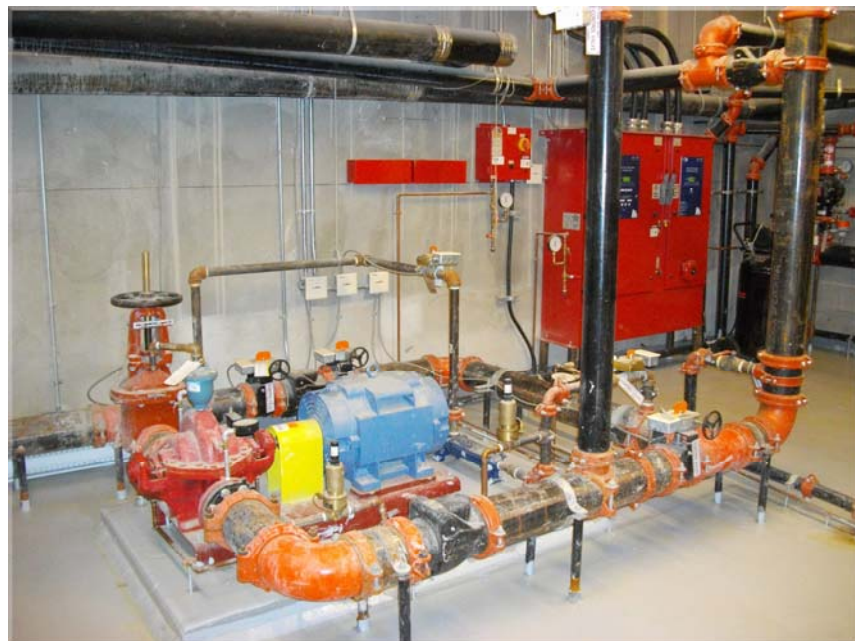
PHOTO M-18

Fire pump with
control panel.

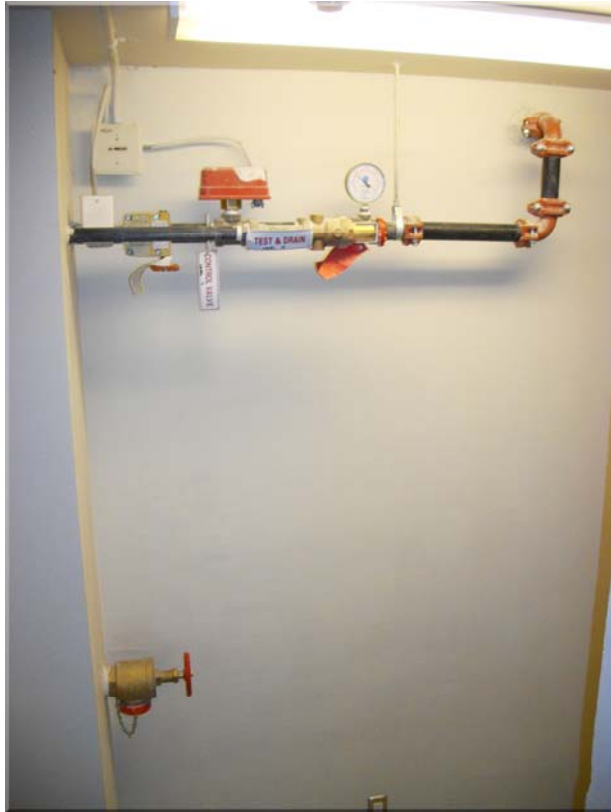
PHOTO M-19

Standpipe c/w 2 ½"
hose valve and floor
sprinkler zone valve.

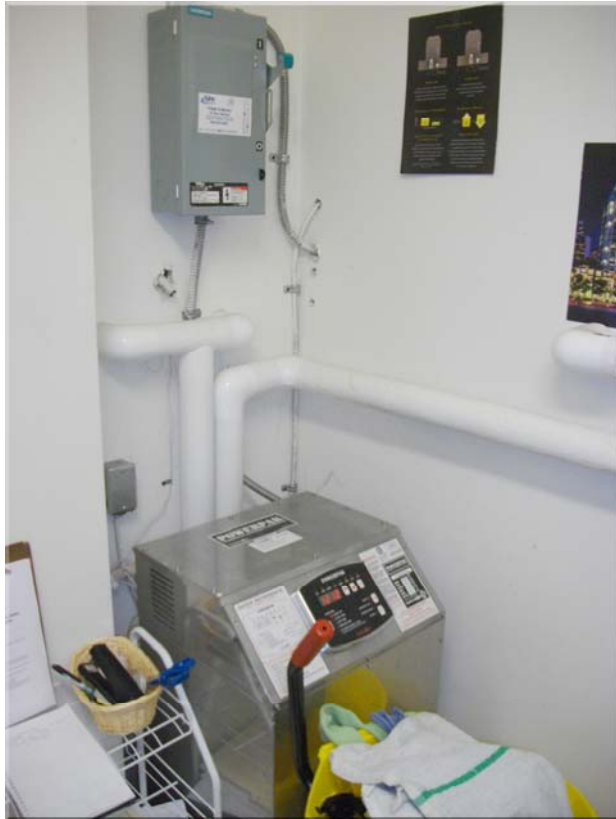
PHOTO M-21

Steam generator.

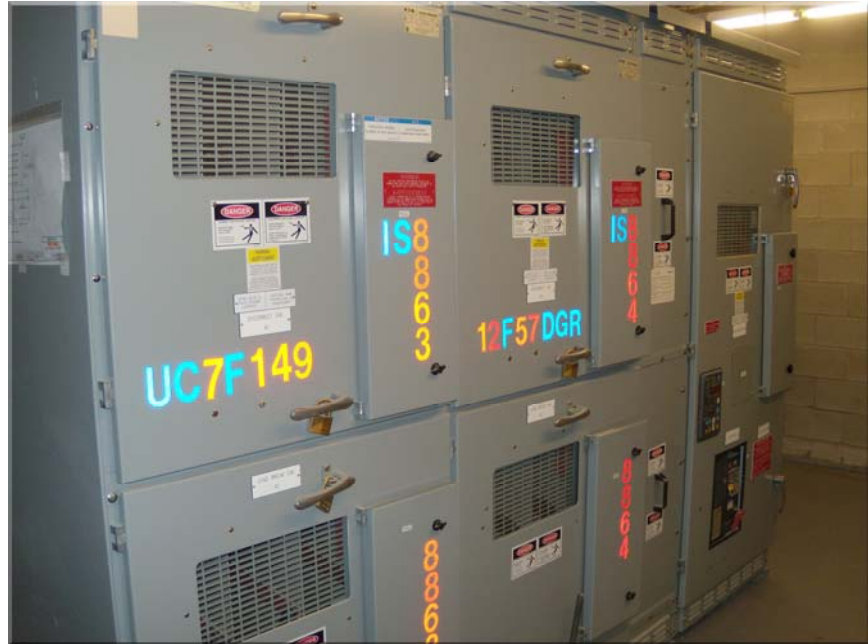
PHOTO E-1

High voltage dual
radial service load
break and isolating
switches.

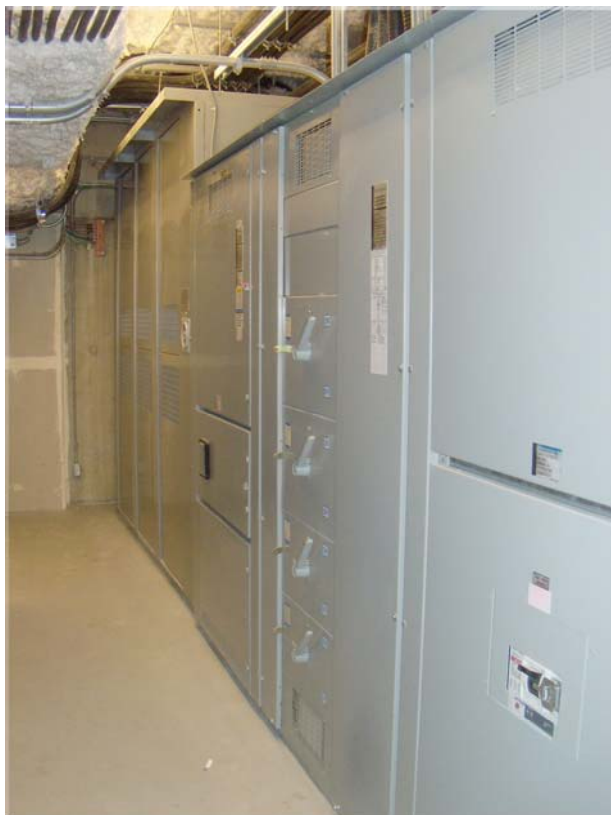
PHOTO E-2

Main secondary
switchboard in main
electrical room.

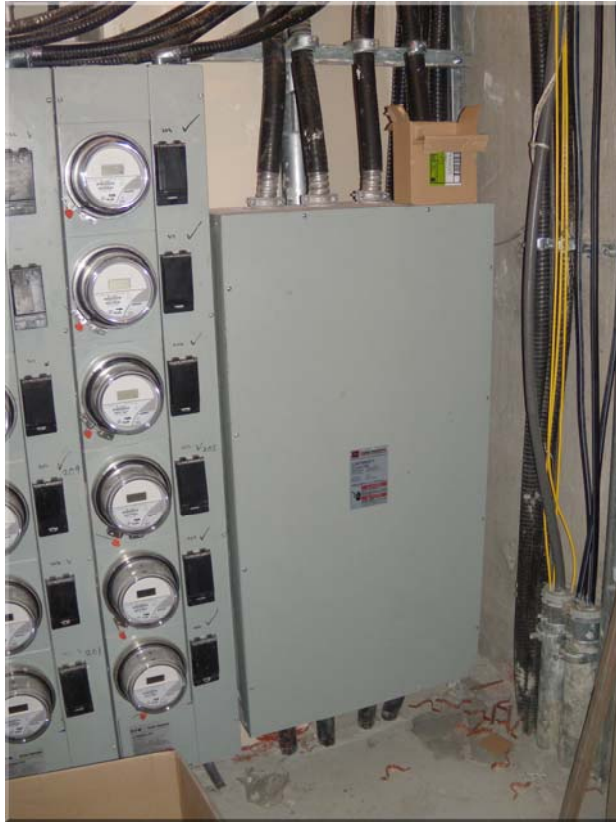
PHOTO E-3

Typical electrical closet with metered tenant feeds and risers.

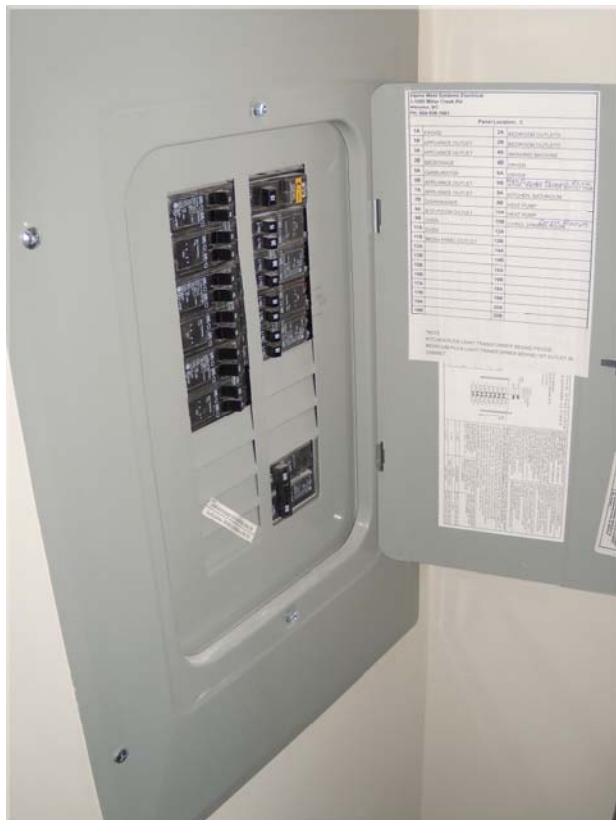
PHOTO E-4

Typical panel board located within tenant suite.

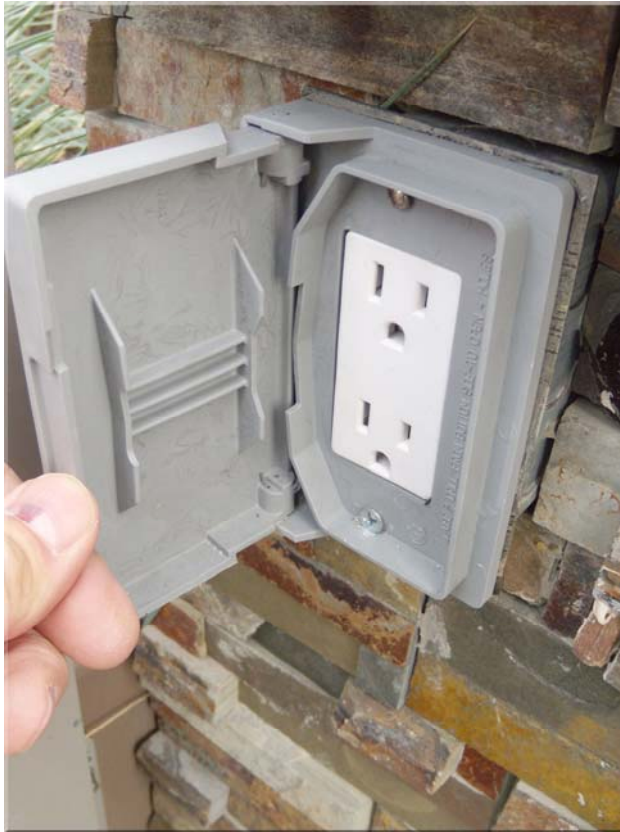
PHOTO E-5

Standard duplex
receptacle on the end
of barbeque island
on Penthouse roof.

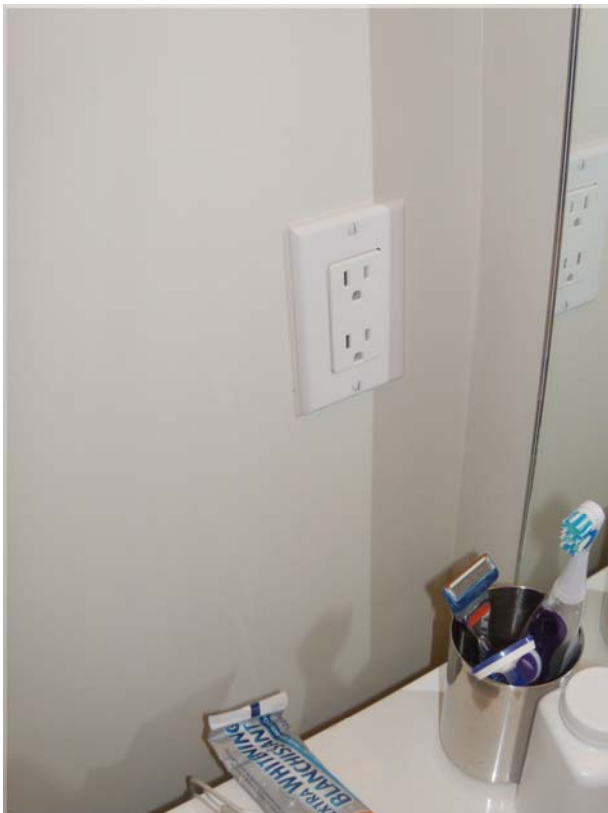
PHOTO E-6

Receptacle adjacent
sink in washroom
within tenant unit.

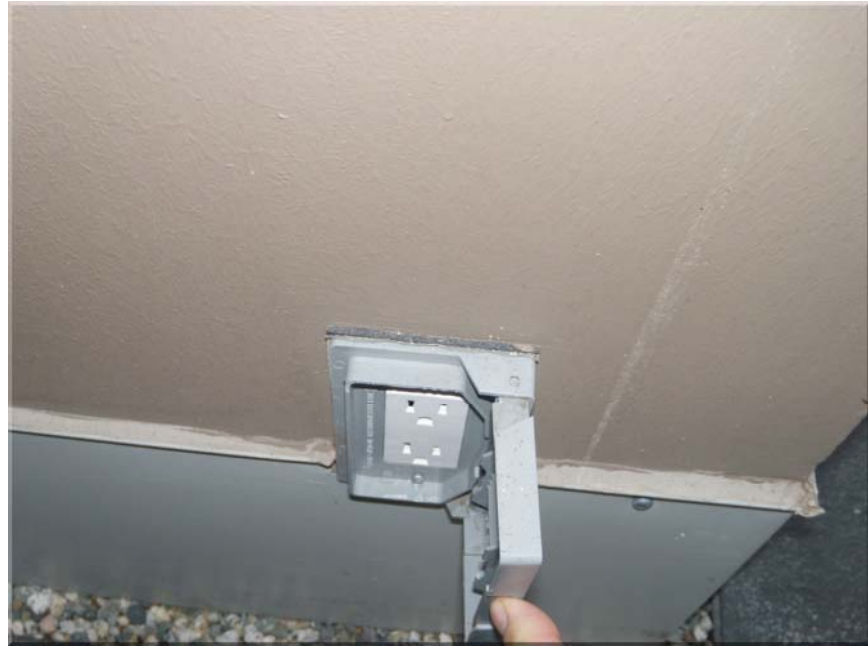
PHOTO E-7

Typical duplex
receptacle installed
on exterior deck of
unit in tower.

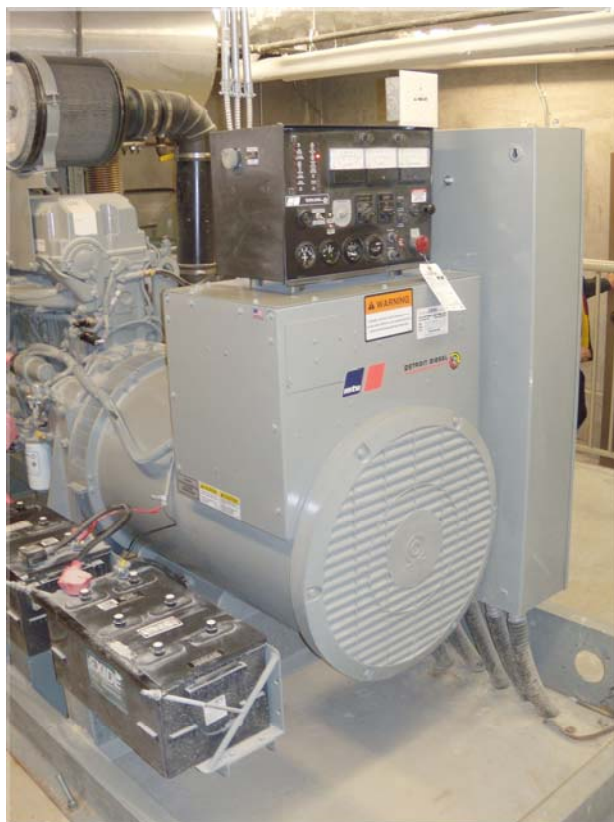
PHOTO E-8

Emergency diesel-
fired generator
located at grade level
in generator room.

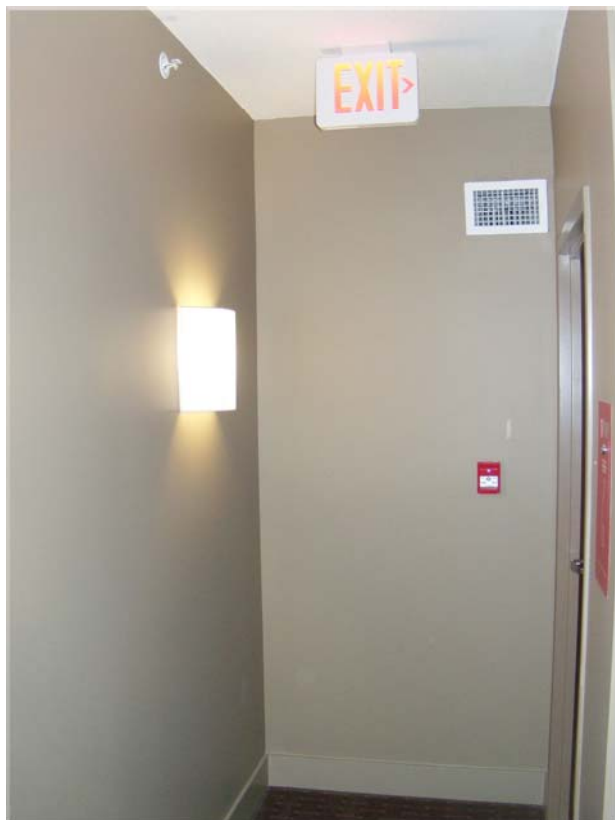
PHOTO E-10

Typical tower floor
exit c/w exit signage,
pull station and
firephone.

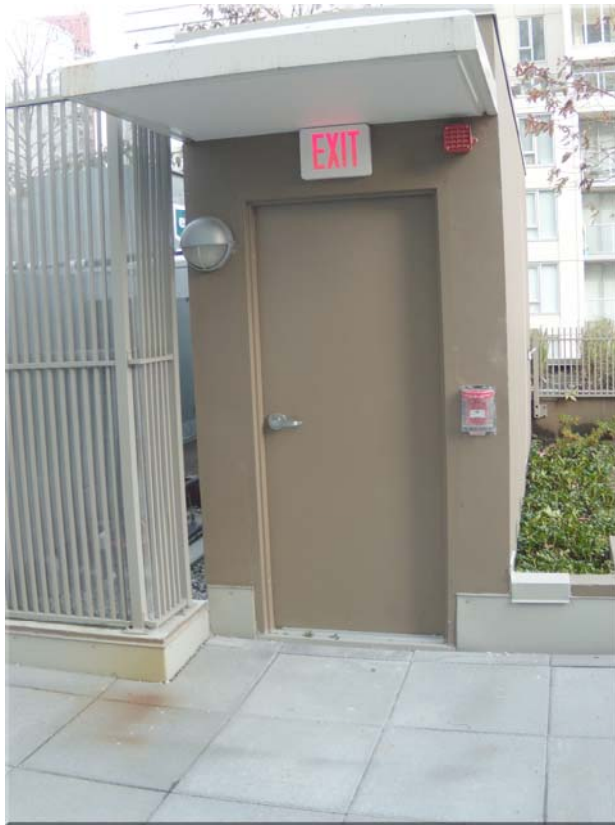
PHOTO E-11

Exit stair from typical
roof top deck.
Weatherproof
pullstation and damp
location rated exit
sign.

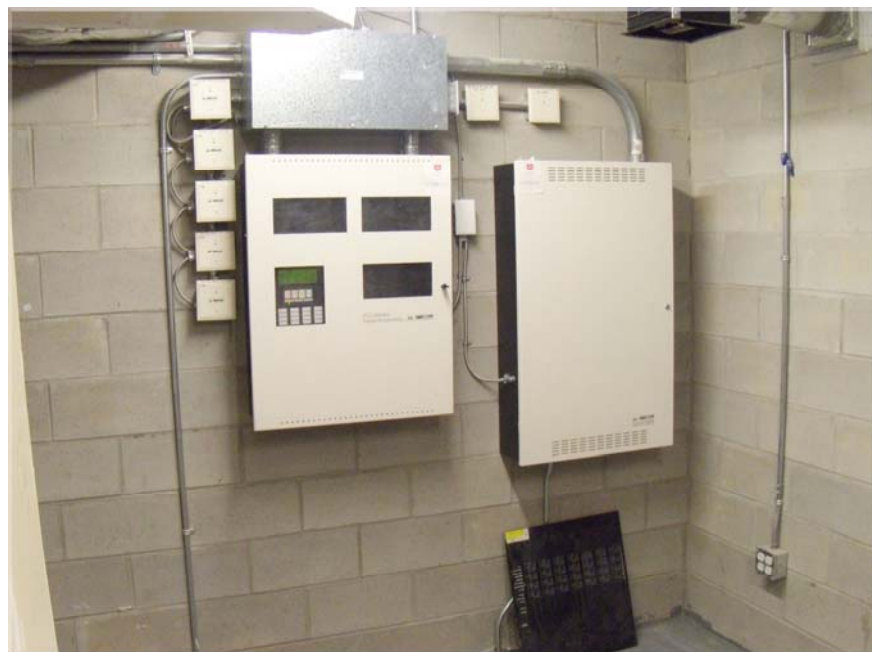
PHOTO E-12

Firealarm control
panel located on 'P1'
parking level.

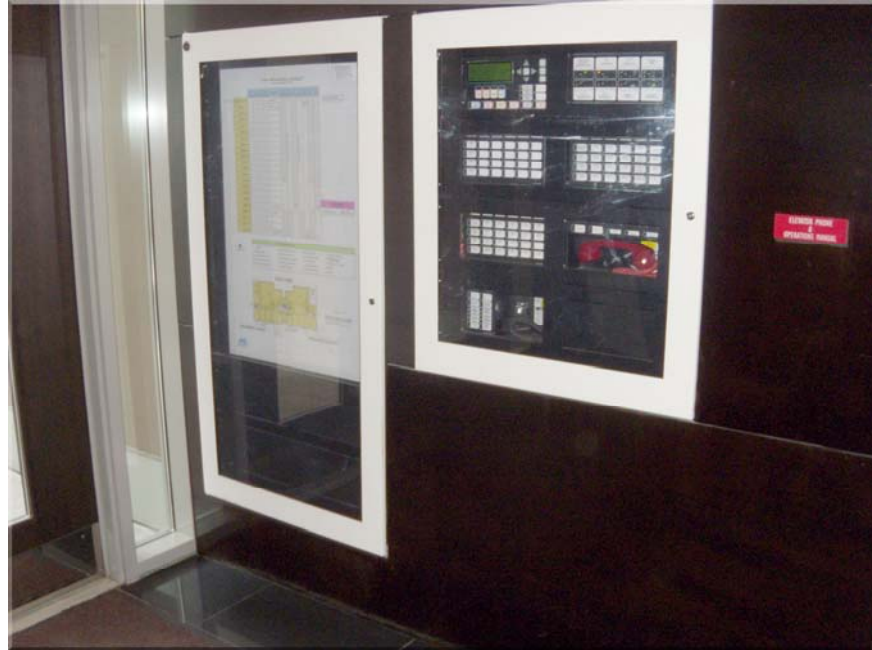
PHOTO E-13

Remote fire alarm
annunciators located
within the main
entrance lobby of
building.

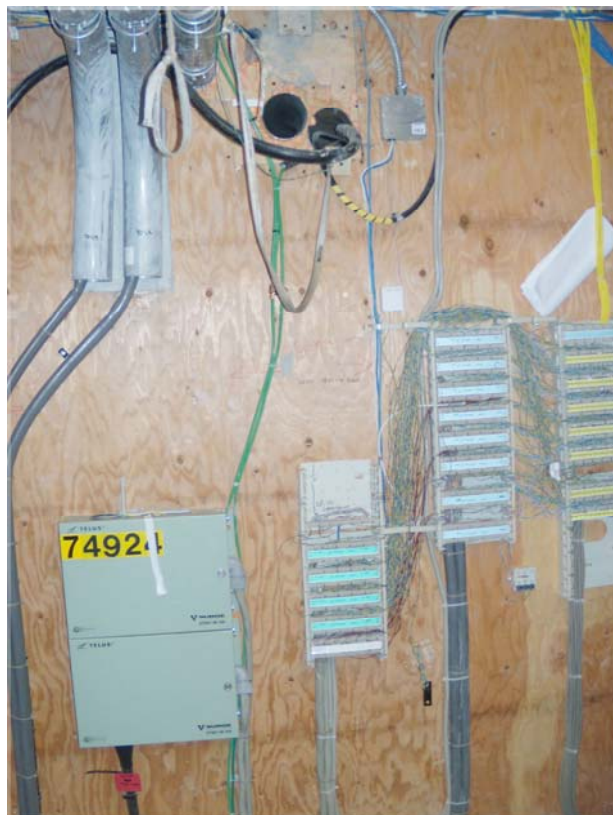
PHOTO E-14

Incoming telephone
and fibre optic
service into main
telephone room.

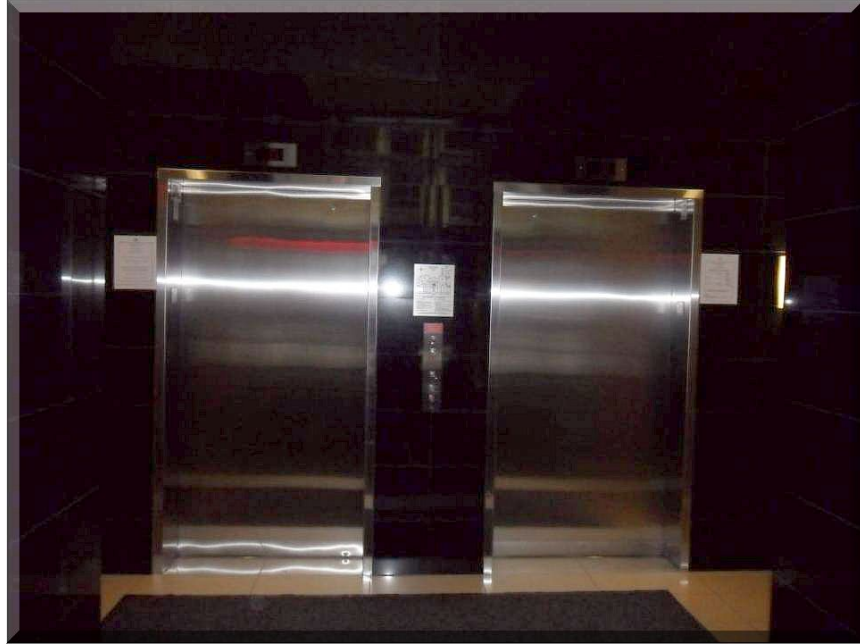
PHOTO ELEV-1

Main floor elevator lobby.

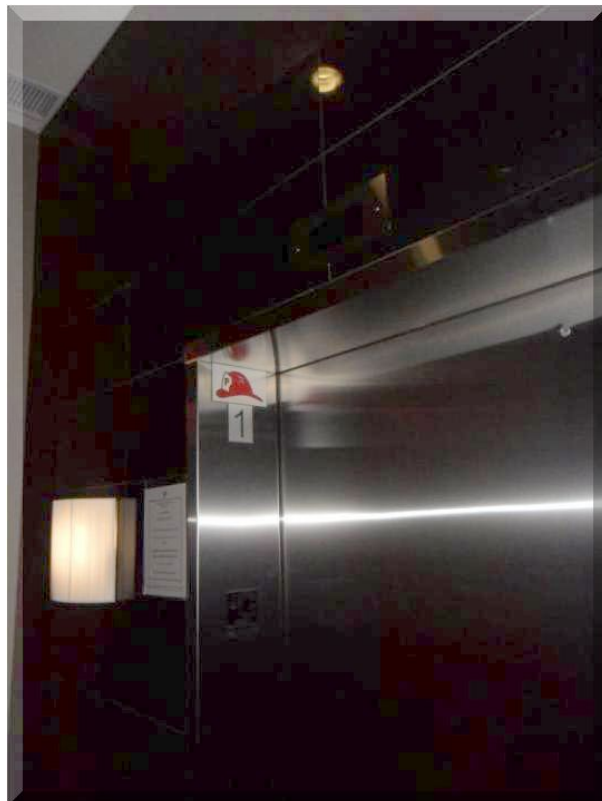
PHOTO ELEV-2

Designated fire fighter elevator signage.

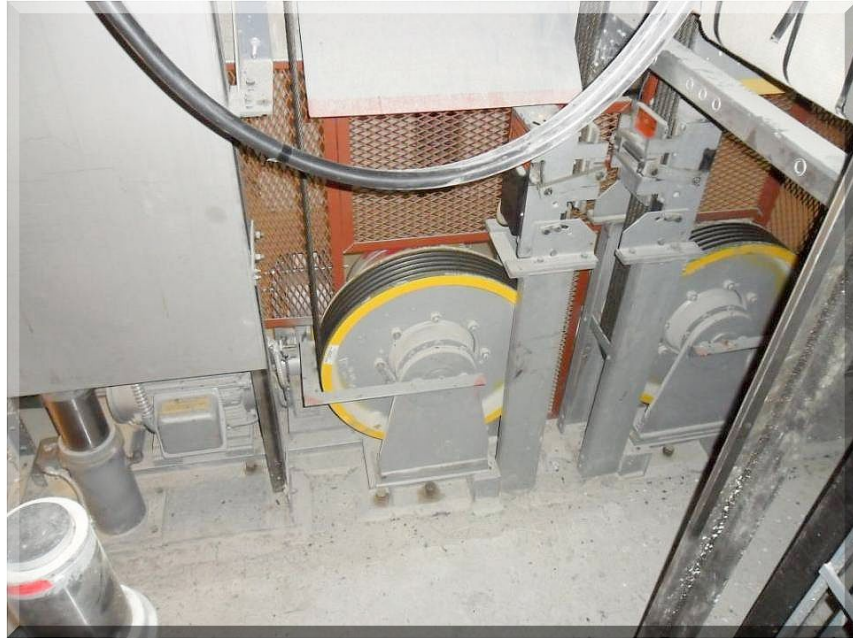
PHOTO ELEV-3

Basement machine
and rope brake
viewed from pit.

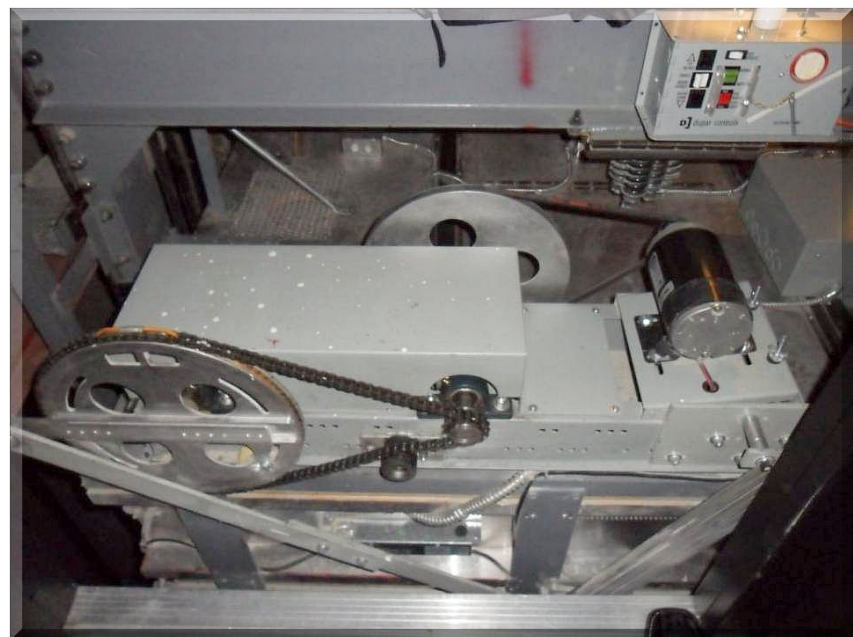
PHOTO ELEV-4

ECI 1010 door
operator.

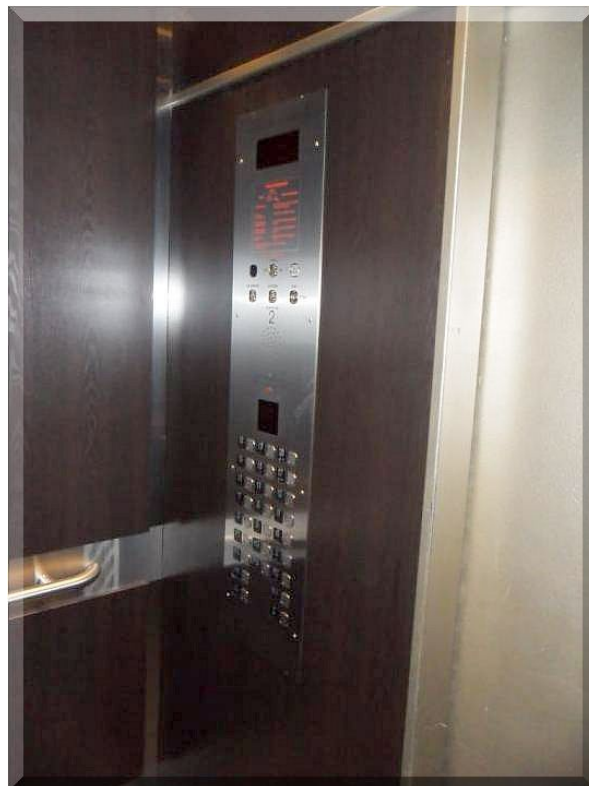
PHOTO ELEV-6

Car operating panel.

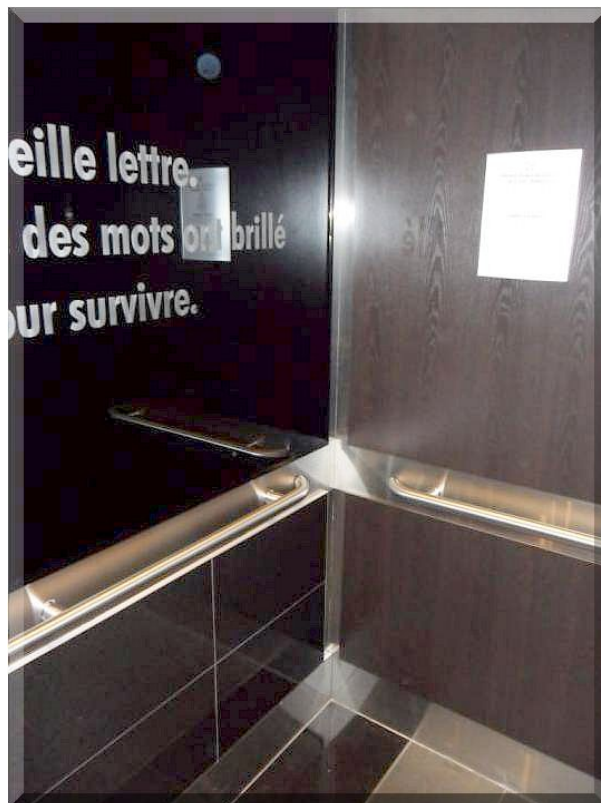
PHOTO ELEV-8

Cab finishes.

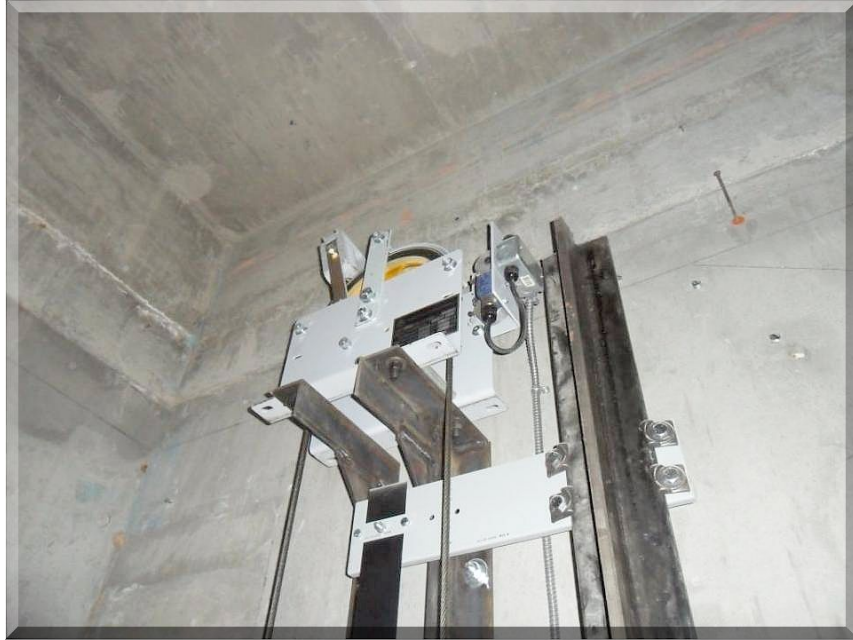
PHOTO ELEV-9

Overspeed governor.

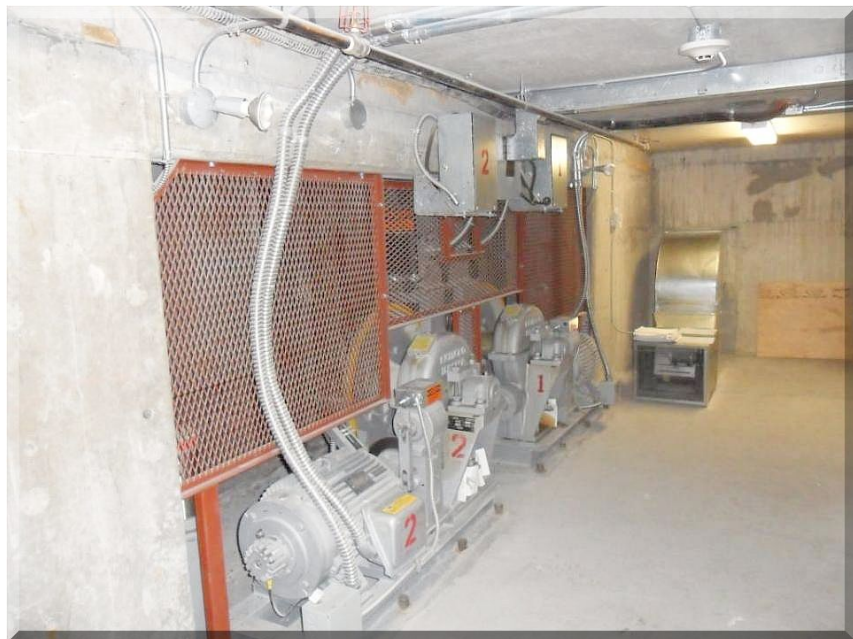
PHOTO ELEV-10

Basement machine room.

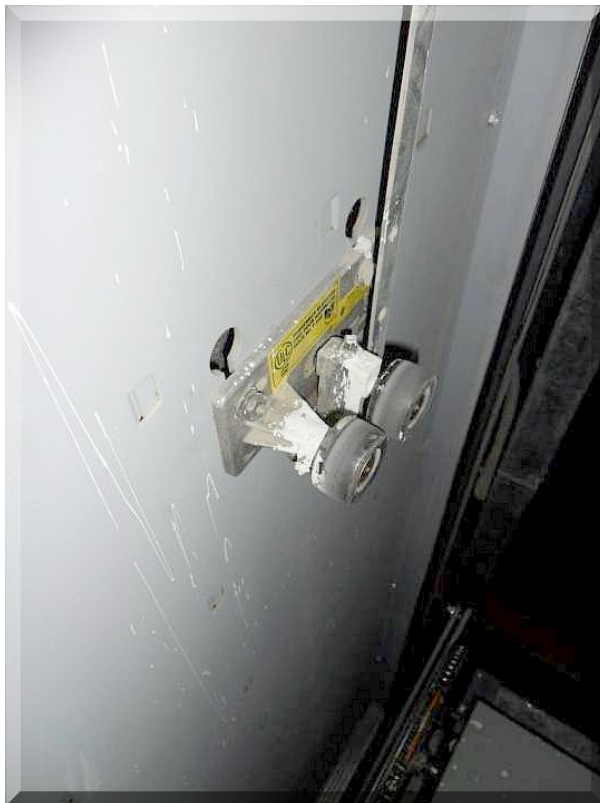
PHOTO ELEV-14

Paint on elevator #2
18th floor door lock
pickup assembly.

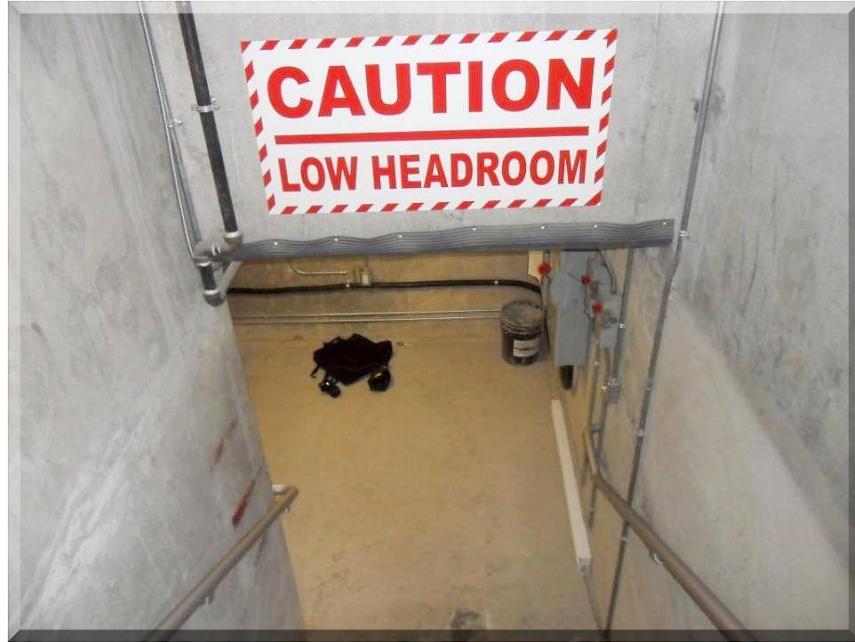
PHOTO ELEV-15

Low head room
warning sign at
elevator machine
room.
