THE DONOVAN
1055 RICHARDS STREET
VANCOUVER, BC
PROPERTY CONDITION
ASSESSMENT
FEBRUARY 25, 2011

OMICRON PROJECT NO. 10-10-221

**Re: Property Condition Assessment
1055 Richards Street, Vancouver BC**

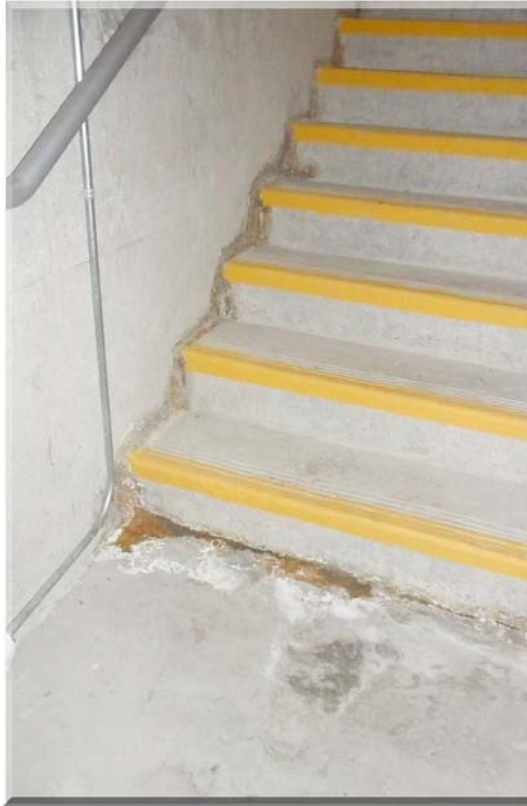
PHOTO ELEV-17

Seepage at base of stairs in elevator machine room.
