XTR Building Services Ltd

“Exterior building envelope review & maintenance”

C/O Vancouver Condominium Services The Savoy- 928 Richard Street, Vancouver B.C

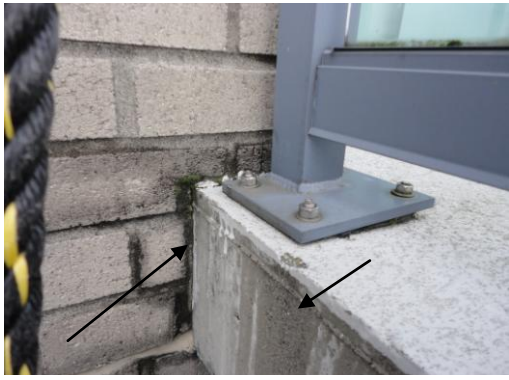
<p>32nd floor PH: Sealant missing at balcony saddle to prevent water running down the inside corner and damaging the brick mortar. Balcony membrane was not carried over the face of the balcony edge typical along the run. Sealant missing at railing mounts typical on this run.</p>
<ul style="list-style-type: none"> •

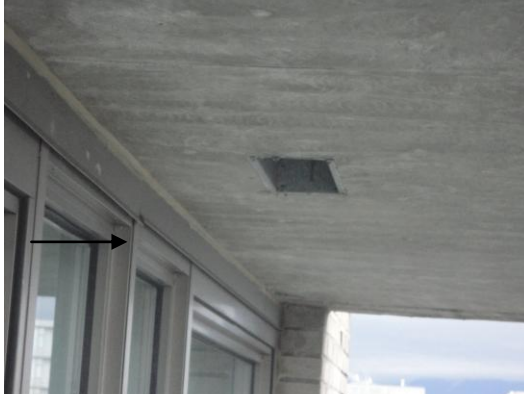
<p>31st floor: Vent cover is missing.</p>
<ul style="list-style-type: none"> •

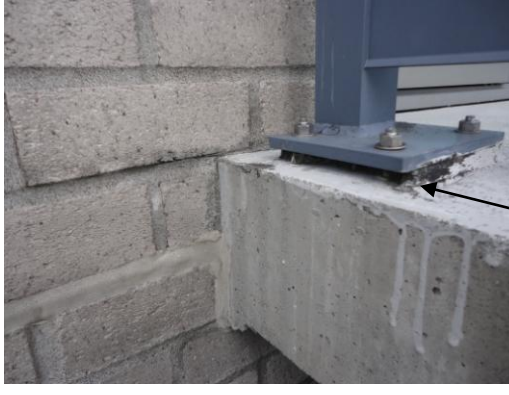
<p>31st floor: Missing sealant at railing mounts and saddle connection. Membrane missing at balcony face.</p>

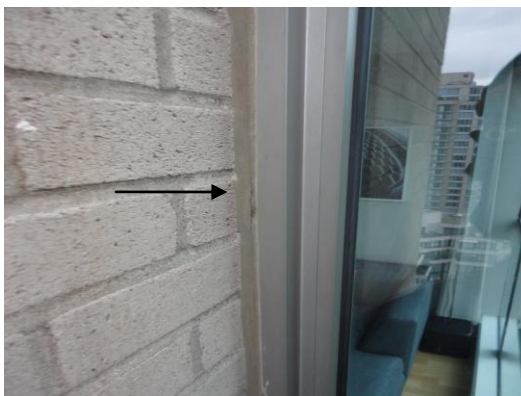
<p>18th floor: Sealant failure at window jamb typical to this run.</p>

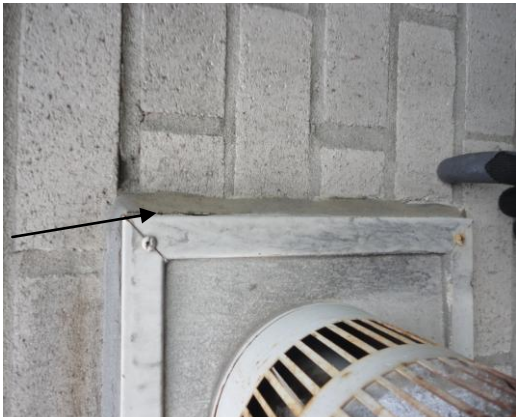
<p>5th floor: Sealant failure at fireplace vent typical along this run. Crack in brick.</p>
<ul style="list-style-type: none">•

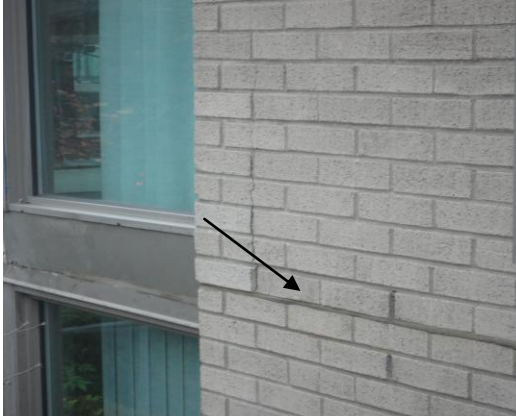
<p>3rd floor: Crack in brick and window gasket out of place.</p>
<ul style="list-style-type: none">•

>Crack repairs in brick veneer

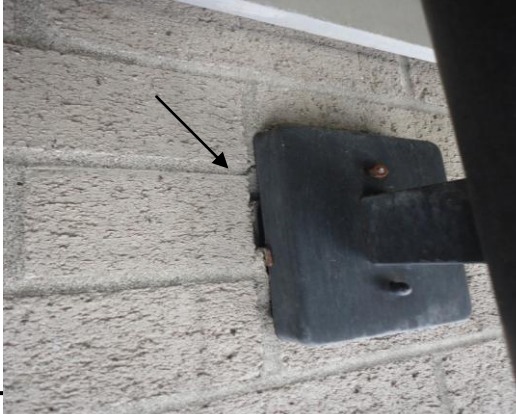
<p>P1: Back Alley Sealant missing at 3 sides of light fixture.</p>

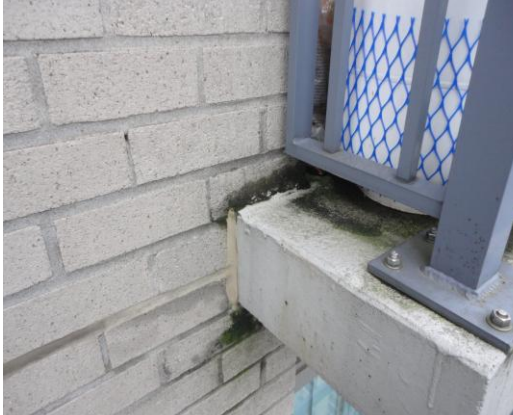
<p>29th Floor:</p> <p>Missing sealant at upper brick to deck transition. Waterproofing has been applied over the face of balcony slab. Sealant is missing at railing bases. Balcony membrane is very dirty.</p>
<ul style="list-style-type: none"> •

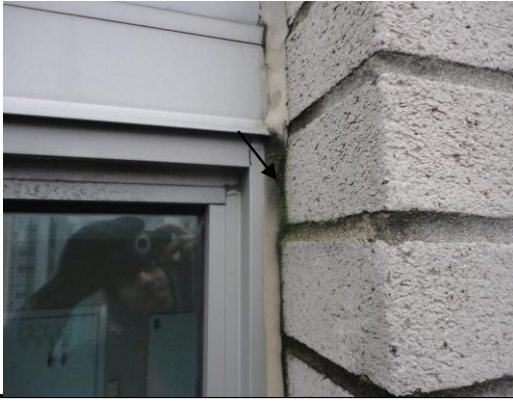
<p>28th floor:</p> <p>Sealant failure at window jamb. Organic growth on the brick and sealant (will cause premature failure of sealants).</p>

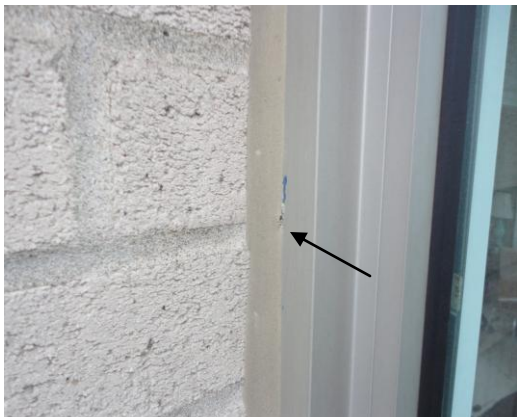
22 nd floor: Failed sealat at window jamb typical
•

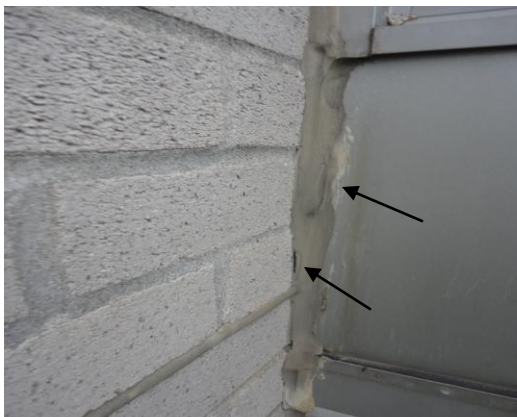
22 nd and 21 st floor: Sealant failure at metal panel between floors.
•

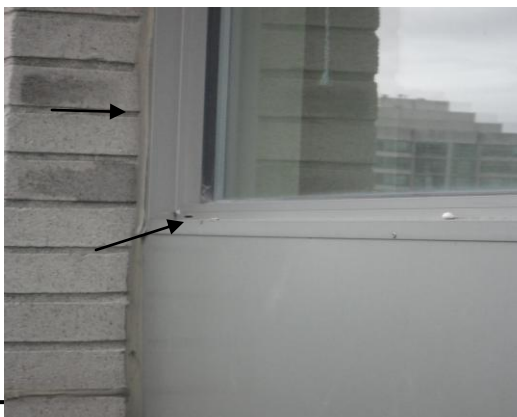
20 th floor: Sealant failure at sill and jamb.

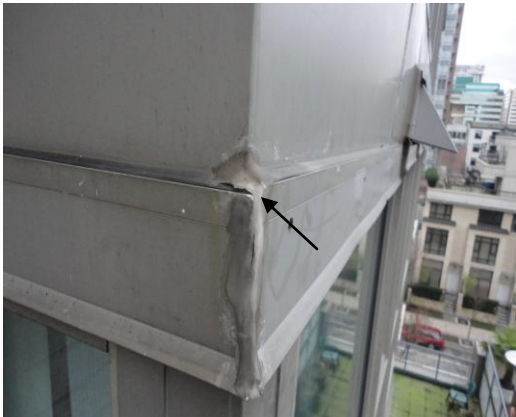
<p>6th floor: Failed sealant at outside corner of the window frame.</p>
<ul style="list-style-type: none">•

>Window wall outside corners where sealant has failed and rubber seals are short.

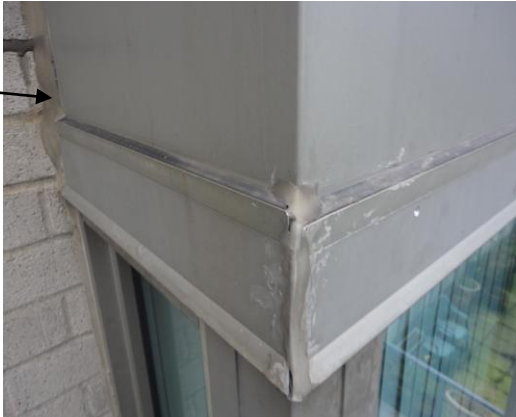
<p>5th floor: Failed sealant at metal panel.</p>
<ul style="list-style-type: none">•

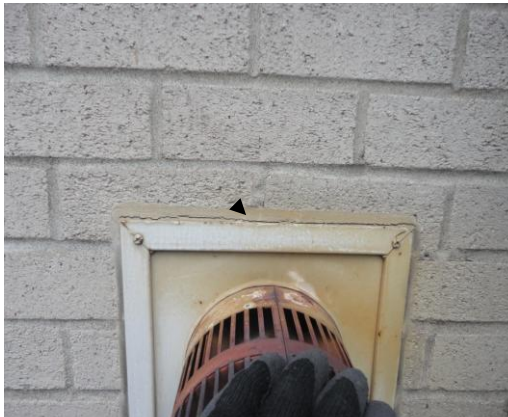
<p>3rd floor: Sealant failure at fireplace vent.</p>
<ul style="list-style-type: none">•

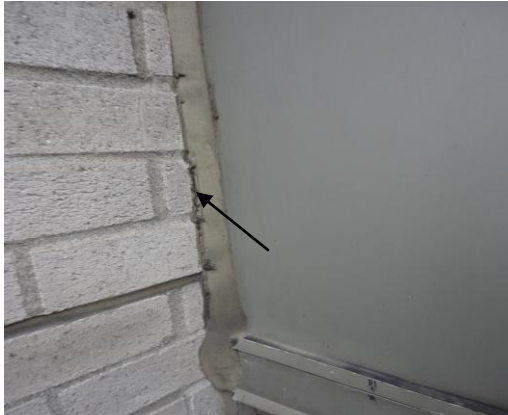
<p>3rd floor: sealant failure at metal panel</p>
<ul style="list-style-type: none">•

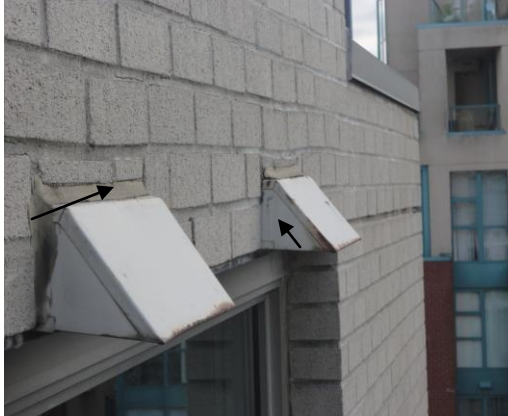
<p>North Elevation drop #3: 30th floor: Missing and failed sealant at vent</p>
<ul style="list-style-type: none">•

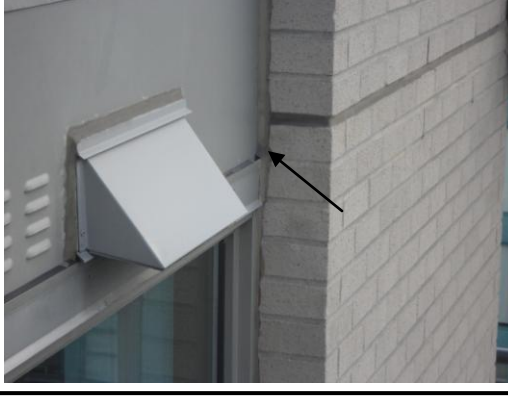
<p>30th floor: Failed sealant at panel</p>

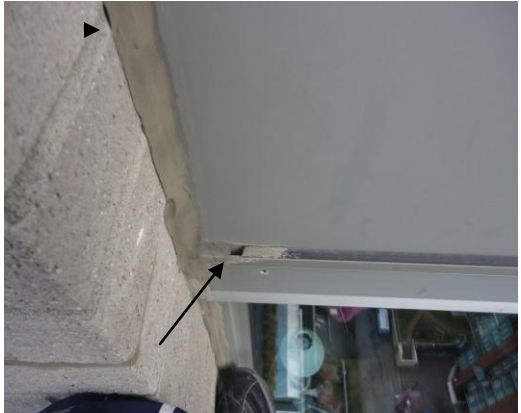
<p>27th floor: Failed sealant at metal panel typical along this run and failed gasket repairs by others.</p>
•

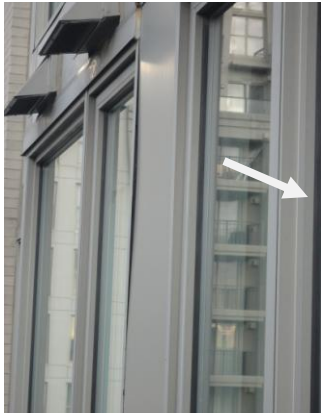
<p>27th floor: Missing sealant at vertical joint all floors.</p>
•

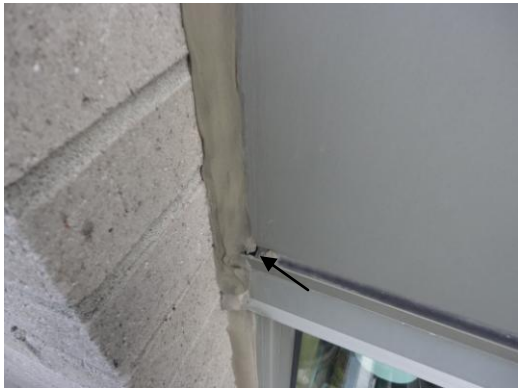
<p>26th floor: Sealant missing at metal panel. Typical along entire run.</p>

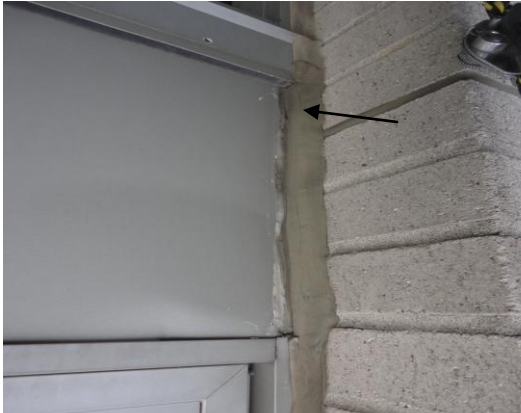
23 rd floor: Sealant failure at panel and panel dented.
•

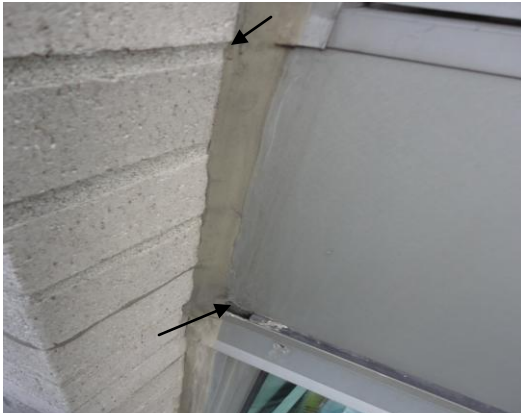
21 st floor: Failed sealat at panel and gasket repair needed.
•

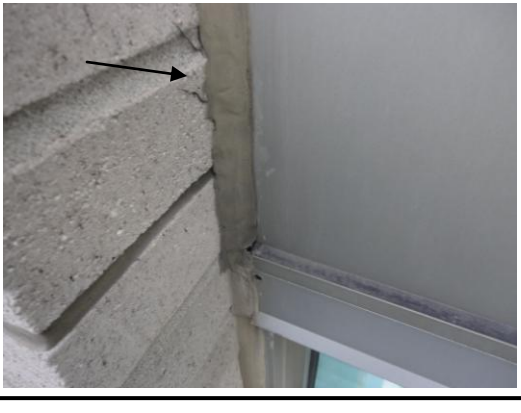
20 th floor: Failed sealant at jamb and brick cracked.

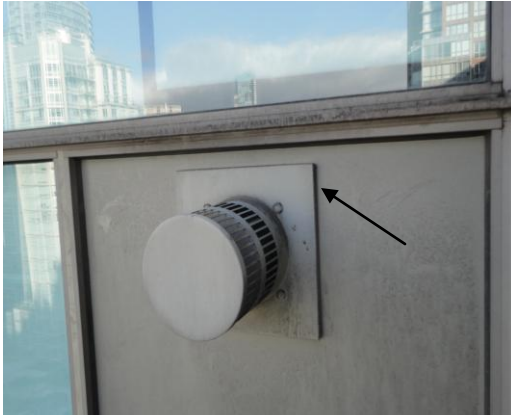
<p>26th floor: Vents missing sealant.</p>
•

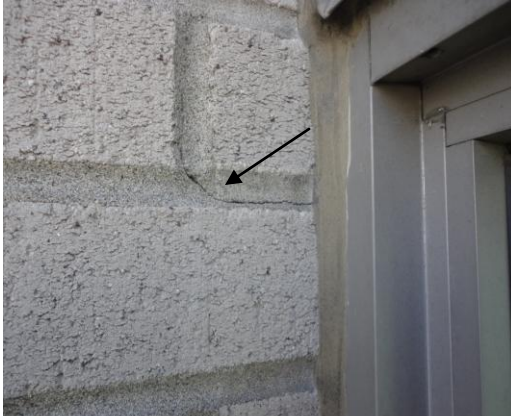
<p>24th floor: Crack on brick</p>
•

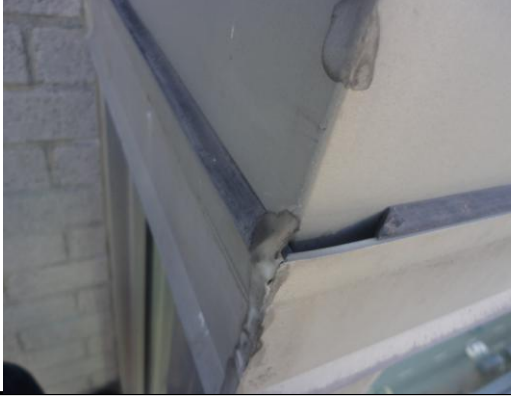
<p>22nd Floor: Failed sealant at panel typical along this run and short rubber gasket.</p>
