## **APPENDIX A - PHOTOGRAPHS**

**Appendix A - 1188 Richards Street Photos**

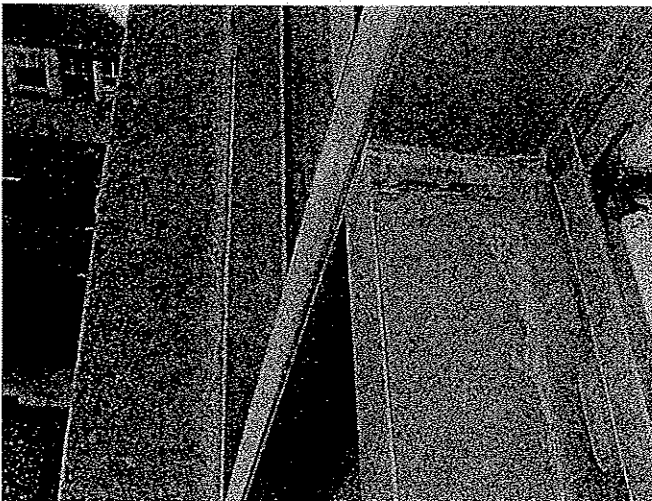
111 1608 window and pre-cast sill

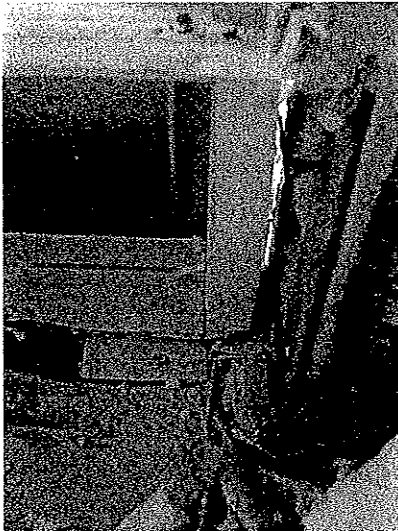
115 1608 showing path to exterior with interior

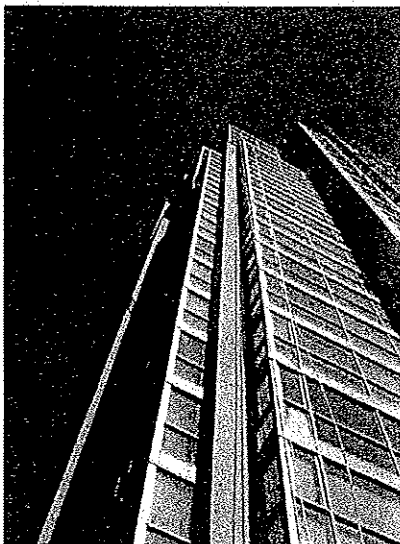
301 Exterior view of 1608 at south east corner

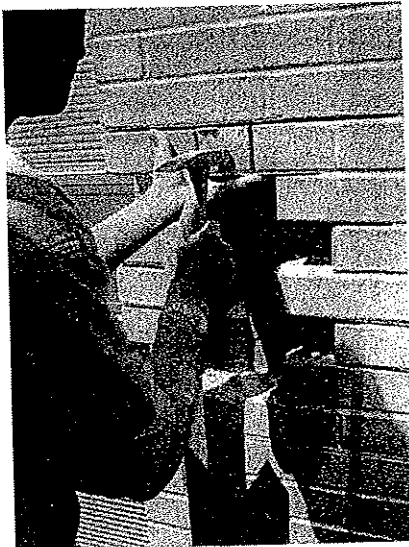
502 1608 Brick removals

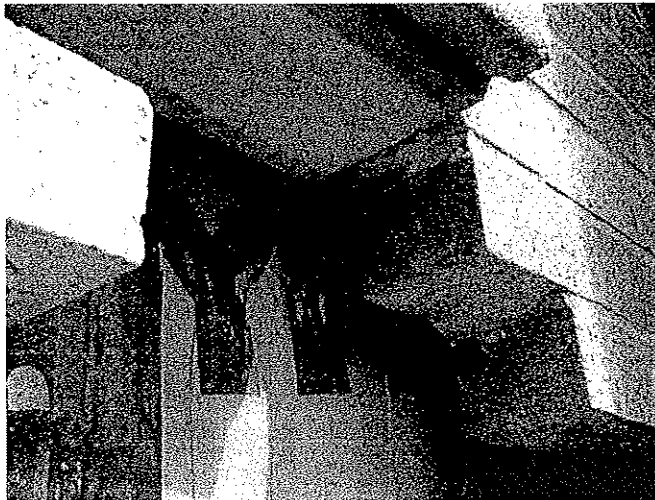
803 Pre cast concrete window sill

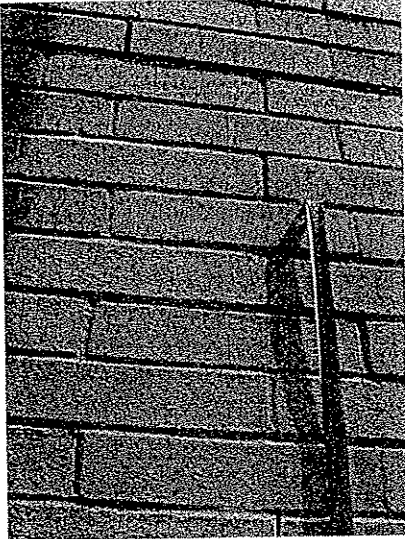
814 Upper tie located in third brick course

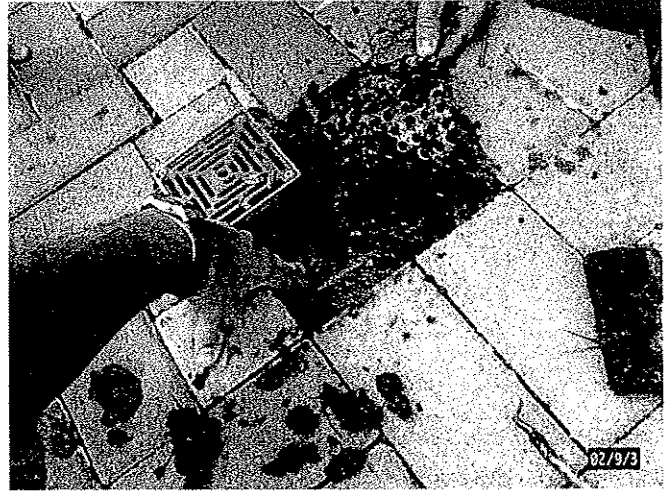
932 Hot rubberized membrane and sheet membrane
