# Depreciation Report

BCS3495 – Grand Central

**RE: Depreciation Report for Strata Plan BCS3495  
File No. B3495DR17**

The subject of this depreciation report consists of “Grand Central” – Strata Corporation Section, a 642-unit apartment and commercial complex constructed in 2009/2012/2014 and located at 2968 – 2978 Glen Drive and 2975 Atlantic Avenue in Coquitlam, BC. We are pleased to present you with the enclosed depreciation report, which we believe will serve as the basis of your reserve planning to help better equip your members for future expenditures.

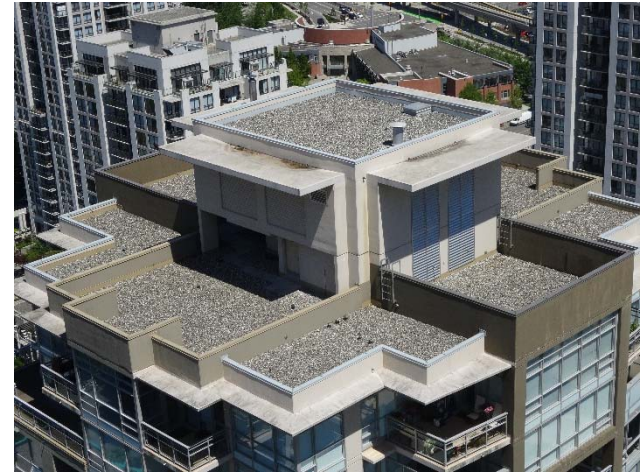
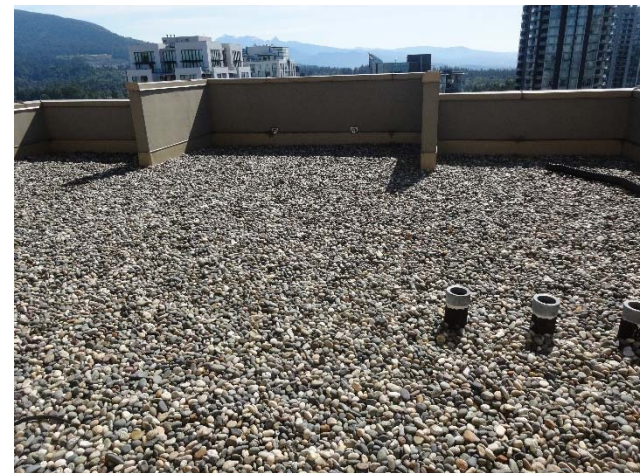
Inverted roof

Phase 2	\$ 85,928	2042	Full replacement.		
Phase 3	\$ 133,193	2044	Full replacement.		
<b>Preventative Maintenance</b>	Some quantities of water may be trapped between insulation and waterproofing layer. Slopes should be constructed with most care, of at least 2%. Plants can block the flow of water off the roof. Identify any exposed areas of the roof, any bare spots are unprotected and can lead to rapid deterioration.				
<b>Remarks</b>	None.

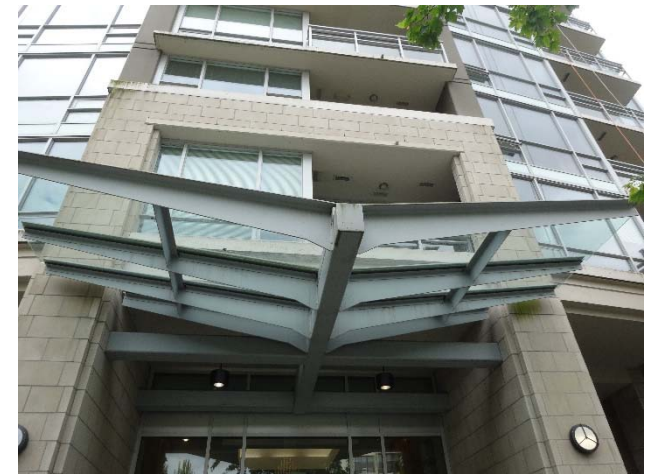
Main entrance canopy

<b>Phase 2</b>	\$ 3,000	2018	Contingency every 7 years.		
<b>Phase 3</b>	\$ 3,000	2018	Contingency every 7 years.		
<b>Preventative Maintenance</b>	Inspect every 2 years. Repair as needed. Repaint every 6-8 years.				
<b>Remarks</b>	None.

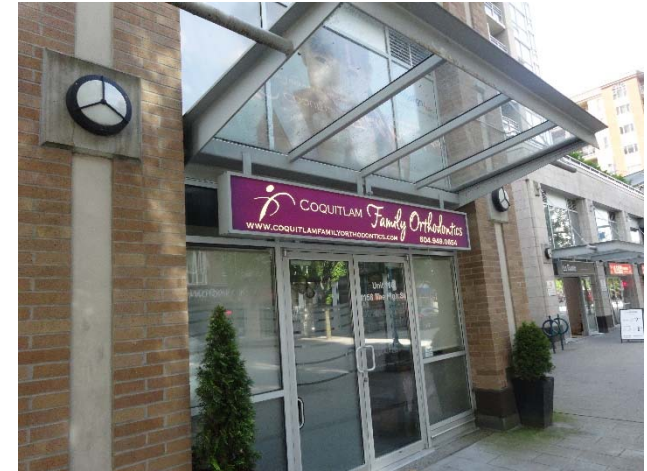
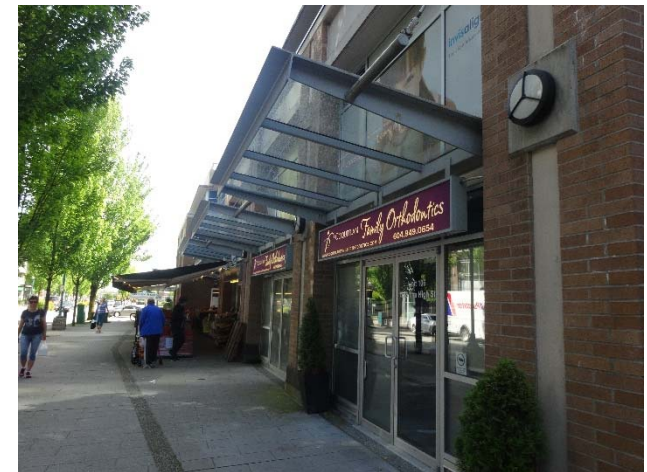
Brick veneer

Phase 2	\$ 7,000	2040	Contingency every 7 years.		
Phase 3	\$ 2,000	2043	Contingency every 7 years.		
<b>Preventative Maintenance</b>	Clean surfaces with water or cleaning solutions, every 5 years (use non-pressurized water). Review masonry for cracking, spalling, and loose units and repair as needed. Mortar joints may be repaired by re-pointing or "tuck pointing" (typically, every 15 years).				
<b>Remarks</b>	None.

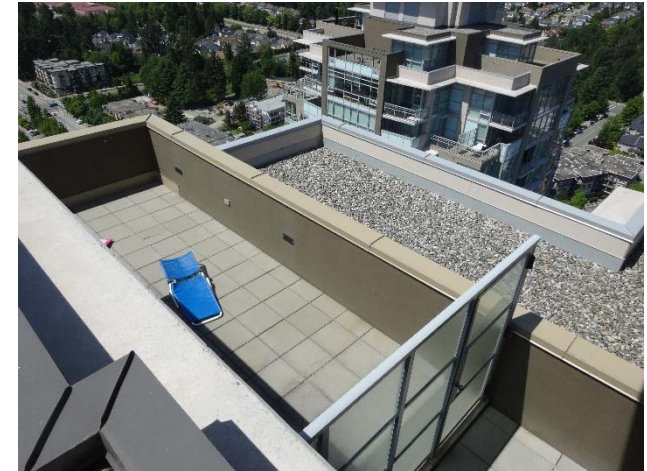
Terrace flooring

Phase 2	\$ 7,000	2030	Contingency every 7 years.		
Phase 3	\$ 7,000	2033	Contingency every 7 years.		
<b>Preventative Maintenance</b>	Periodic review. Repair/replace the damaged pavers. Check drainage devices regularly for obstructions, remove accumulated debris and reset missing strainers. Review flashings and caulk seals for damage and deterioration, loss of adhesion, and gaps in terminations.				
<b>Remarks</b>	None.

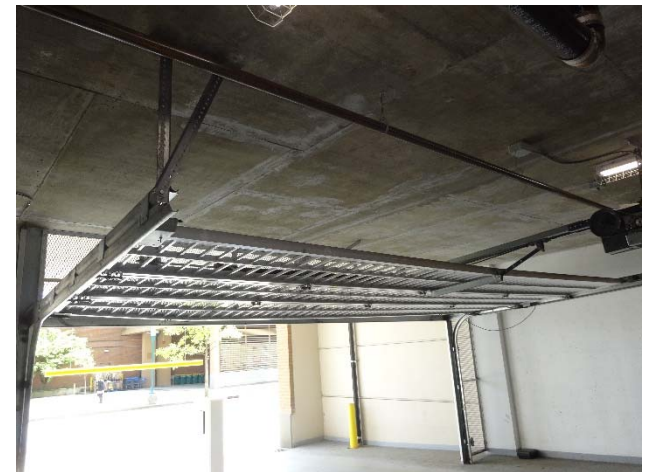
Garage door, motor and traction system

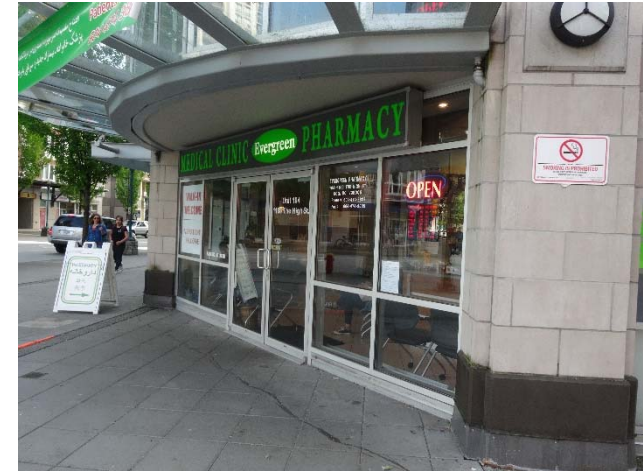
Main entrance door at commercial unit

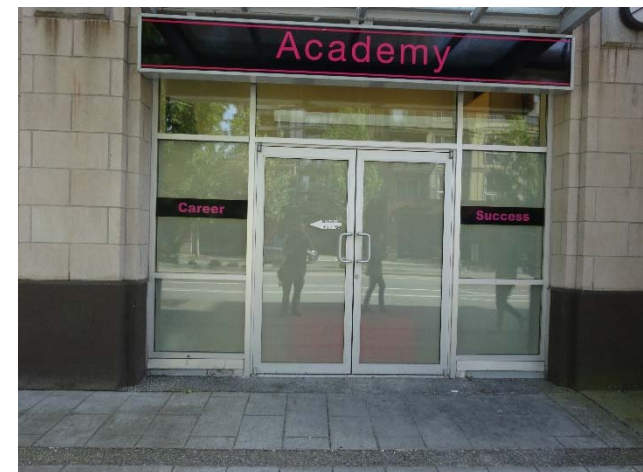
Main entrance door at commercial unit

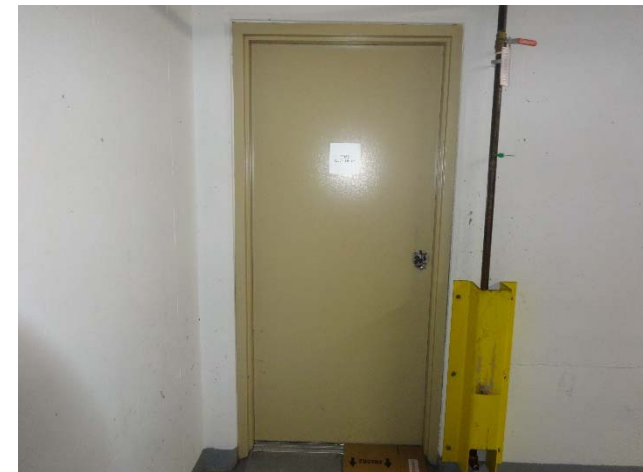
Service door

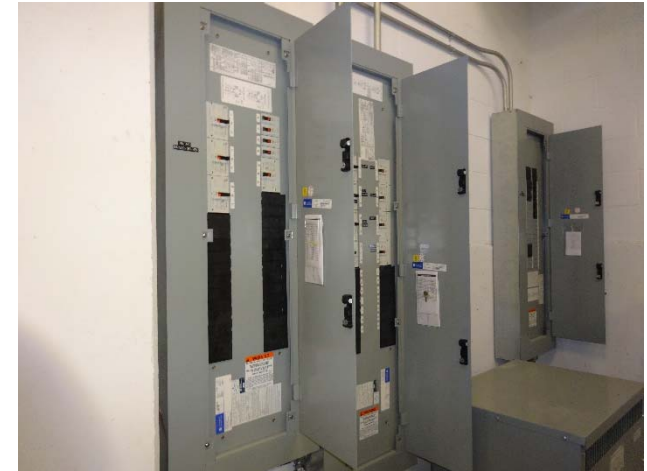
Distribution panels

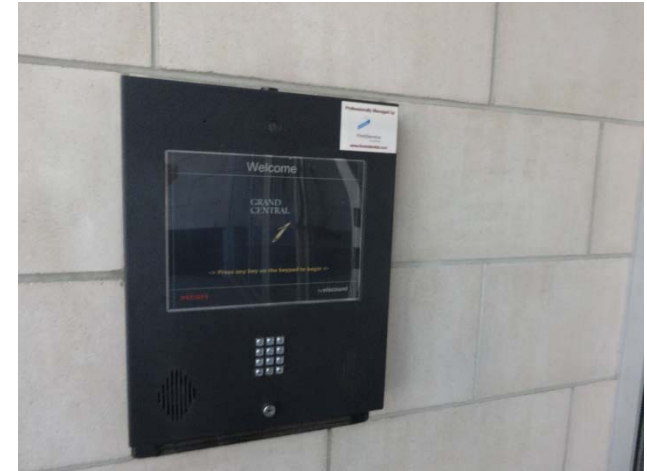
Intercom panel

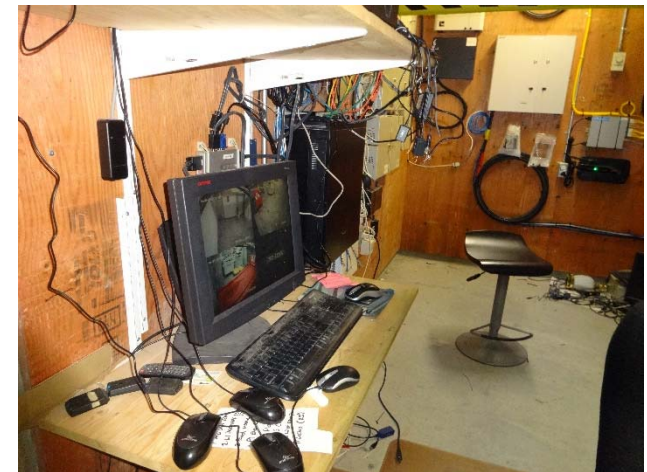
Video and security system

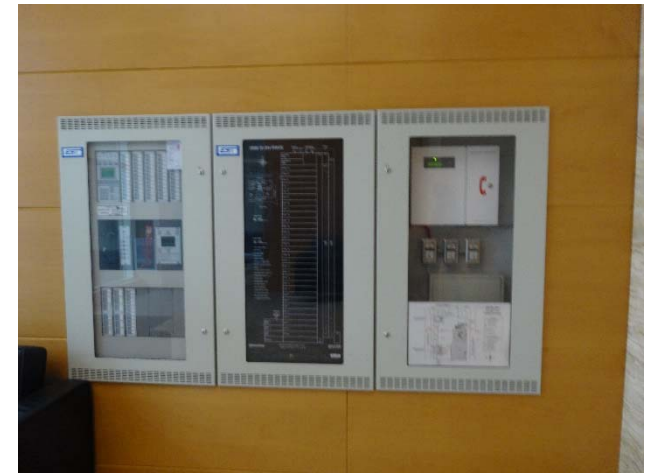
Annunciator panels

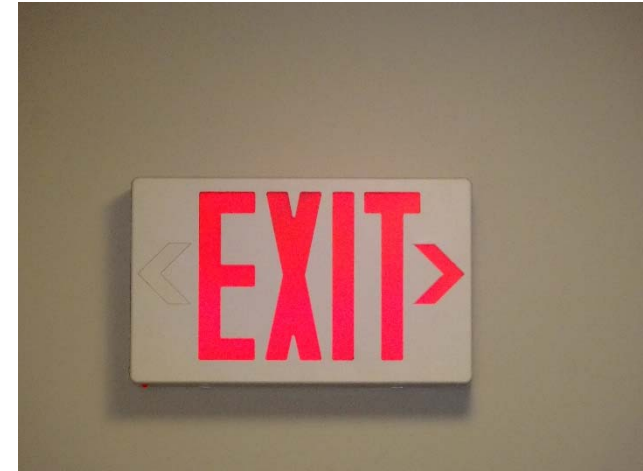
Exit sign

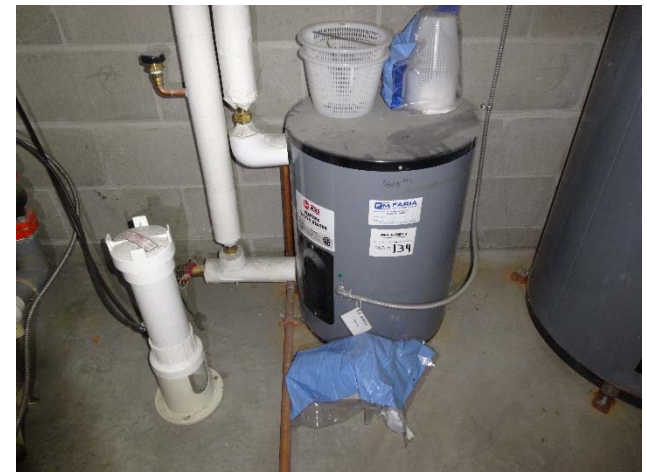
Electric water heater

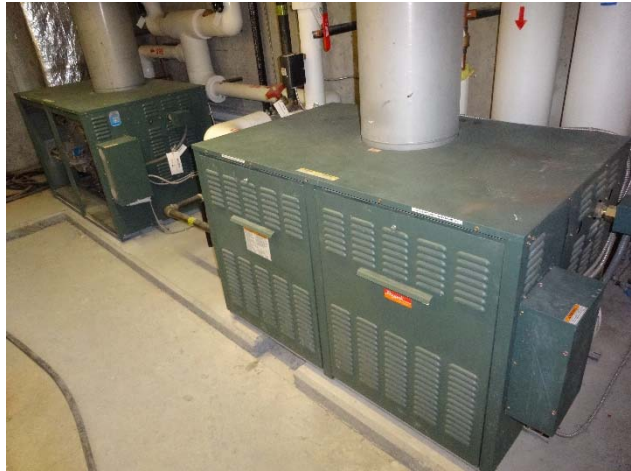
Boilers

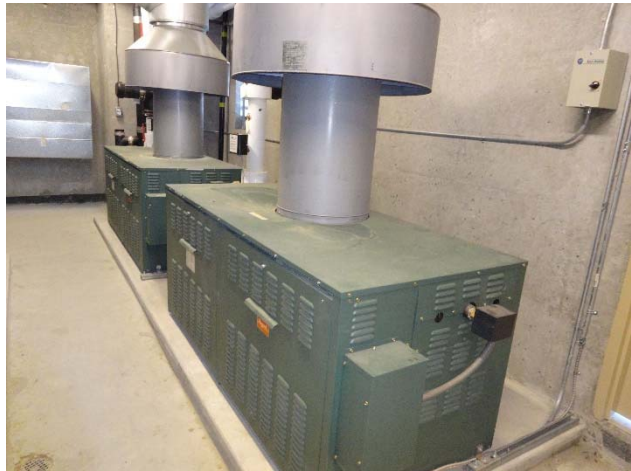
Boilers

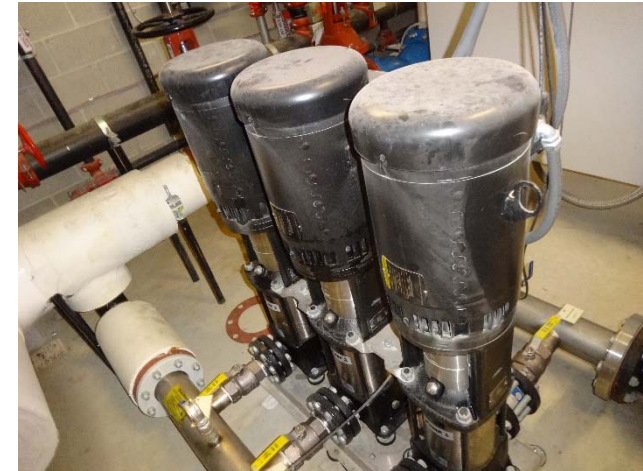
Booster pumps

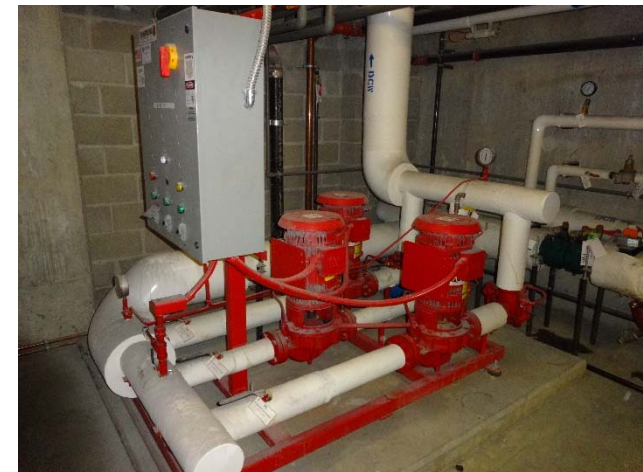
Booster pumps

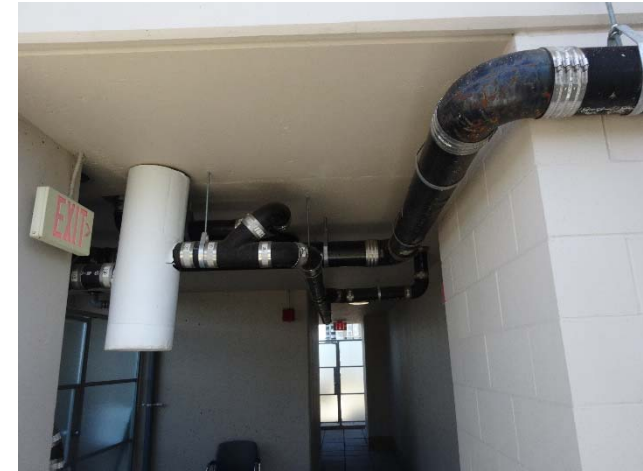
Sanitary pipes

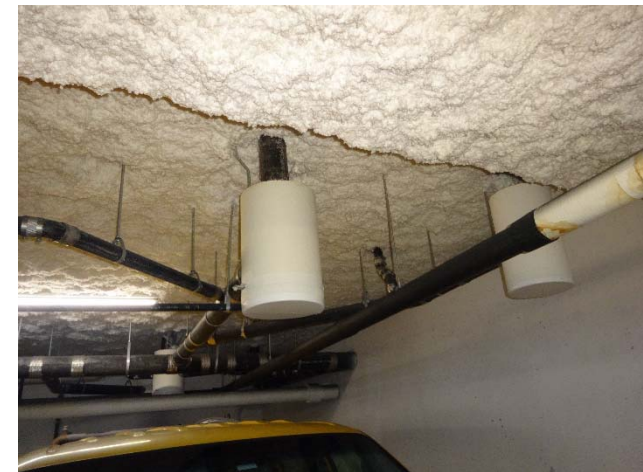
Sanitary pipes

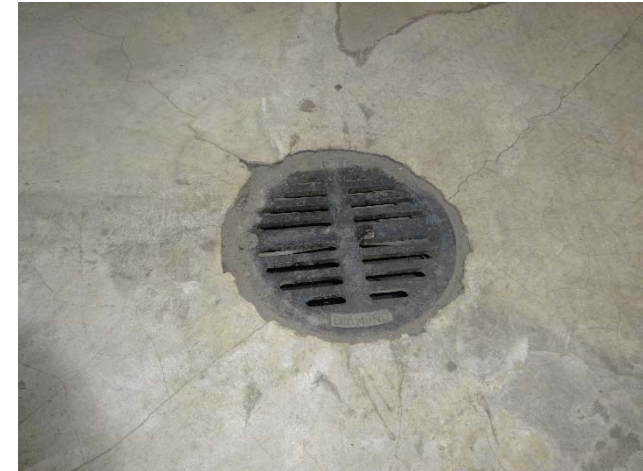
Catch basin

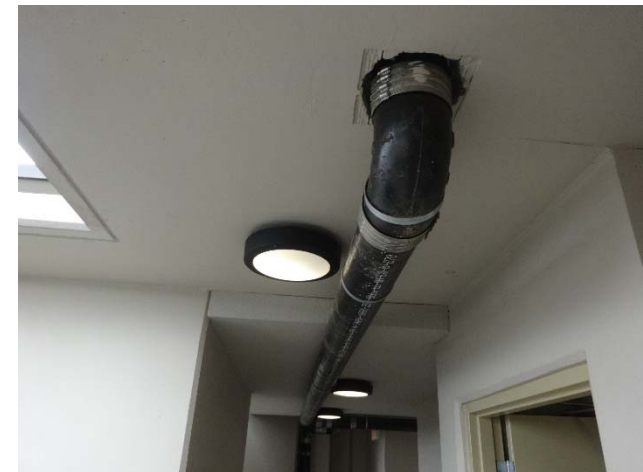
Drainage pipe

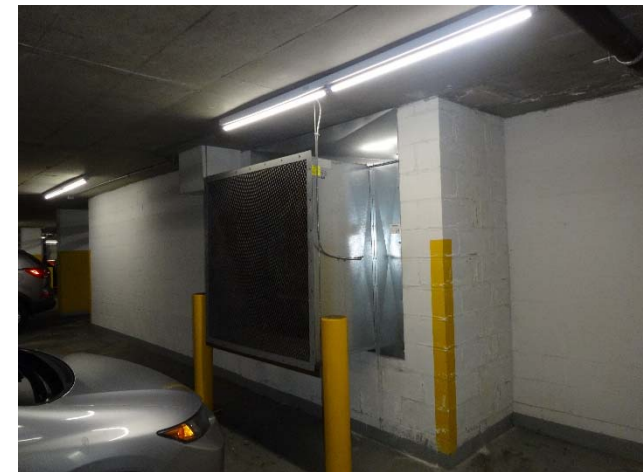
Exhaust fan in parkade

<b>Phase 3</b>	\$ 20,000	2037	Full replacement.		
<b>Preventative Maintenance</b>	Annual maintenance may include: checking blades for dust buildup and clean if necessary, checking fan RPM to design specifications, checking belt tension, wear and alignment, bearing collar set screws to make sure that they are tight, lubricate fan bearings and motor. Measure motor amperage using a C clamp amprobe. Increased current flow may indicate that bearings are seizing.				
<b>Remarks</b>	None.

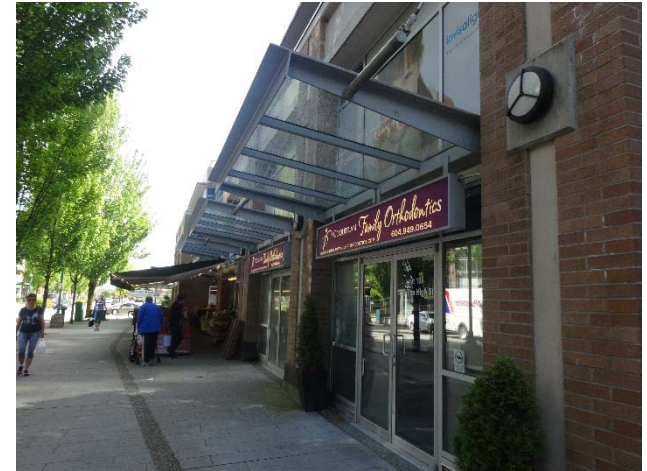
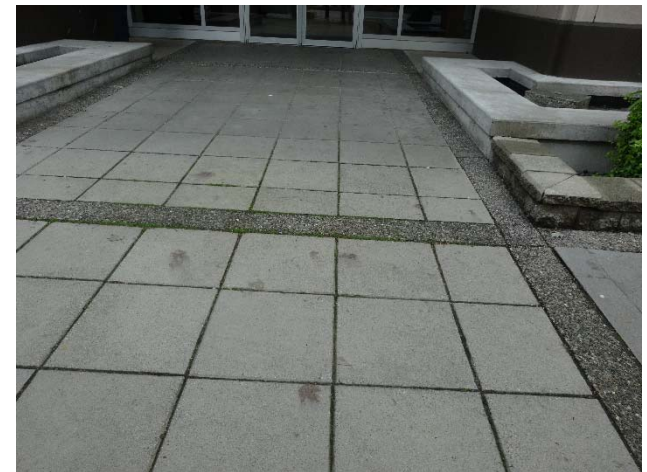
Concrete unit pavers on pedestrian plaza around buildings

<b>Phase 3</b>	\$ 25,000	2030	Contingency every 7 years.		
<b>Preventative Maintenance</b>	Inspect every two years, repair as needed.				
<b>Remarks</b>	None.

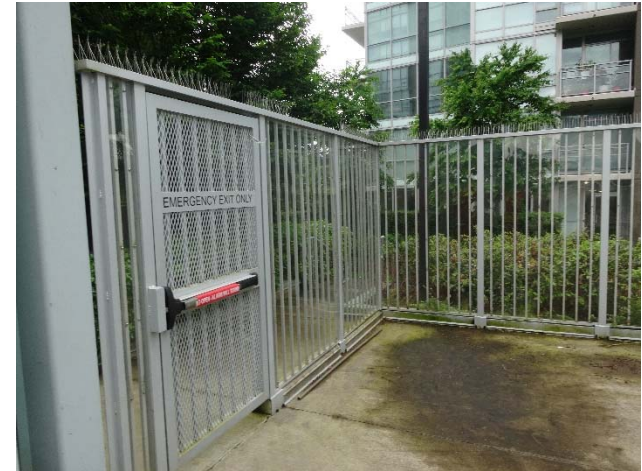
Metal fence with gate

<b>Reserve Component</b> G20400101	<b>Fencing</b>				
<b>Properties</b>	Metal fence with gates				
<b>Potential Deterioration</b>	Settlement and mechanical impacts may lead to leaning, broken posts, or detachment..				
<b>Condition Analysis</b>	<b>Deterioration</b>	None apparent.			
	<b>Repair History</b>	Not available.			
	<b>Overall Condition</b>	Good.			
<b>Life Cycle Analysis</b>	<b>DOI</b>	<b>CA</b>	<b>EUL</b>	<b>EA</b>	<b>RUL</b>
<b>Phase 1</b>	2009	8 years	50 years	8 years	42 years
<b>Phase 2</b>	2012	5 years	50 years	5 years	45 years
<b>Phase 3</b>	2014	3 years	50 years	3 years	47 years
<b>Cost Analysis</b>	<b>Current Cost</b>	<b>Starting Year</b>	<b>Funding Method</b>		
<b>Phase 1</b>	\$ 0				
<b>Phase 2</b>	\$ 0				
<b>Phase 3</b>	\$ 0				
<b>Preventative Maintenance</b>	Periodically inspect fasteners, gate locks, hinges. Check posts for stability, soil erosion, etc. Repair/replace as needed.

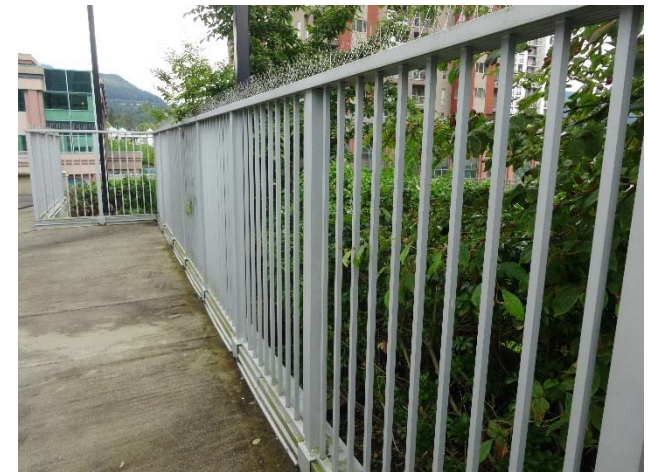
Metal fence

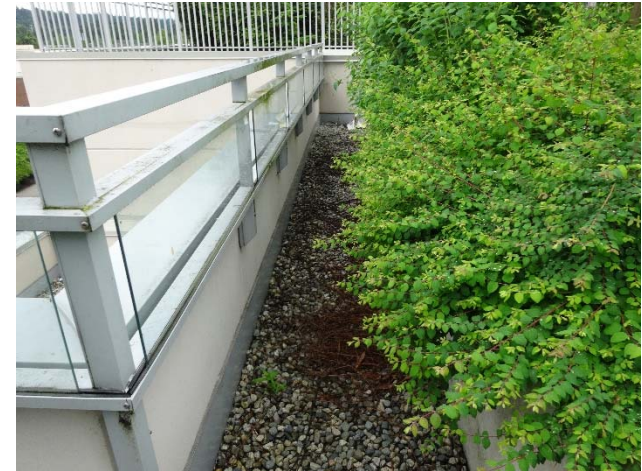
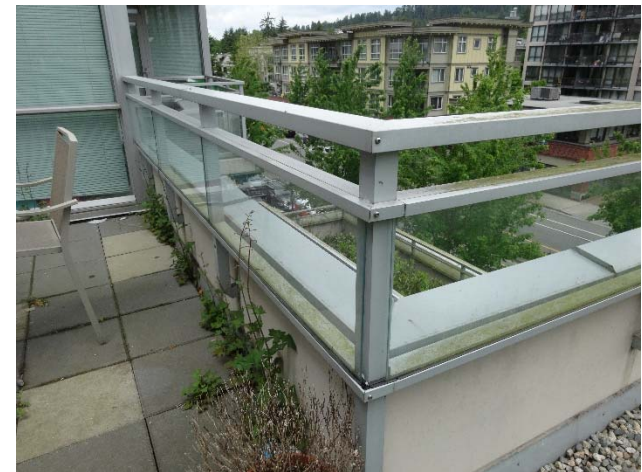
Exterior railings

<b>Reserve Component</b> G20400113	<b>Exterior railings</b>				
<b>Properties</b>	Prefinished aluminum with glass inserts				
<b>Potential Deterioration</b>	Fasteners on metal railings may become loose over time, leading to detachment.				
<b>Condition Analysis</b>	<b>Deterioration</b>	None apparent.			
	<b>Repair History</b>	Not available.			
	<b>Overall Condition</b>	Good.			
<b>Life Cycle Analysis</b>	<b>DOI</b>	<b>CA</b>	<b>EUL</b>	<b>EA</b>	<b>RUL</b>
<b>Phase 1</b>	2009	8 years	Building life	8 years	Building life
<b>Phase 2</b>	2012	5 years	Building life	5 years	Building life
<b>Phase 3</b>	2014	3 years	Building life	3 years	Building life
<b>Cost Analysis</b>	<b>Current Cost</b>	<b>Starting Year</b>	<b>Funding Method</b>		
<b>Phase 1</b>	\$ 3,000	2024	Contingency every 7 years.		
<b>Phase 2</b>	\$ 3,000	2027	Contingency every 7 years.		
<b>Phase 3</b>	\$ 3,000	2030	Contingency every 7 years.		
<b>Preventative Maintenance</b>	Periodically inspect fasteners. Check posts for stability, etc. Repair/replace as needed.

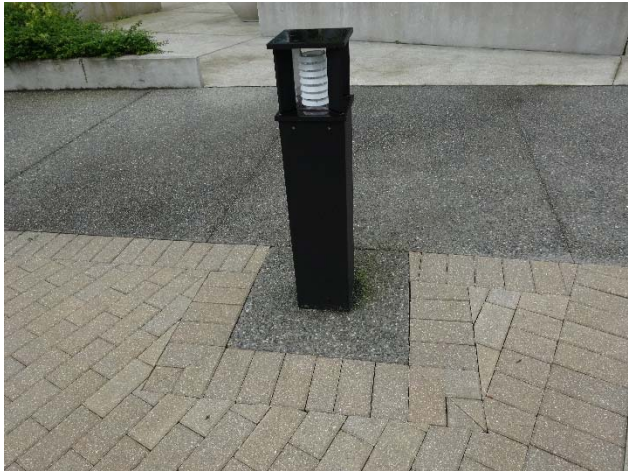
Post mounted light fixture

Reserve Component G40200101		Site lighting			
<b>Properties</b>	External lighting				
<b>Potential Deterioration</b>	Site lighting is generally replaced based on aesthetic and energy saving considerations and/or for better illumination of the areas served. Over time the corrosion may occur on the casing or discoloring and yellowing may occur on the lens.				
<b>Condition Analysis</b>	<b>Deterioration</b>	None apparent.			
	<b>Repair History</b>	Not available.			
<b>Overall Condition</b>		Good.			
Life Cycle Analysis	DOI	CA	EUL	EA	RUL
Phase 1	2009	8 years	Contingency	8 years	Contingency
Phase 2	2012	5 years	Contingency	5 years	Contingency
Phase 3	2014	3 years	Contingency	3 years	Contingency
Cost Analysis	Current Cost	Starting Year	Funding Method		
Phase 1	\$ 2,000	2024	Contingency every 7 years.		
Phase 2	\$ 2,000	2027	Contingency every 7 years.		
Phase 3	\$ 2,000	2030	Contingency every 7 years.		
<b>Preventative Maintenance</b>	Maintenance service should be performed annually and typically include: removing of old lamps and cleaning the fixtures, inspecting wiring, contacts, terminals and sockets, installation of new lamps, putting back into service and testing the operation.

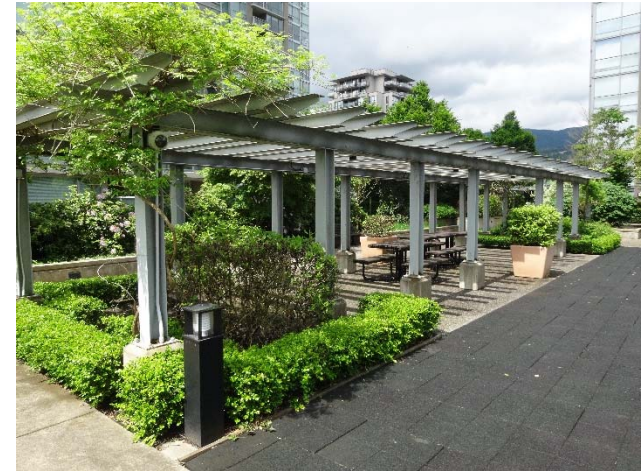
Landscaping

<b>Preventative Maintenance</b>	Plants will need regular pruning and maintenance. Mechanical equipment such as pumps and irrigation systems will need regular servicing.
<b>Remarks</b>	The budget for Lanscaping is split with Residential Section.

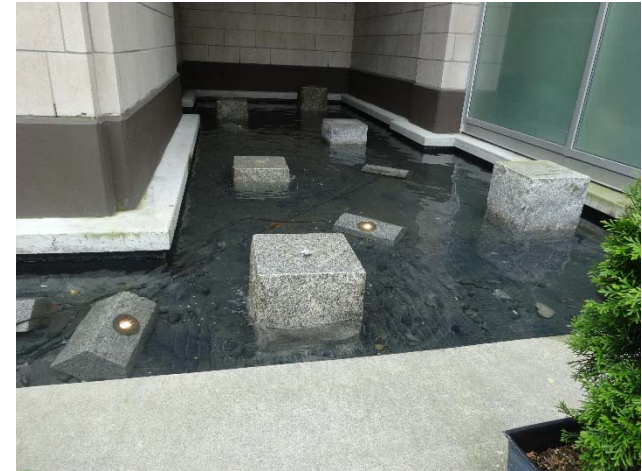
Water features

<b>Phase 1</b>	\$ 10,000	2027	Contingency every 10 years.		
<b>Phase 2</b>	\$ 10,000	2030	Contingency every 10 years.		
<b>Phase 3</b>	\$ 10,000	2033	Contingency every 10 years.		
<b>Preventative Maintenance</b>	Maintenance service should be performed semi annually, and typically includes: draining of the fountain, cleaning scale from heads, cleaning of overflows and strainers. Repair any damaged water feature architectural components.				
<b>Remarks</b>	None.
